# Phase 04 Verification Report

Ardrossan, North Shore

| Document Reference: S3240-018 Ardrossan North Shore | | | | Issue: Issue C |

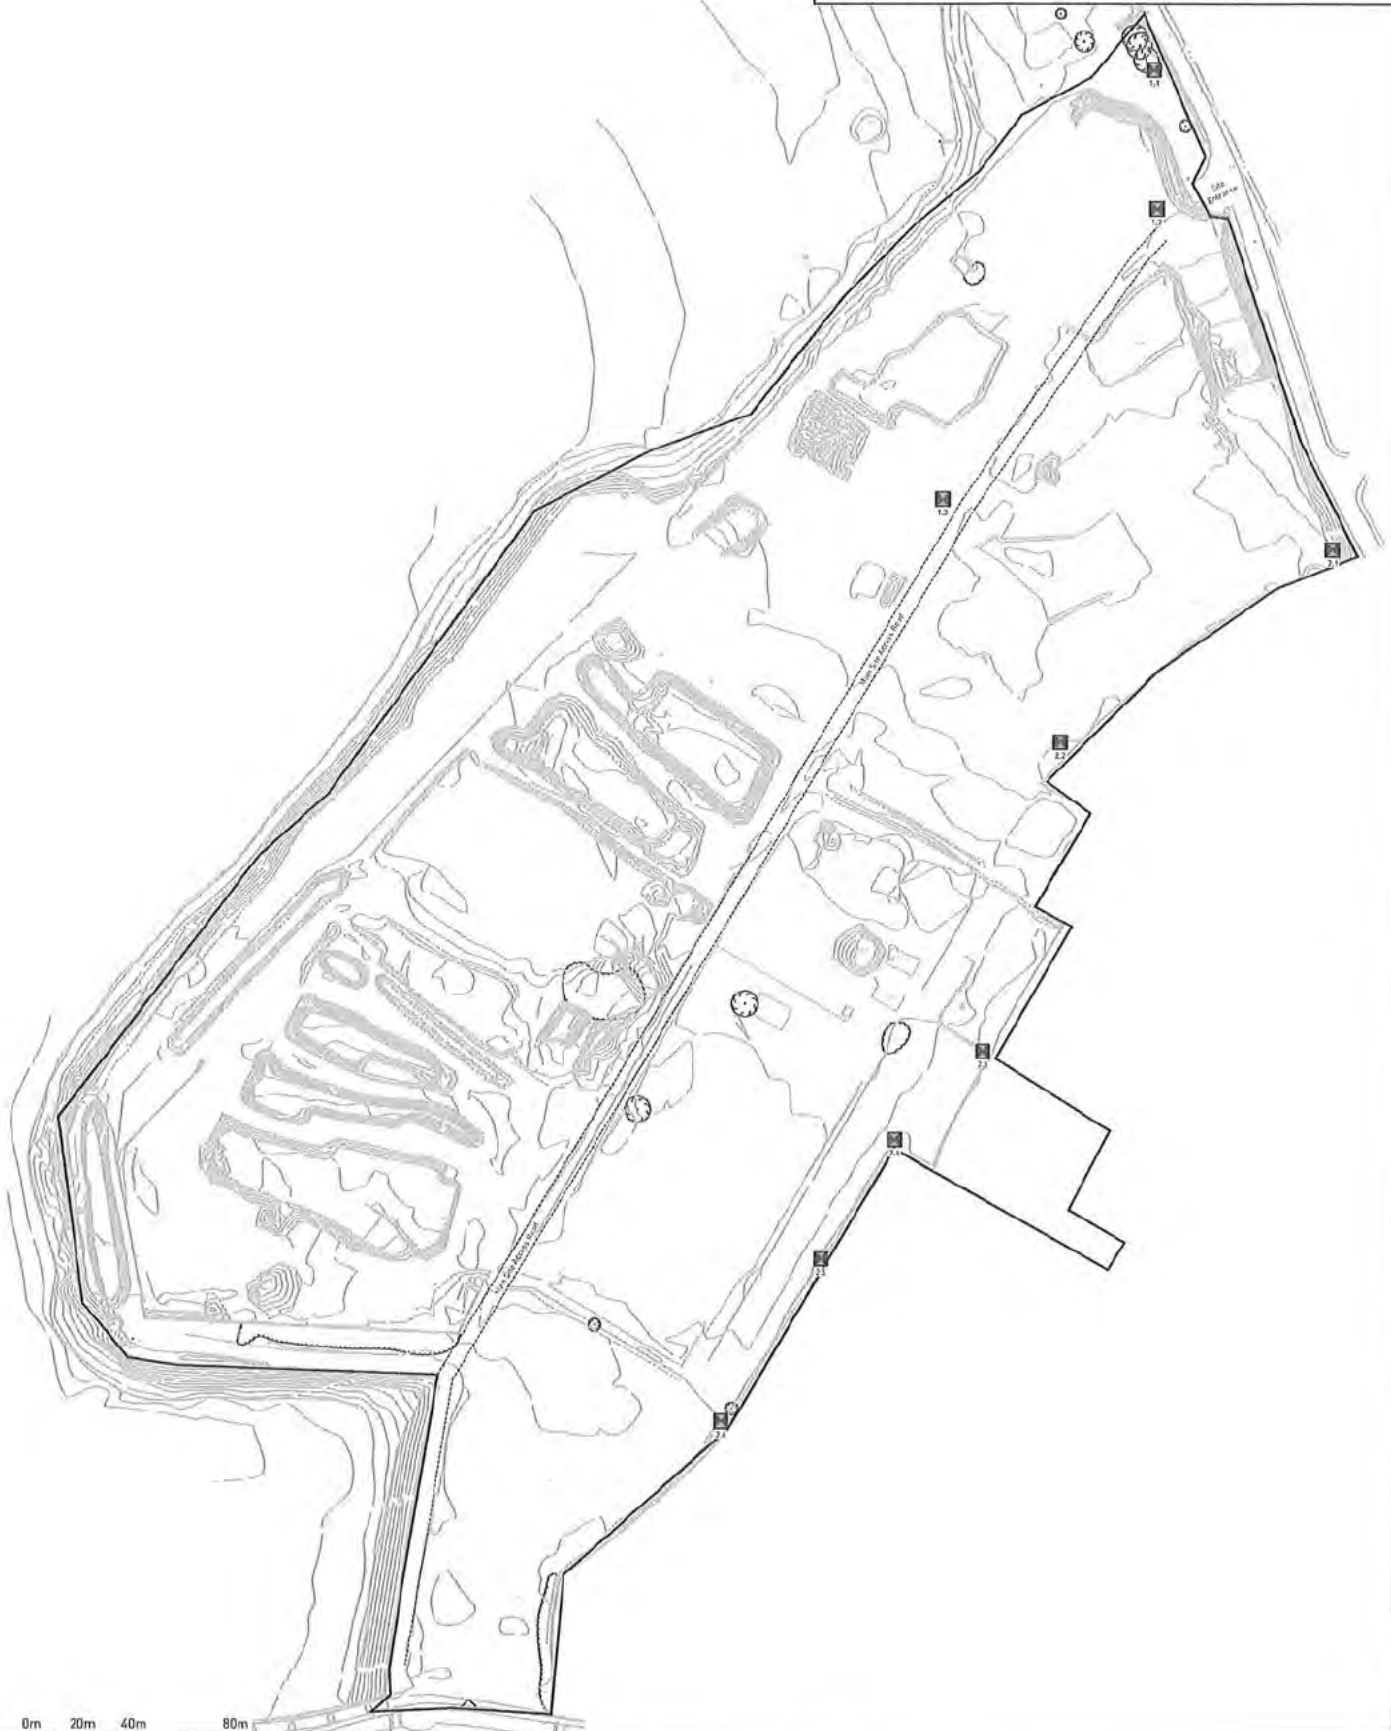
- Site Boundary
- Environmental Monitoring Location (1)
- Approximate Environmental Monitoring Location (2)

Drawing Notes:  
Based on client supplied DWG -  
ARDROSSAN 2D produced by Aird Group  
23/03/2020. All locations are approximate.  
Must be printed in colour. Refer to  
D3249/009 for WTA Schematic.

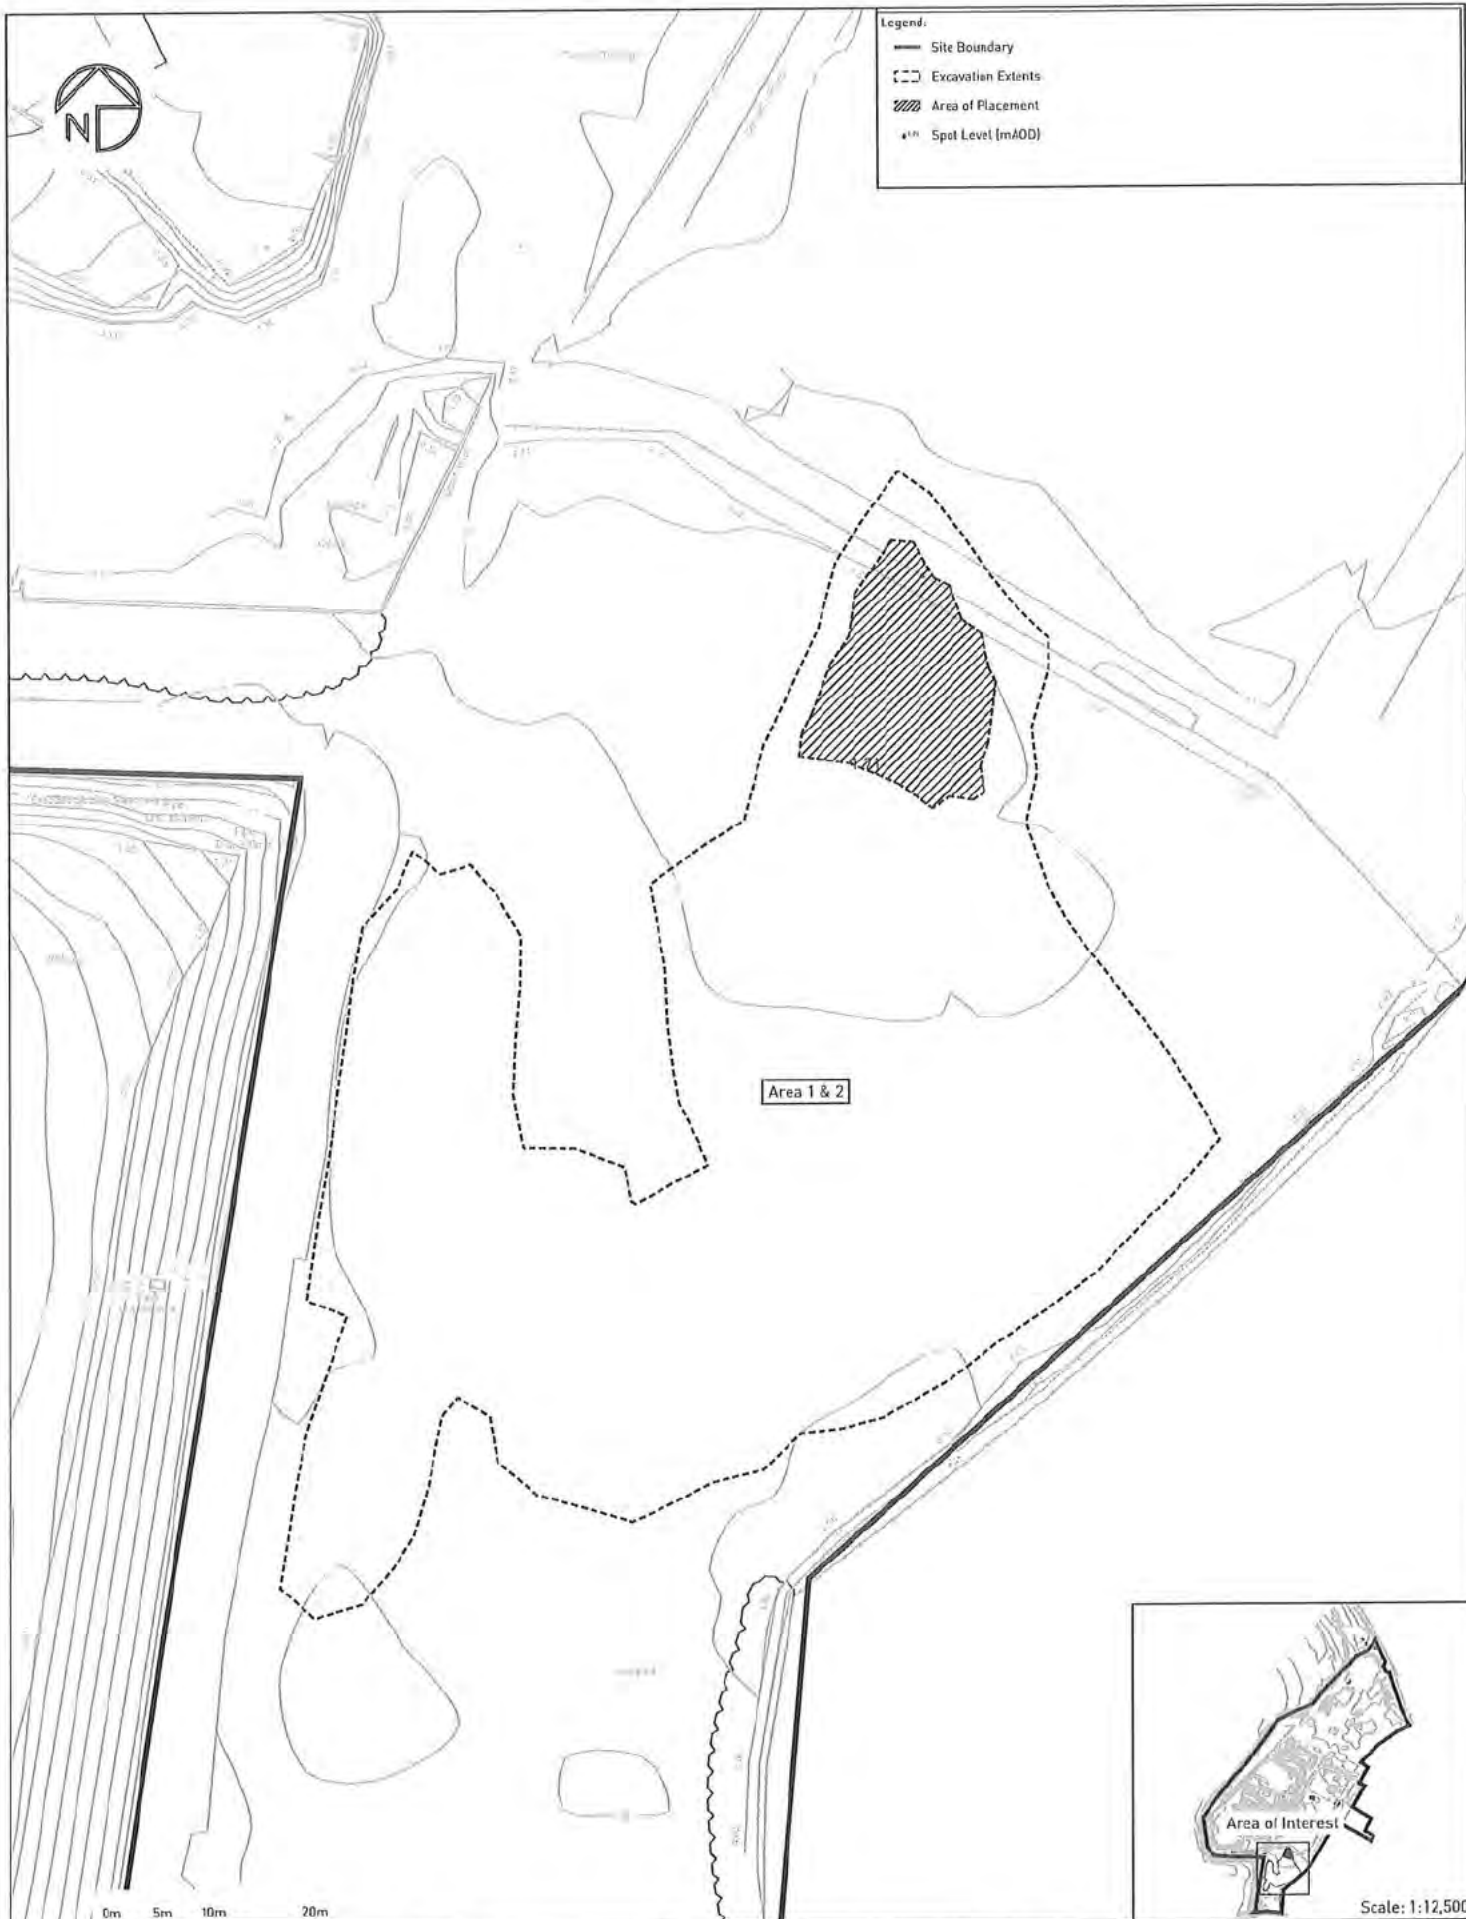
Drawing Notes:  
Based on client supplied DWG -  
AR080SSAN 2D produced by Aird Group,  
23/03/2020. Validation locations surveyed  
by Sanctus Engineer. Must be printed in  
colour.

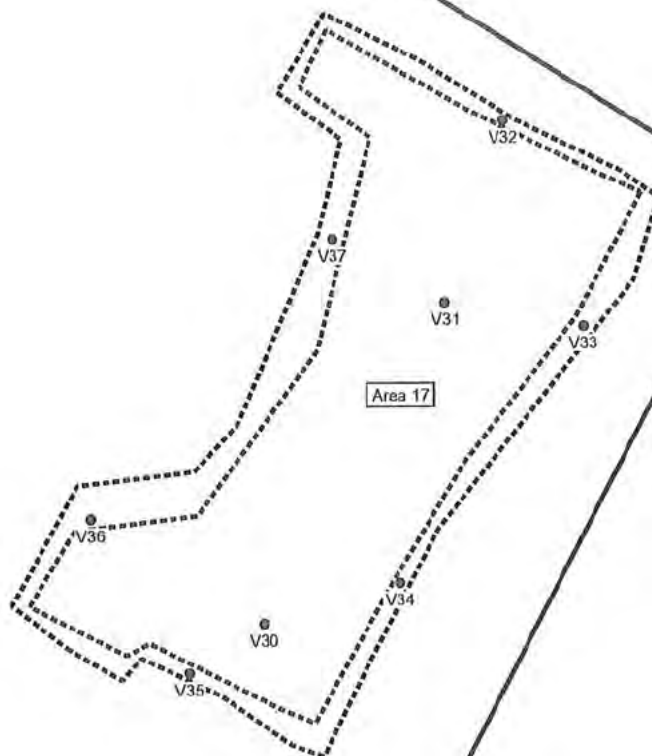
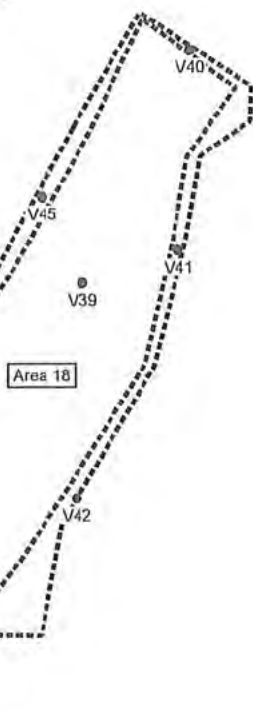
- Legend:
- Site Boundary
  - Sanctus Validation Sample Location
  - Excavation Extents
  - Base of Batter
  - Approximate Cell Division Line

Note: Validation Drawings 082-088 to be Read in Conjunction with each other.

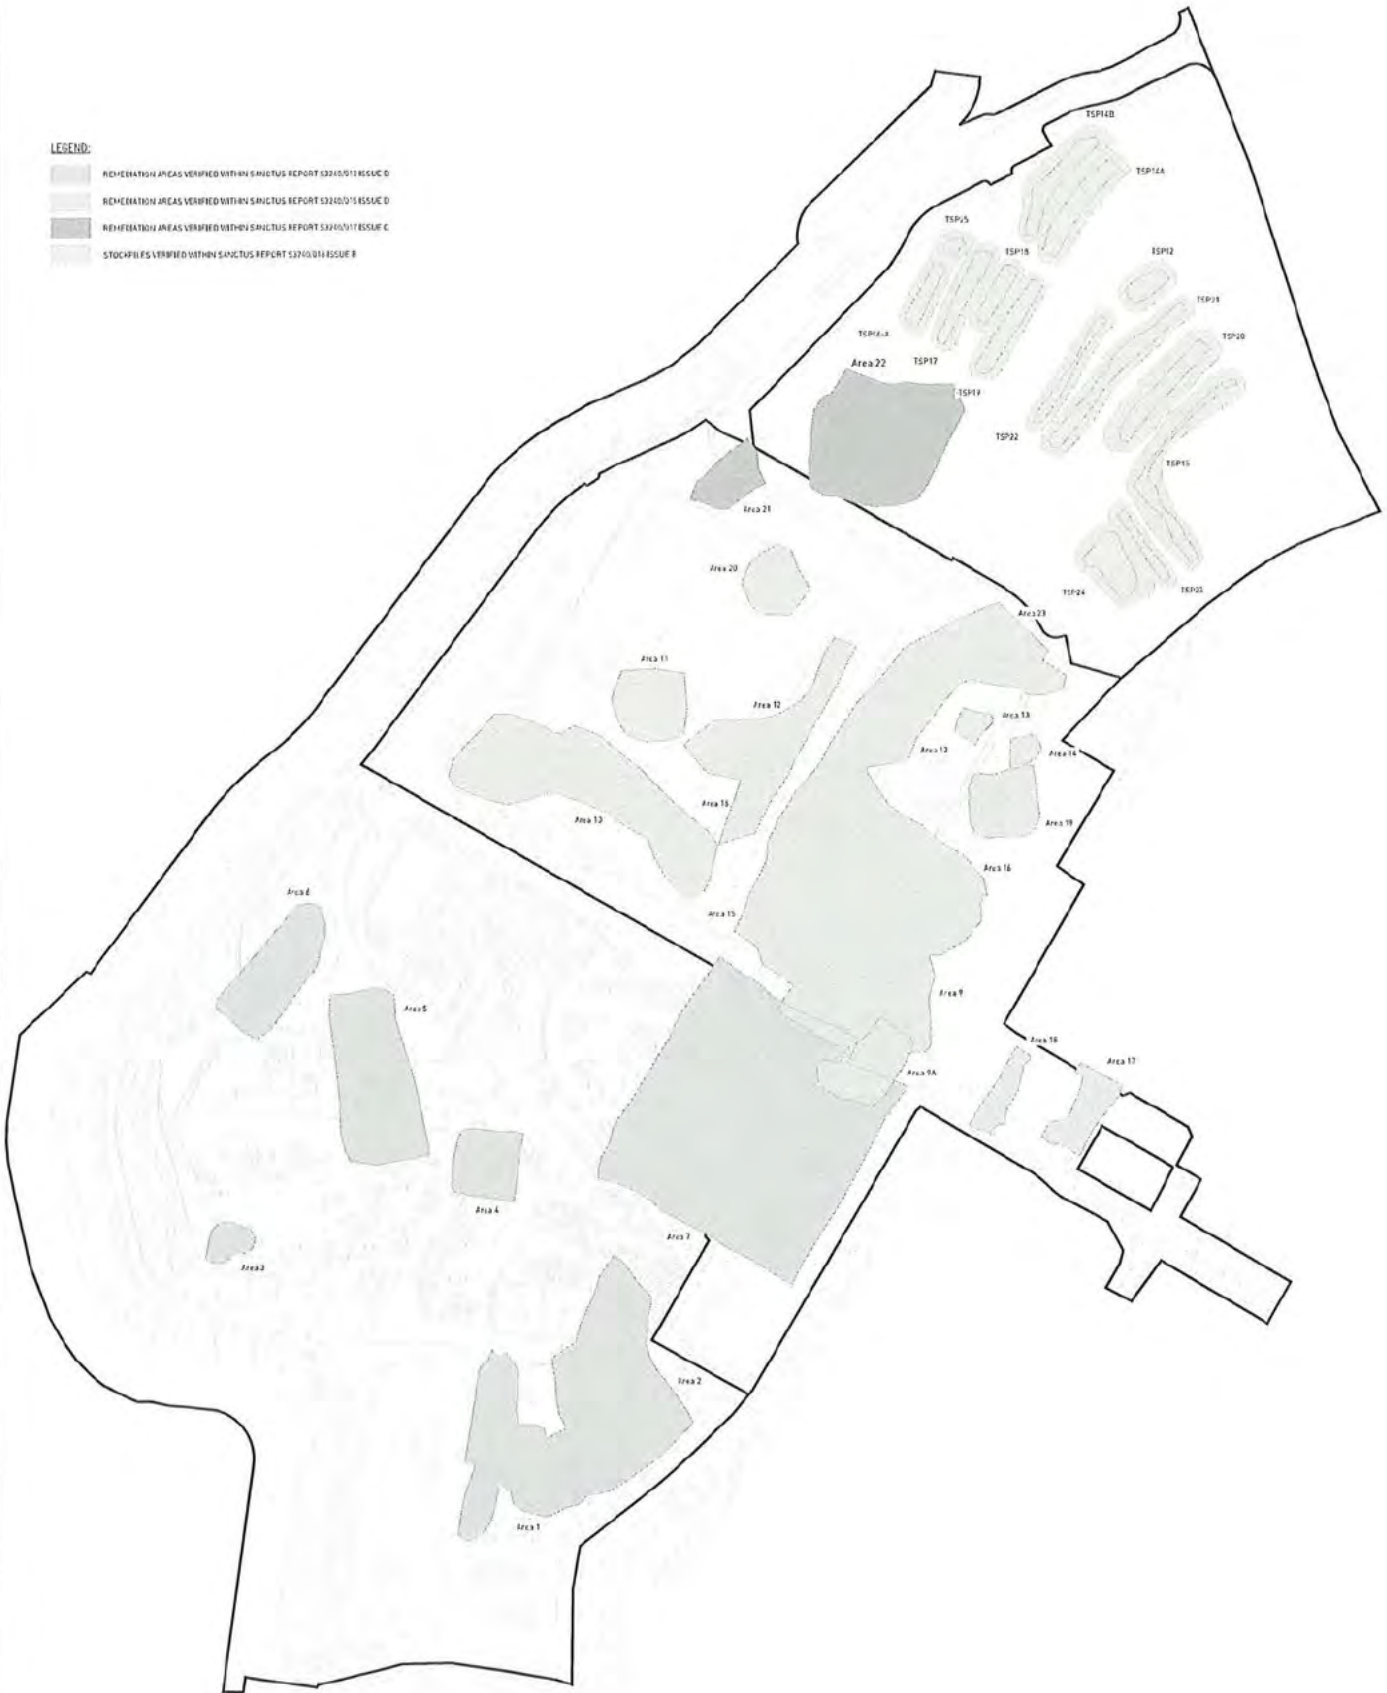
- REHABILITATION AREAS VERIFIED WITHIN SANCTUS REPORT 53210/011 ISSUE D
- REHABILITATION AREAS VERIFIED WITHIN SANCTUS REPORT 53210/011 ISSUE D
- REHABILITATION AREAS VERIFIED WITHIN SANCTUS REPORT 53210/011 ISSUE C
- STOCKPILES VERIFIED WITHIN SANCTUS REPORT 53210/011 ISSUE B
