Contract Name: Ardrossan, North Shore

**Appendix F S3240-015 Phase 02 Verification Report:
S3240-015**

Phase 02 Verification Report

Ardrossan, North Shore

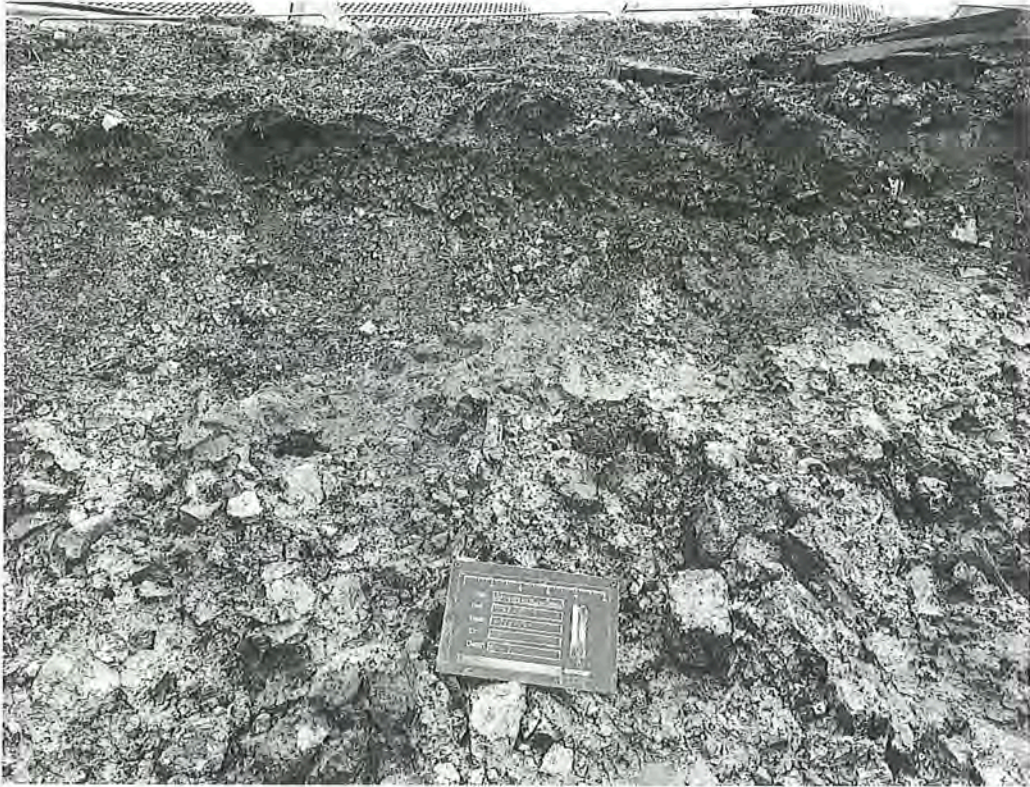
Plate No.: 1

Title.: Area 01 Eastern Face from 1.75 – 4.30m bgl.

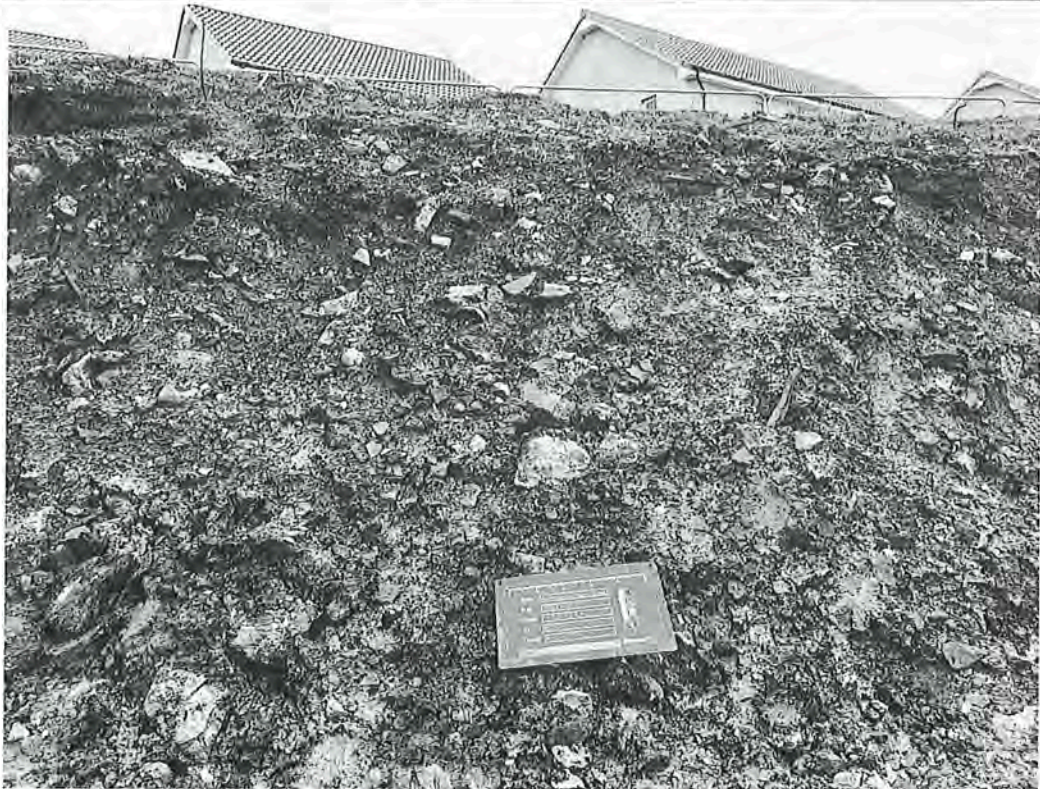
Plate No.: 2

Title.: Area 01 Eastern Face from 1.75 – 4.30m bgl.

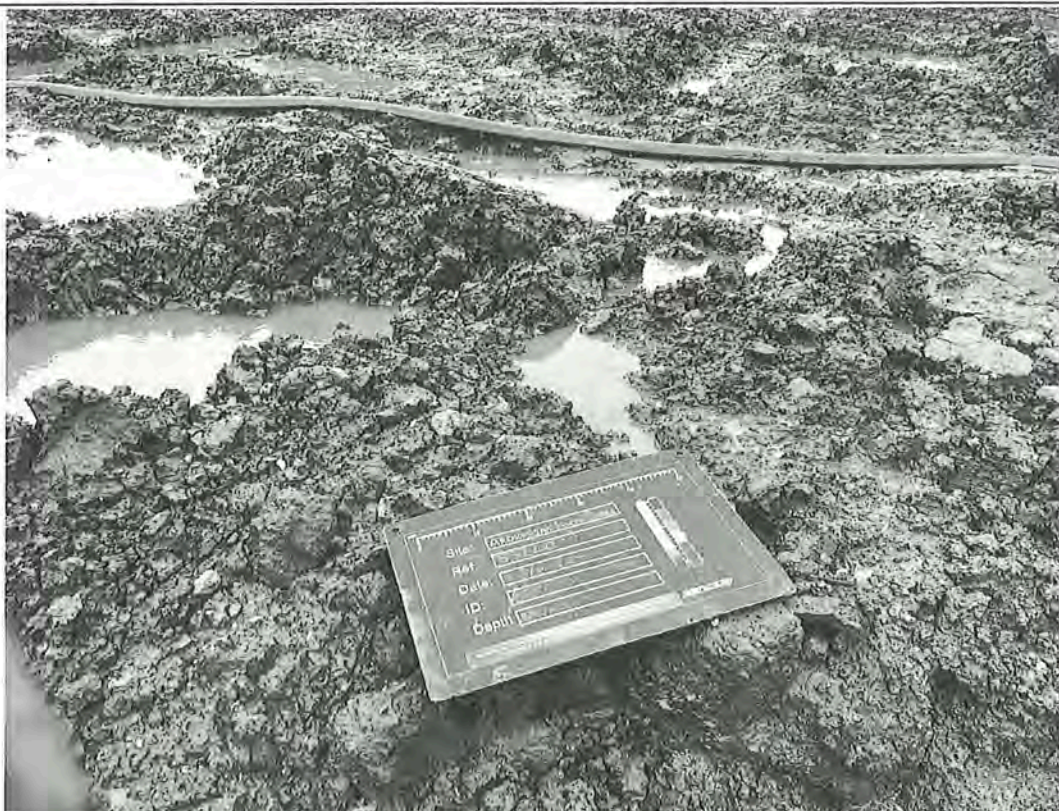
Plate No.: 3

Title.: Area 01 Excavation Base from 4.30m bgl.

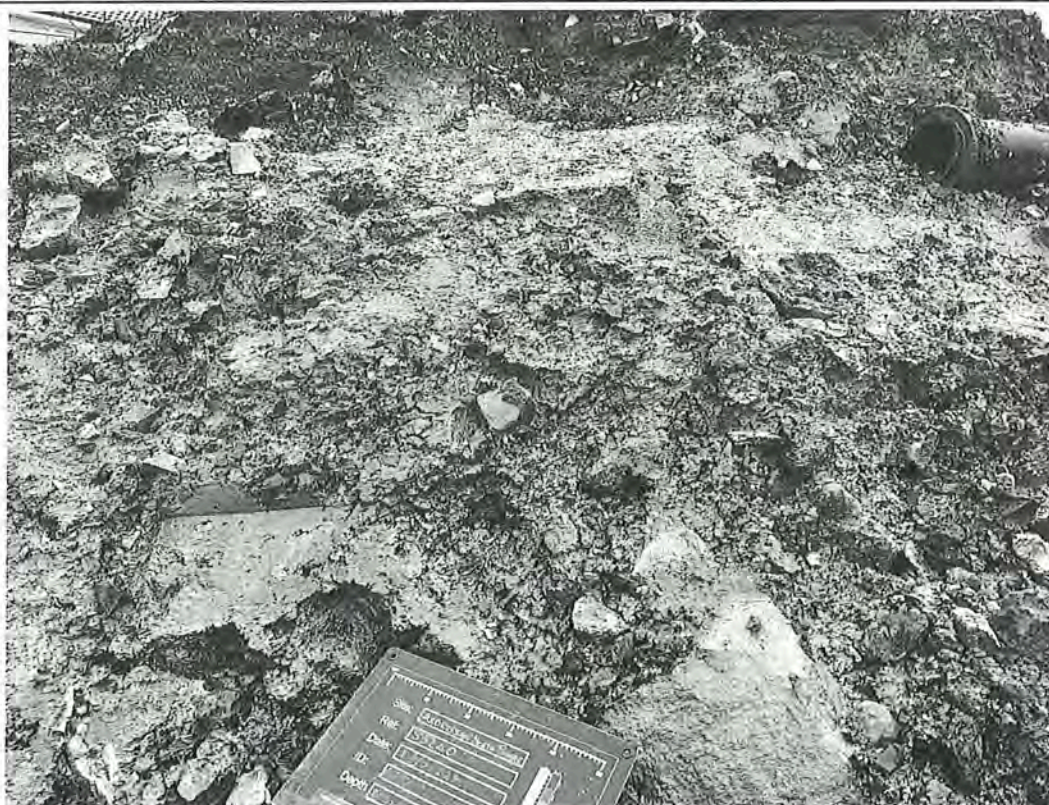
Plate No.: 4

Title.: Area 01 Excavation Base from 4.30m bgl.

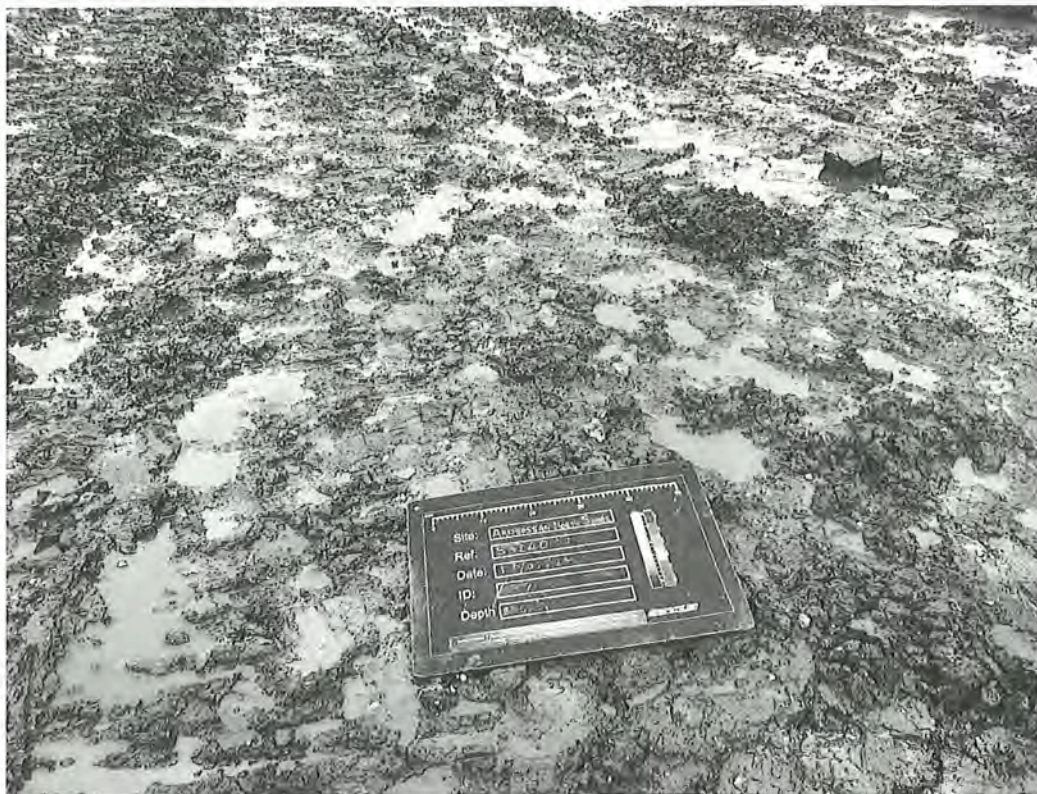
Plate No.: 5

Title.: Area 01 Excavation Base from 4.30m bgl.

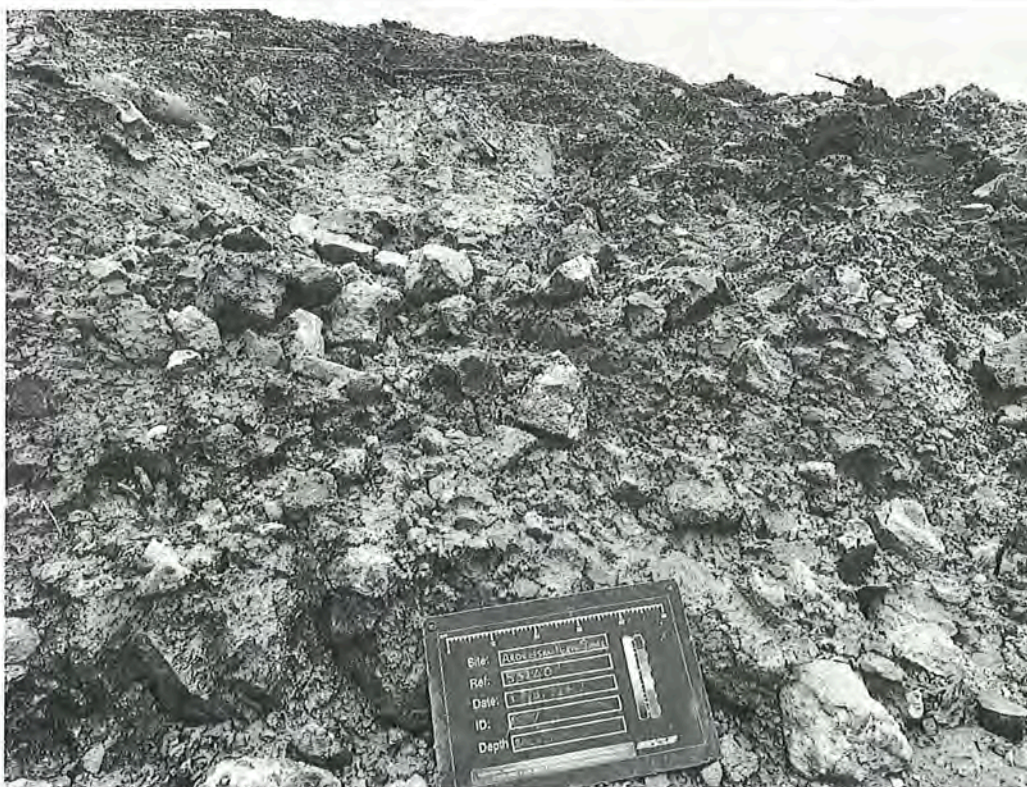
Plate No.: 6

Title.: Area 01 Southern Extent from 1.75 – 4.30m bgl

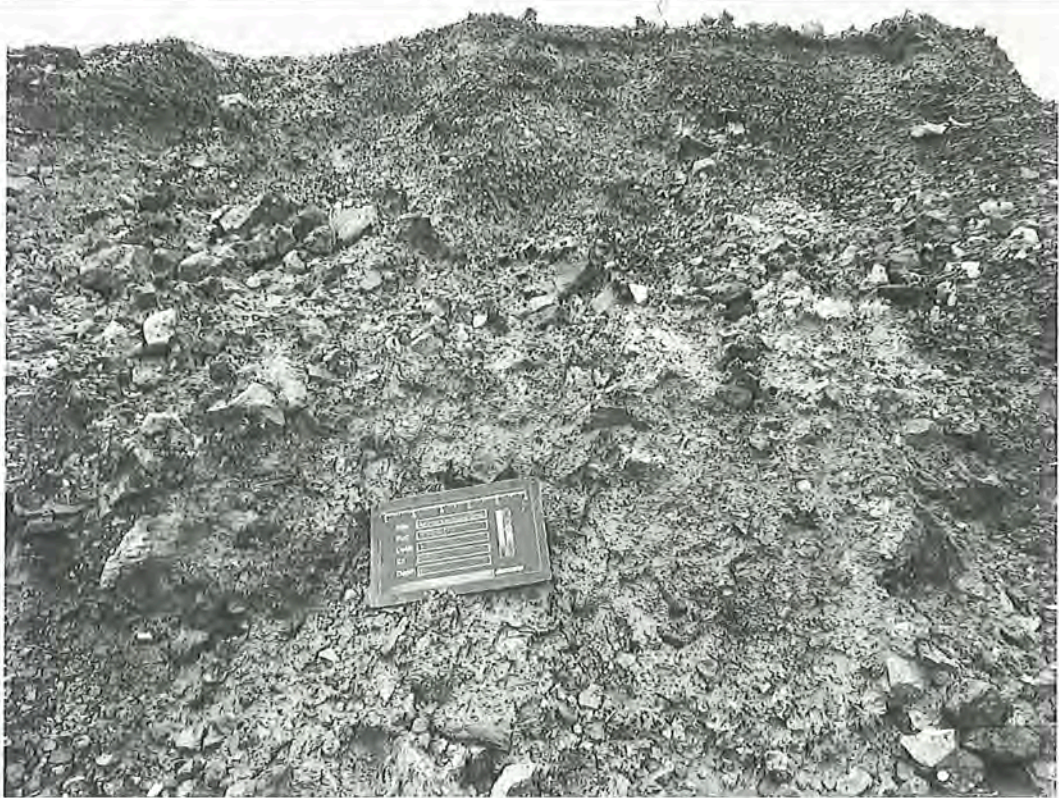
Plate No.: 7

Title.: Area 01 Western Face from 1.75 – 4.30m bgl.

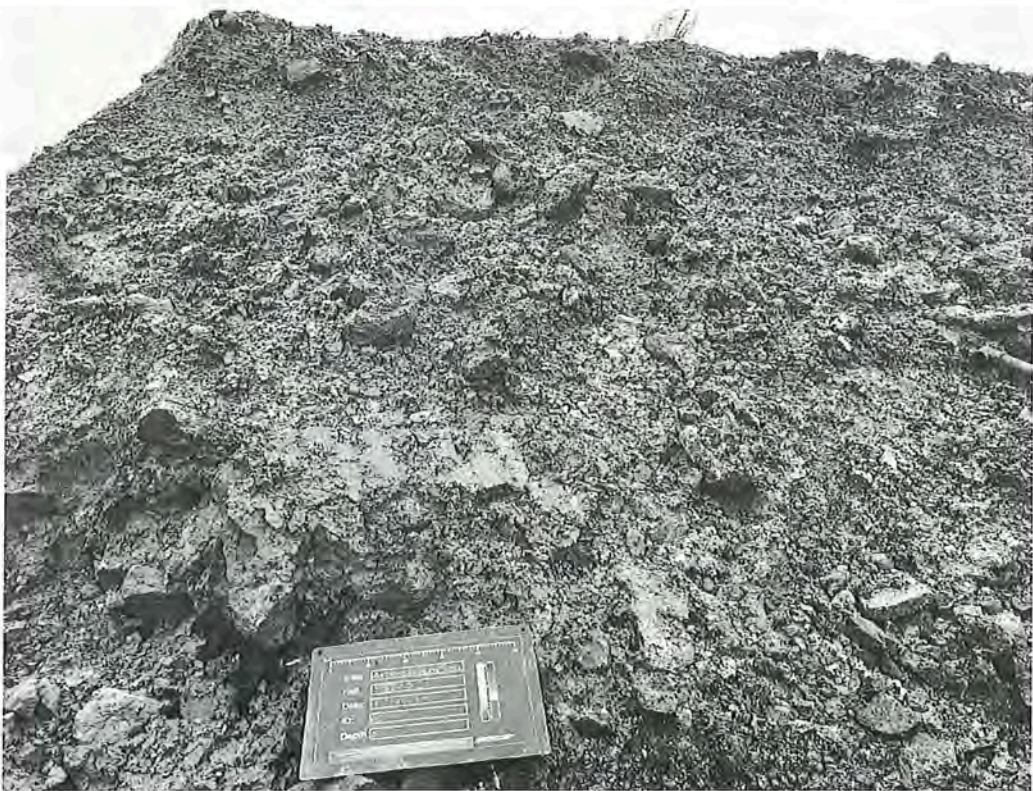
Plate No.: 8

Title.: Area 01 Western Face from 1.75 – 4.30m bgl.

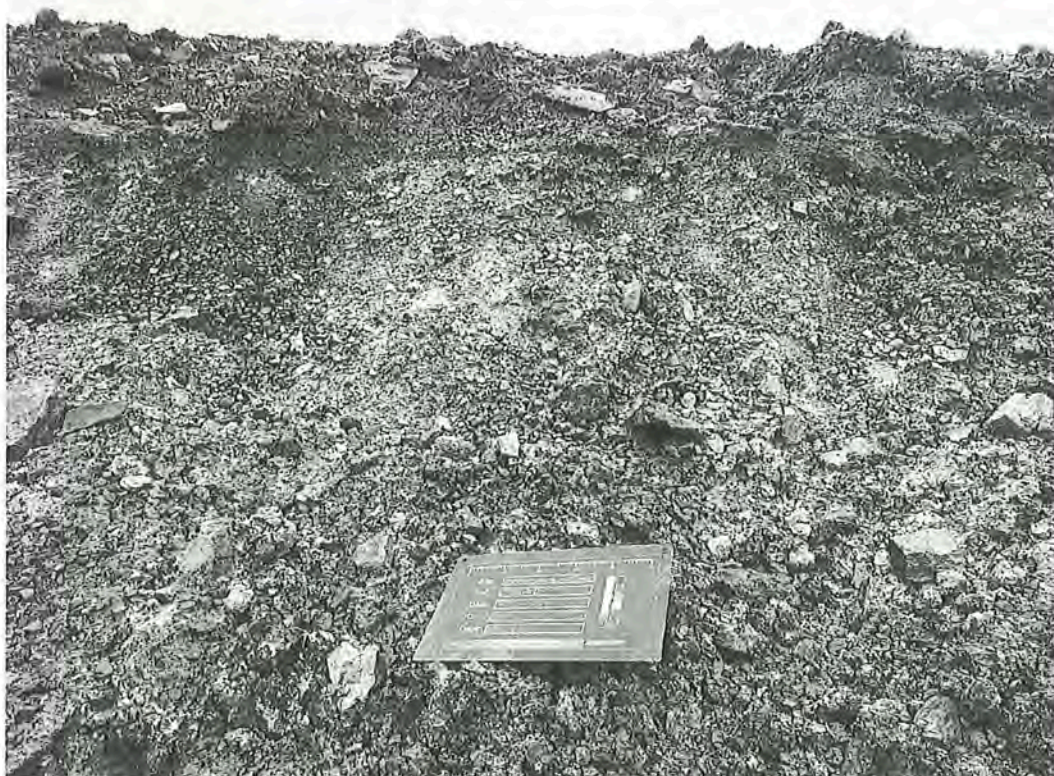
Plate No.: 9

Title.: Area 01 Northern Face from 1.75 – 4.30m bgl.

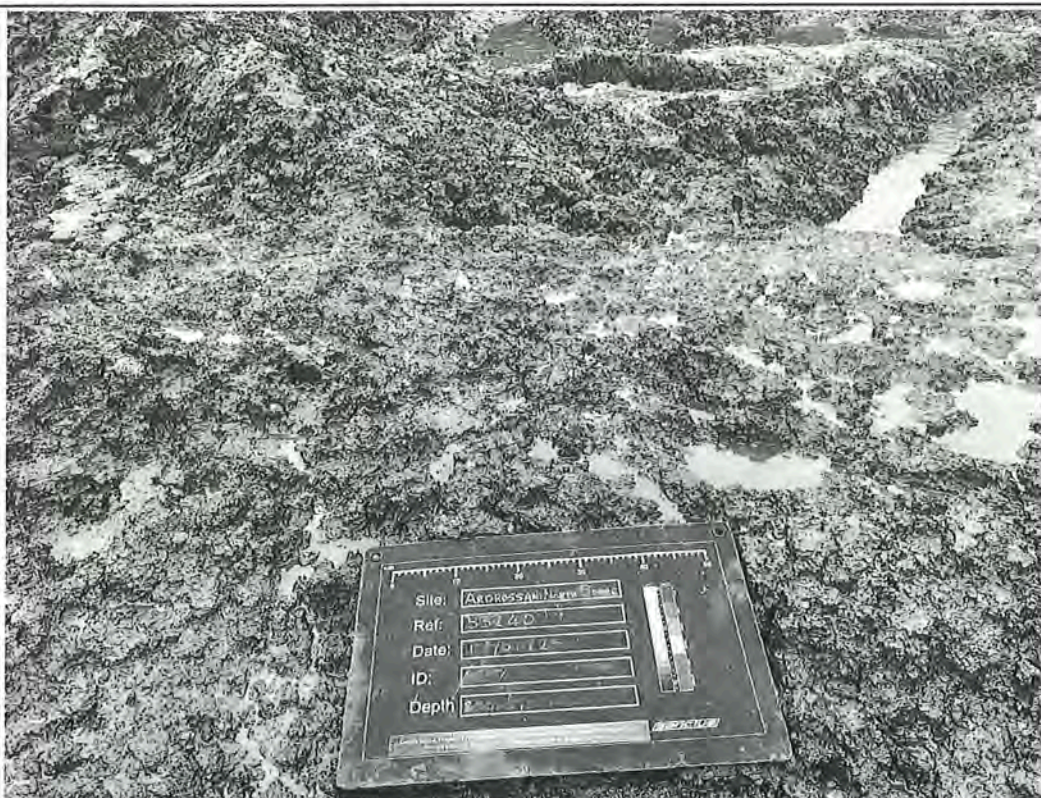
Plate No.: 10

Title.: Area 01 Excavation Base from 1.75 – 4.30m bgl.

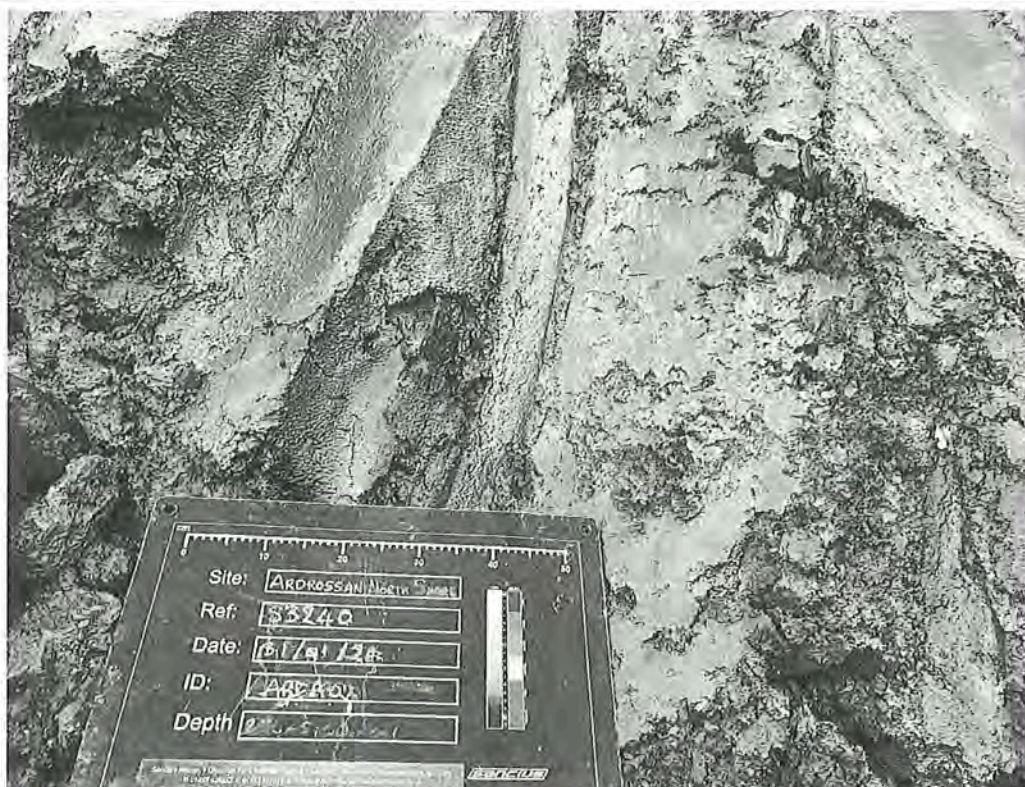
Plate No.: 11

Title.: Area 02 Northern Face from 1.75 – 4.30m bgl.

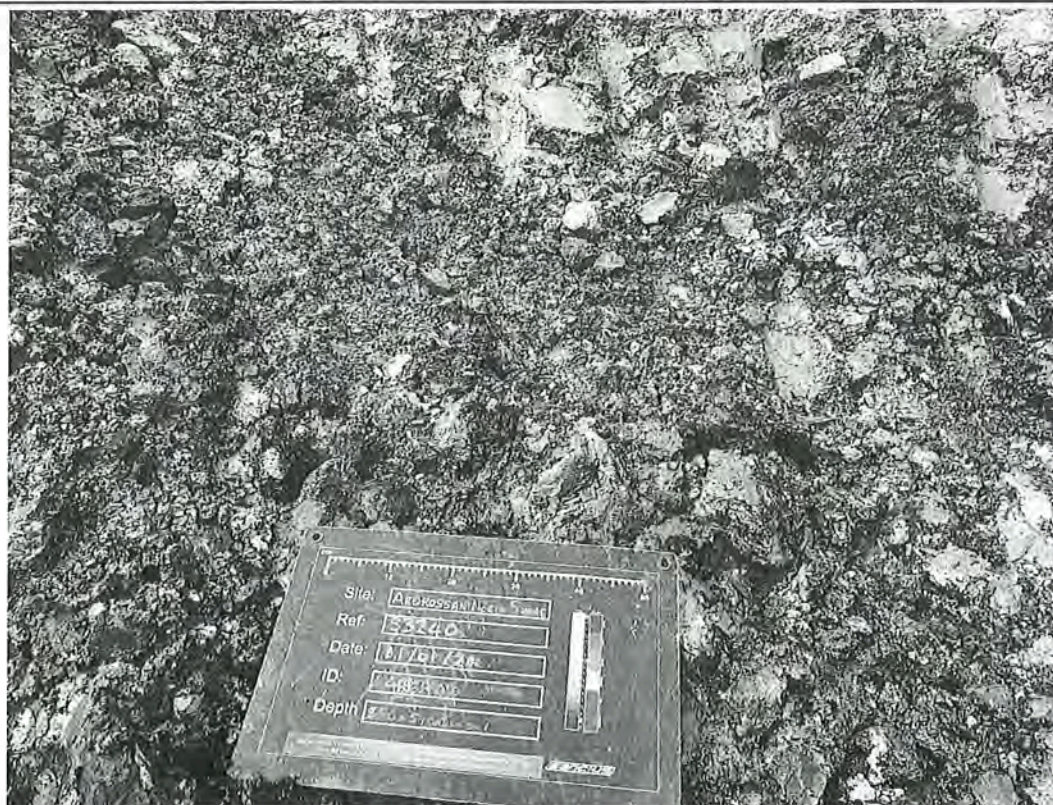
Plate No.: 12

Title.: Area 02 Northern Face from 1.75 – 4.30m bgl.

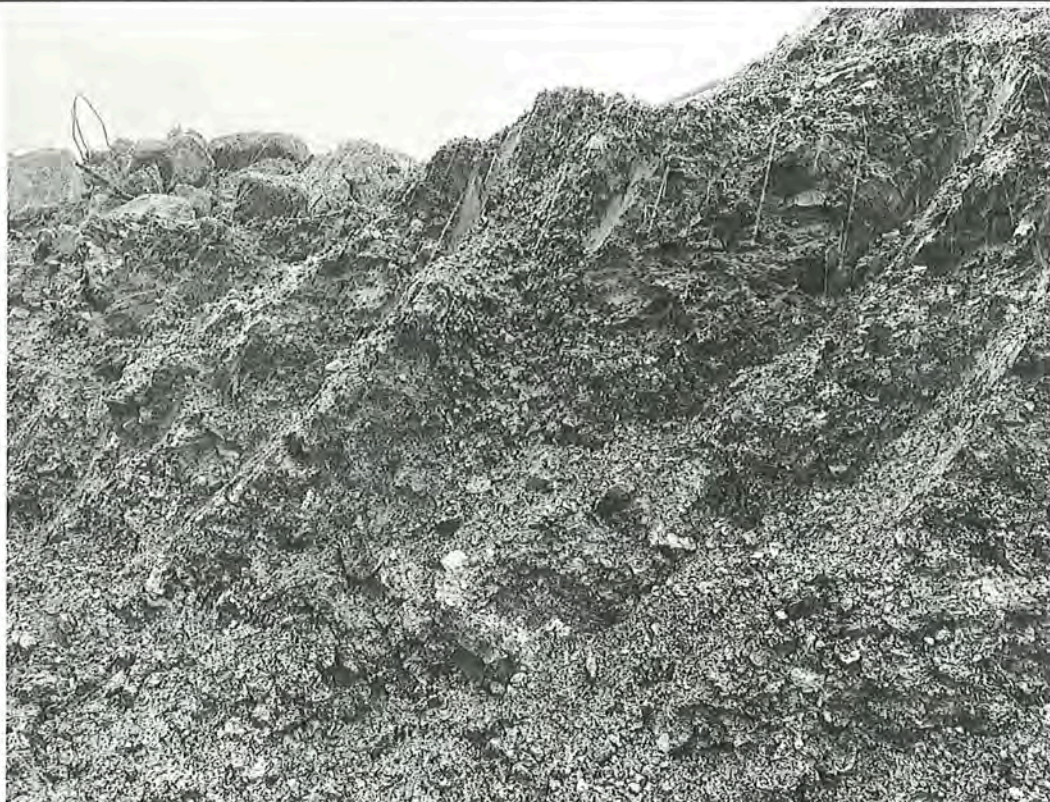
Plate No.: 13

Title.: Area 02 Eastern Face from 1.75 – 4.30m bgl.

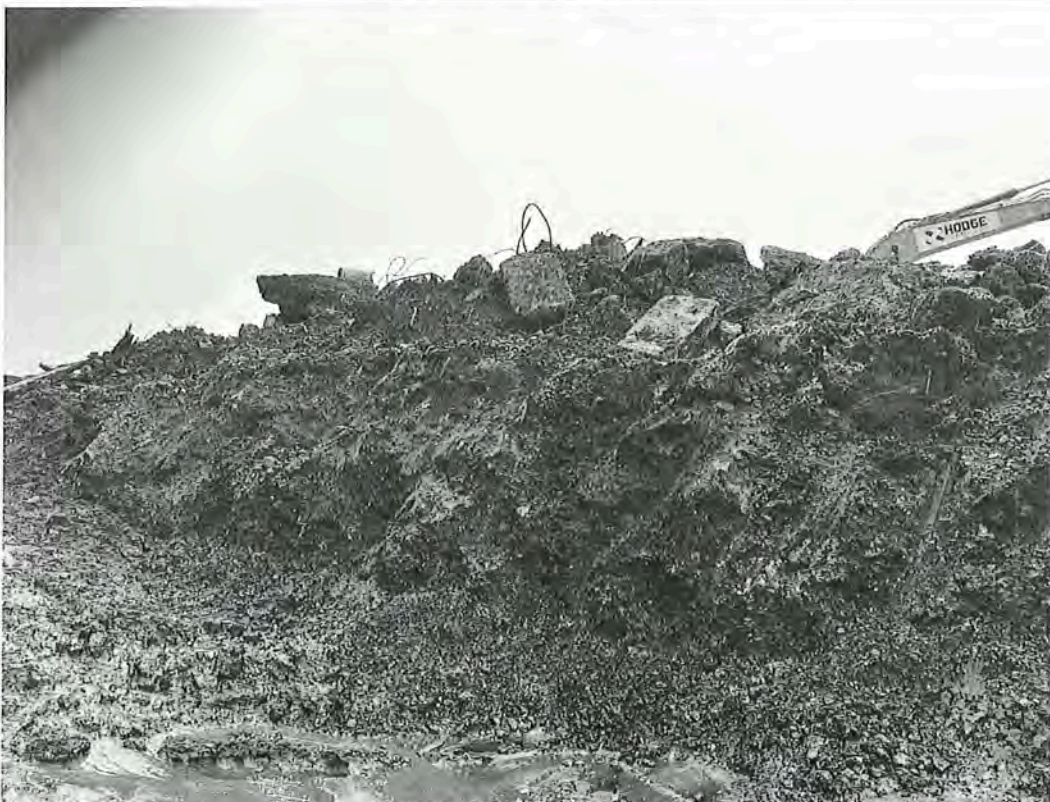
Plate No.: 14

Title.:Area 02 Western Face from 1.75 – 4.30m bgl.

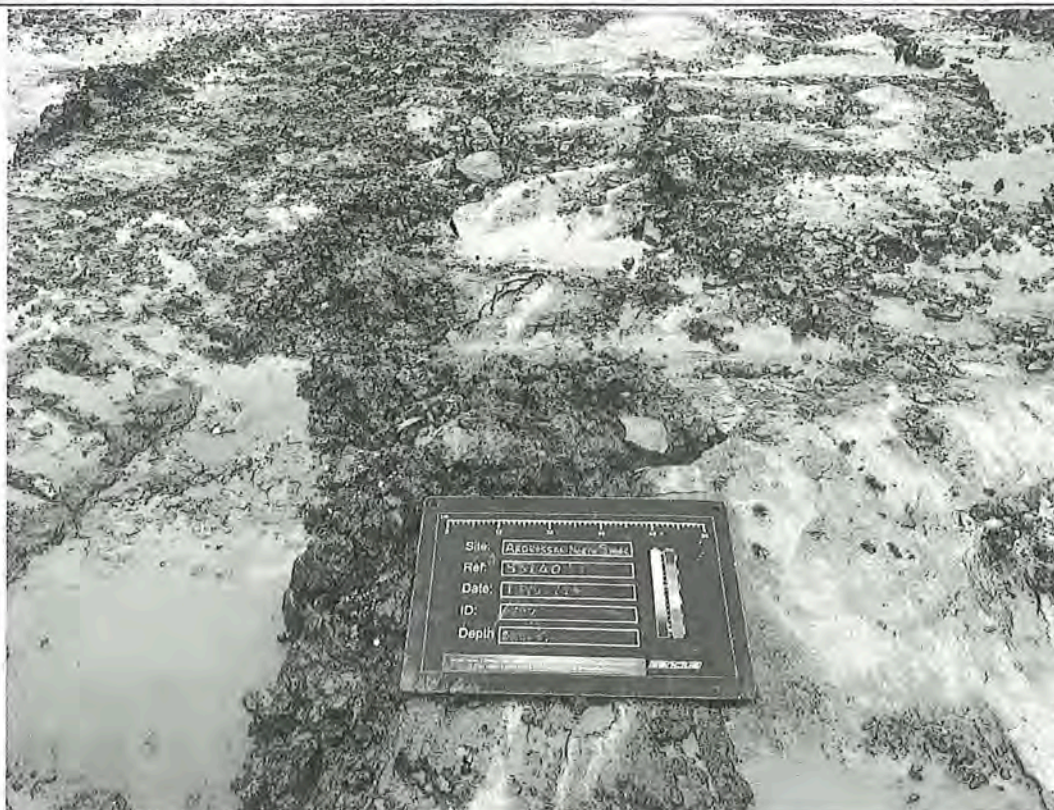
Plate No.: 15

Title.: Area 02 Validation.

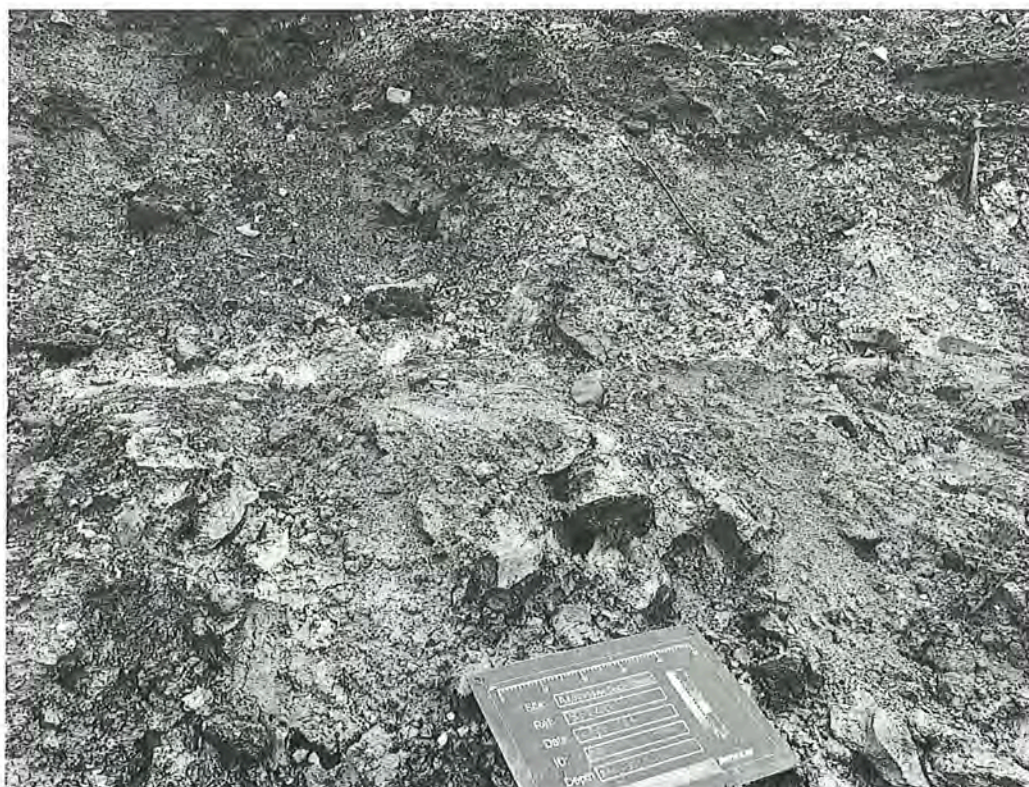
Plate No.: 16

Title.: Area 02 Base from 4.30m bgl.

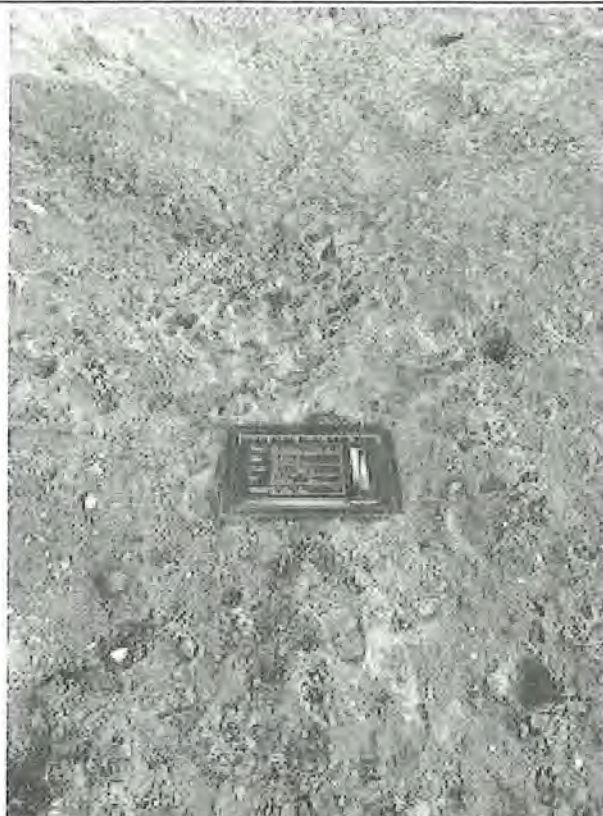
Plate No.: 17

Title.: Area 03 V001 Excavation Base 2.10m bgl

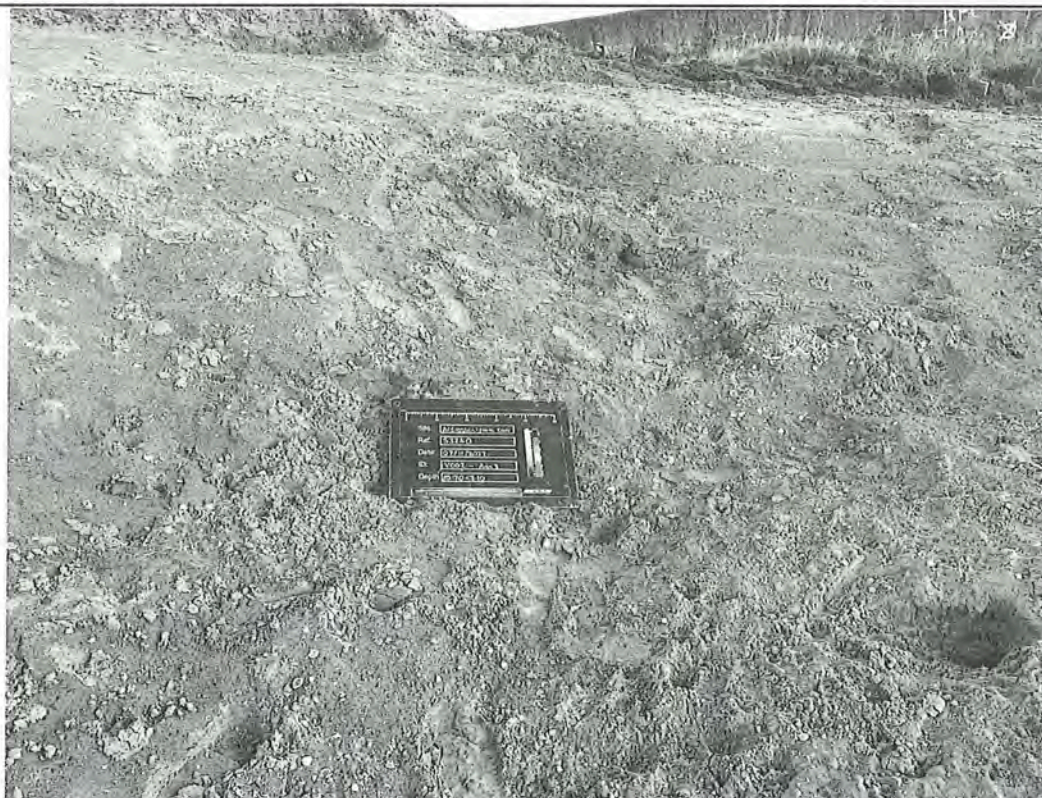
Plate No.: 18

Title.: Area 03 V002 Eastern Face 0.70 – 2.10m bgl

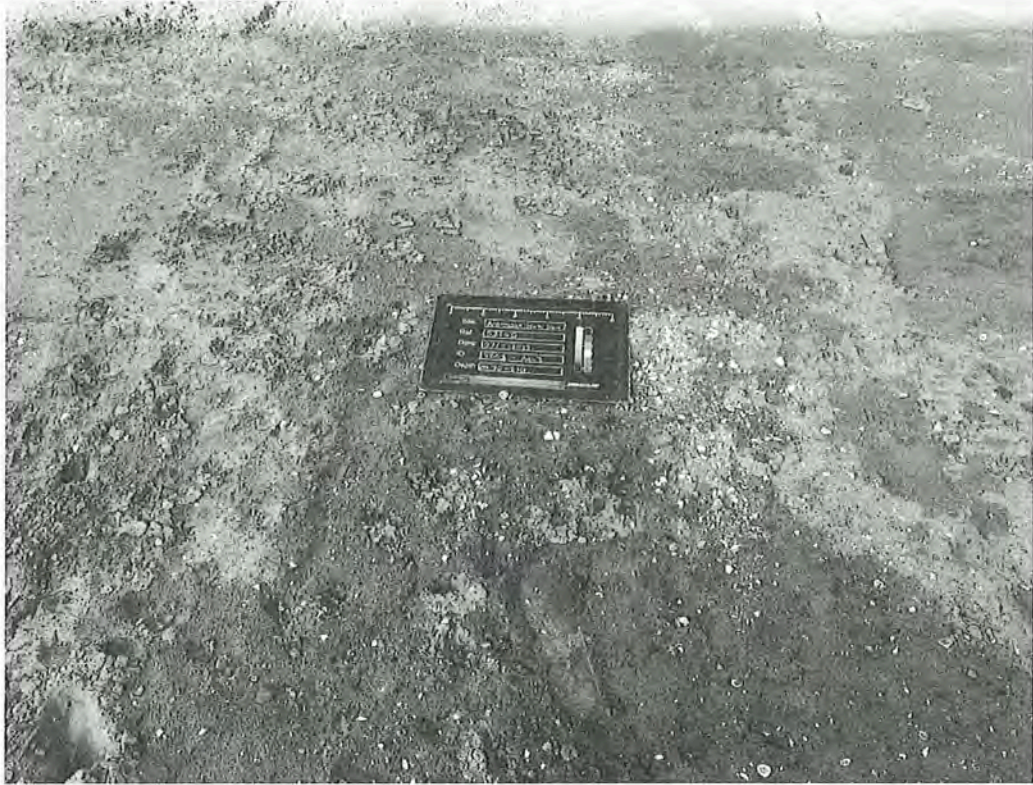
Plate No.: 19

Title.: Area 03 V003 Northern Extent 0.70 – 2.10m bgl

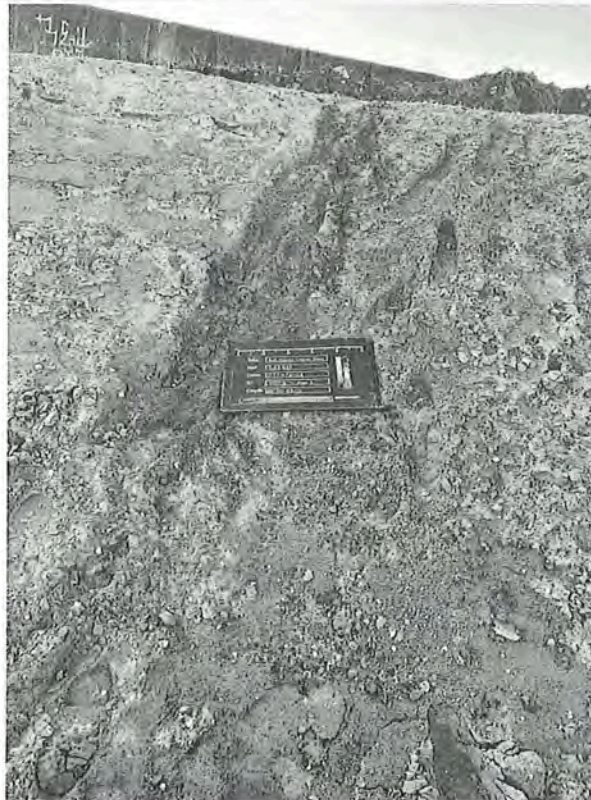
Plate No.: 20

Title.: Area 03 V004 Western Extent 0.70 – 2.10m bgl

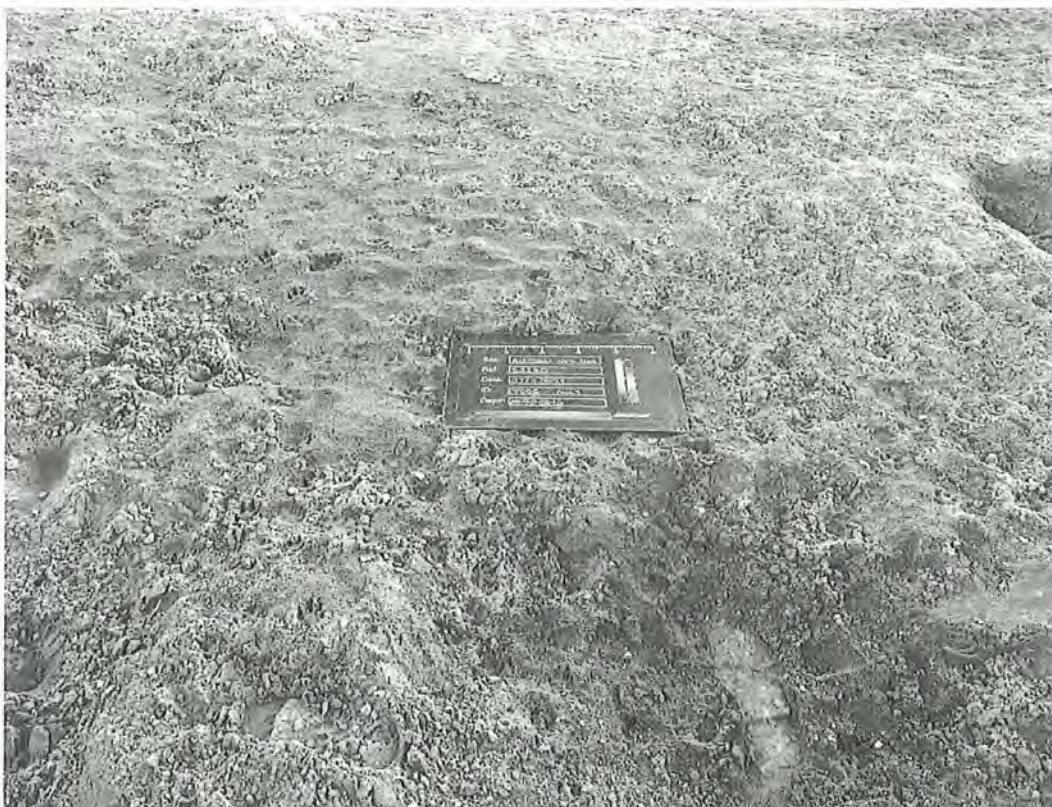
Plate No.: 21

Title.: Area 03 V005 Southern Extent 0.70 – 2.10m bgl

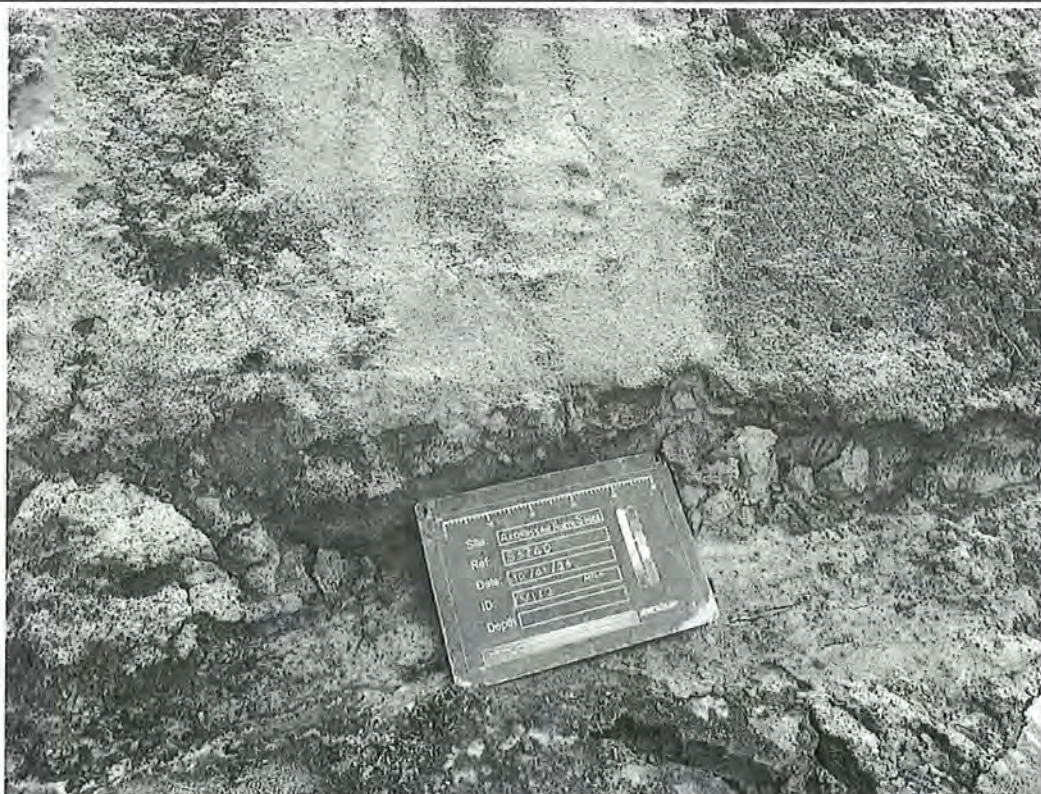
Plate No.: 22

Title.: Area 04 V112 Northern Extent from 0.00 – 4.50m bgl

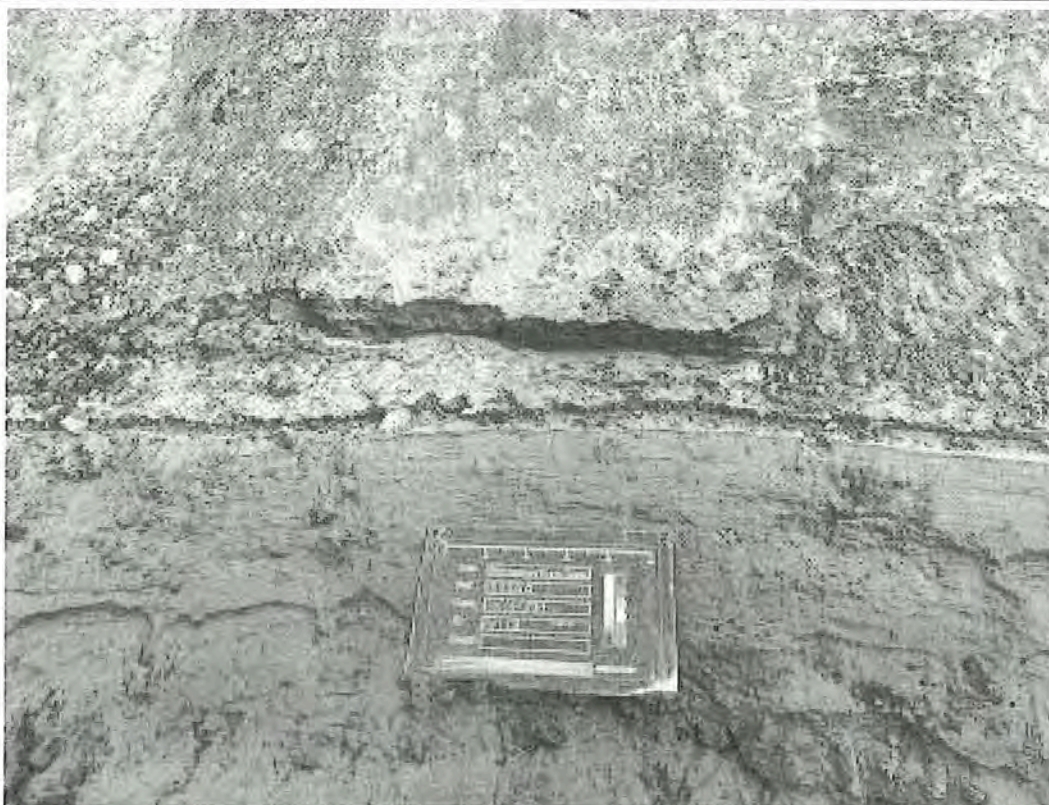
Plate No.: 23

Title.: Area 04 V113 Northern Extent from 0.00 – 4.50m bgl

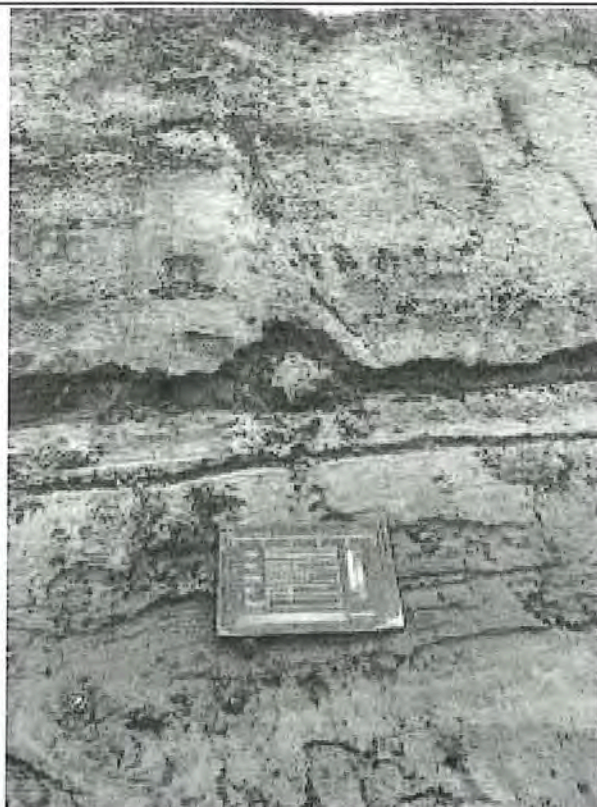
Plate No.: 24

Title.: Area 04 V114 Eastern Extent 0.00 – 4.50m bgl

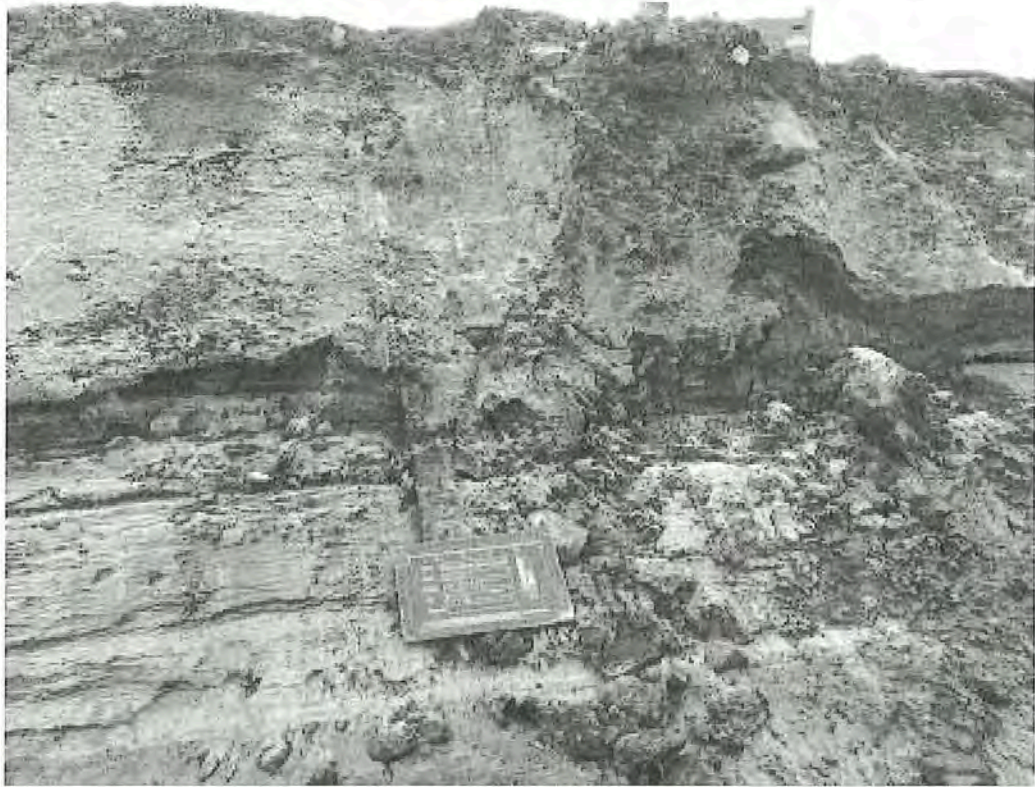
Plate No.: 25

Title.: Area 04 V115 Eastern Extent from 0.00 – 4.50m bgl.

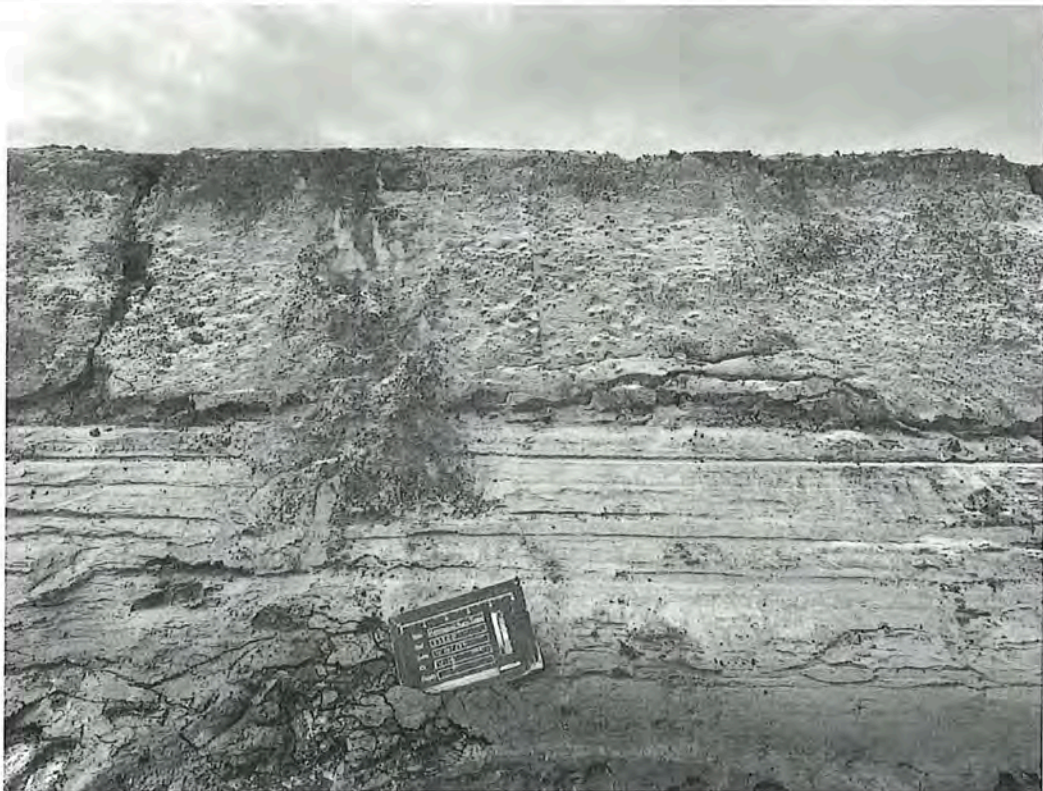
Plate No.: 26

Title.: Area 04 V116 Eastern Extent from 0.00 – 4.50m bgl

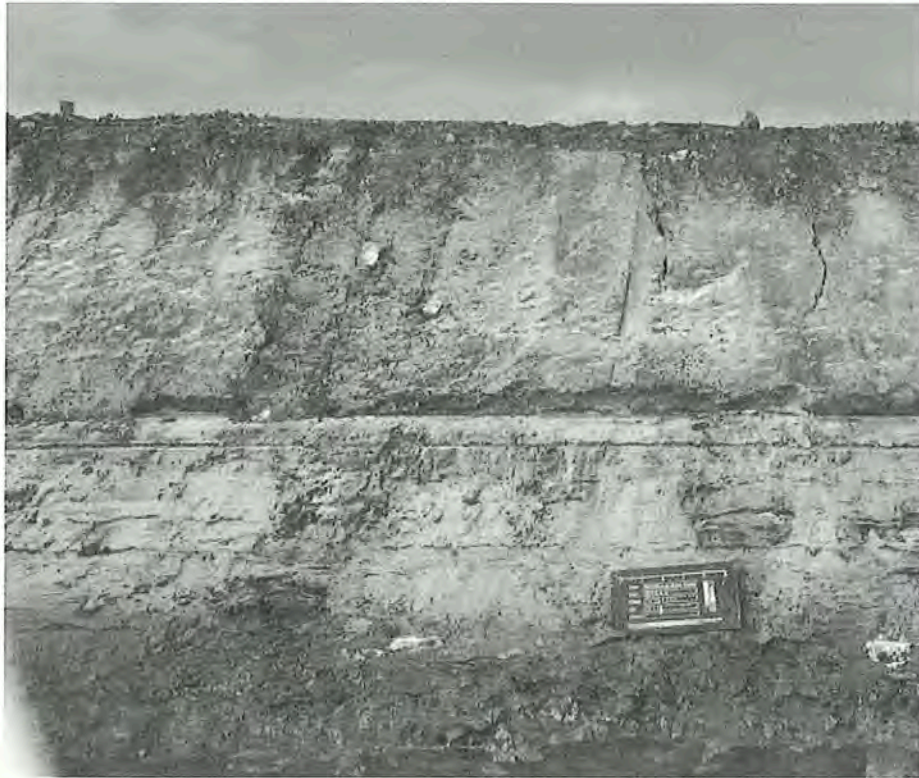
Plate No.: 27

Title.: Area 04 V117 Southern Extent from 0.00 – 4.50m bgl.

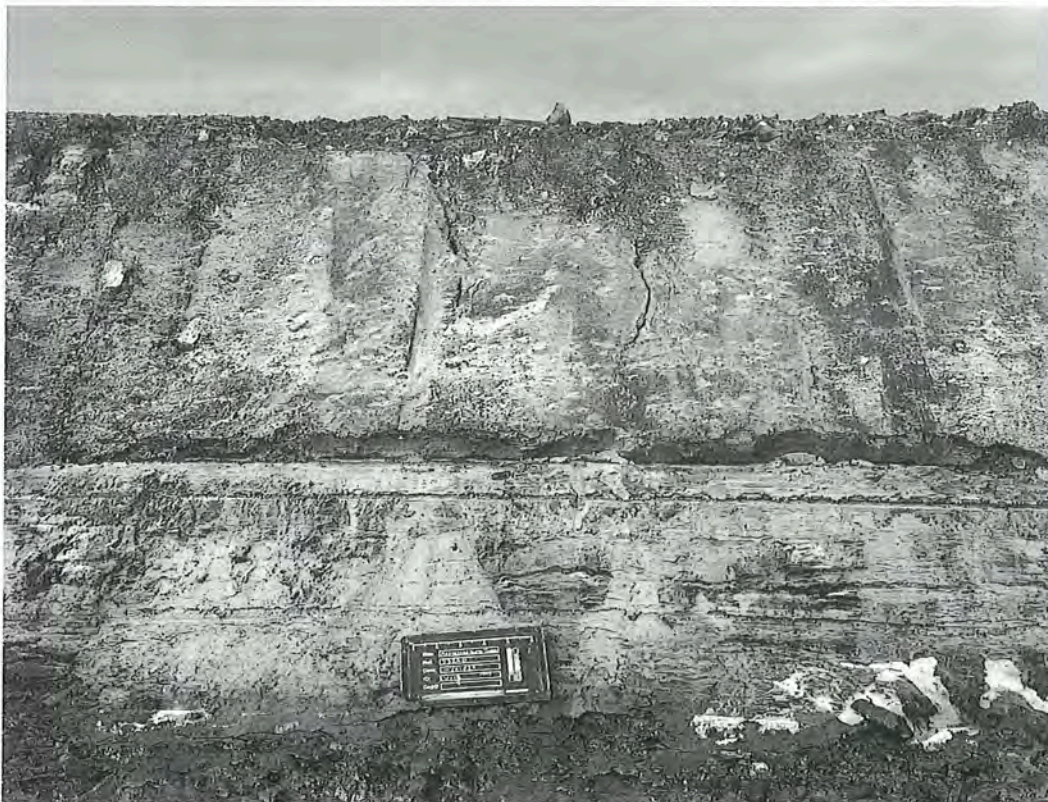
Plate No.: 28

Title.: Area 04 V118 Western Extent from 0.0 – 4.50m bgl.
