Contract Name: Ardrossan, North Shore

**Appendix F S3240-015 Phase 02 Verification Report:
S3240-015**

Phase 02 Verification Report

Ardrossan, North Shore

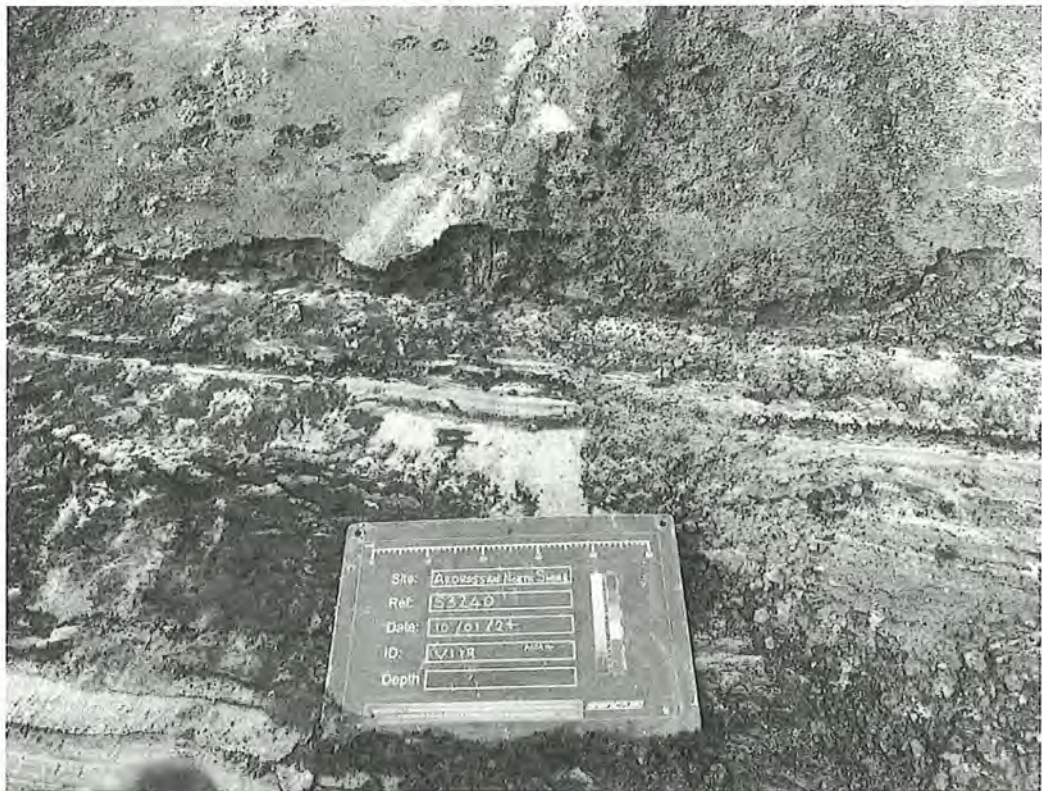
Plate No.: 29

Title.: Area 04 V119 Western Extent 0.00 – 4.50m bgl

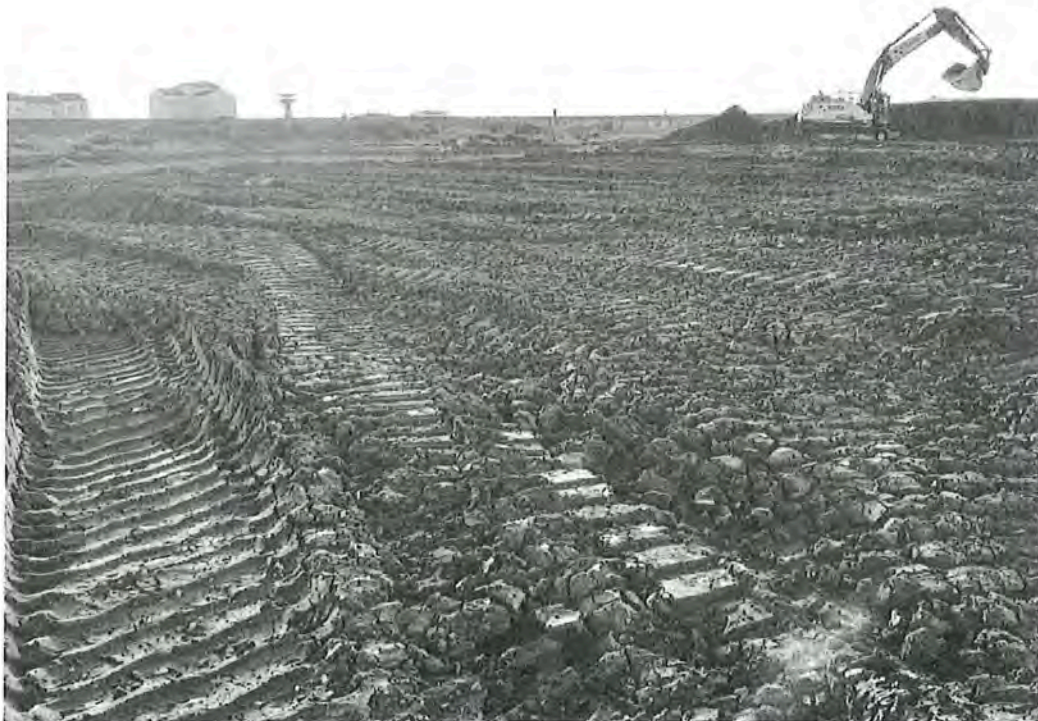
Plate No.: 32

Title.: Area 04 Backfilled Excavation.

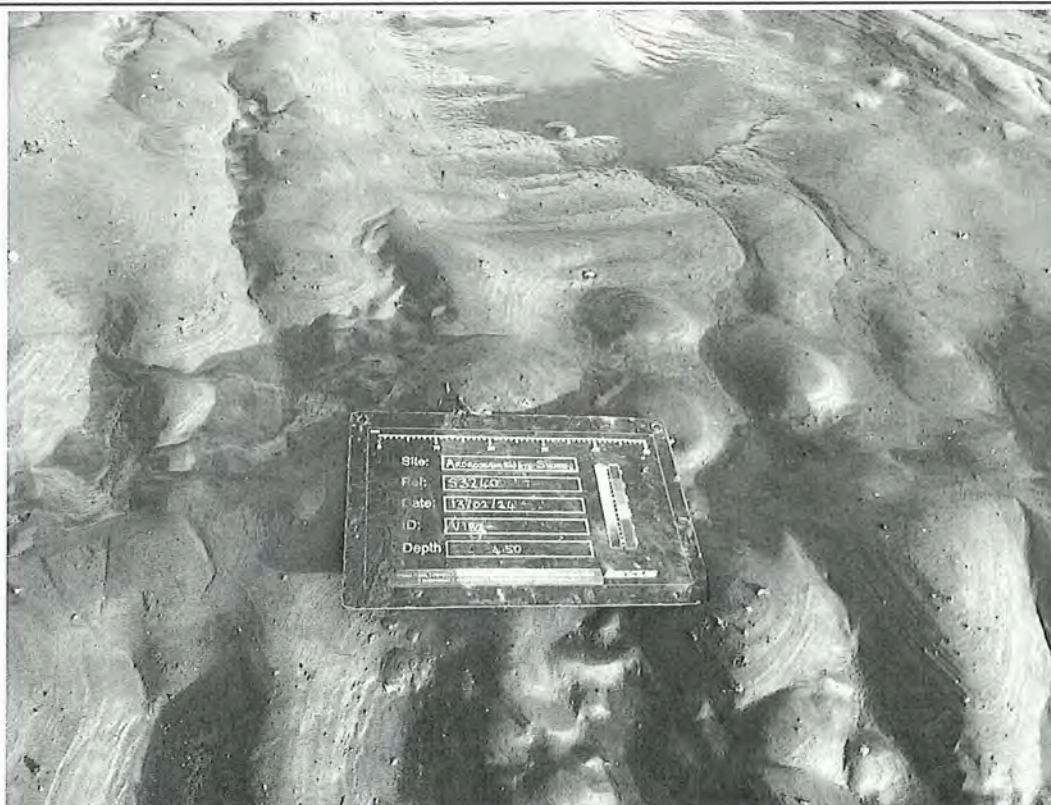
Plate No.: 34

Title.: Area 05 V180 Excavation Base at 5.10m bgl

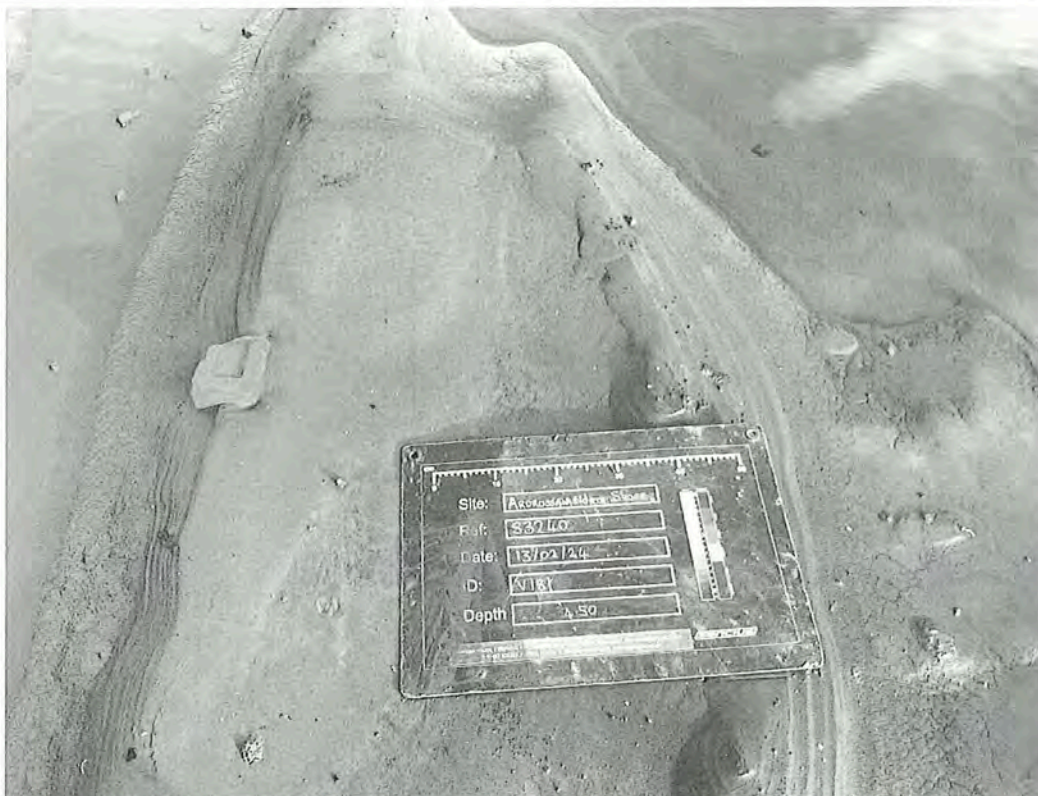
Plate No.: 35

Title.: Area 05 V181 Excavation Base at 4.50m bgl

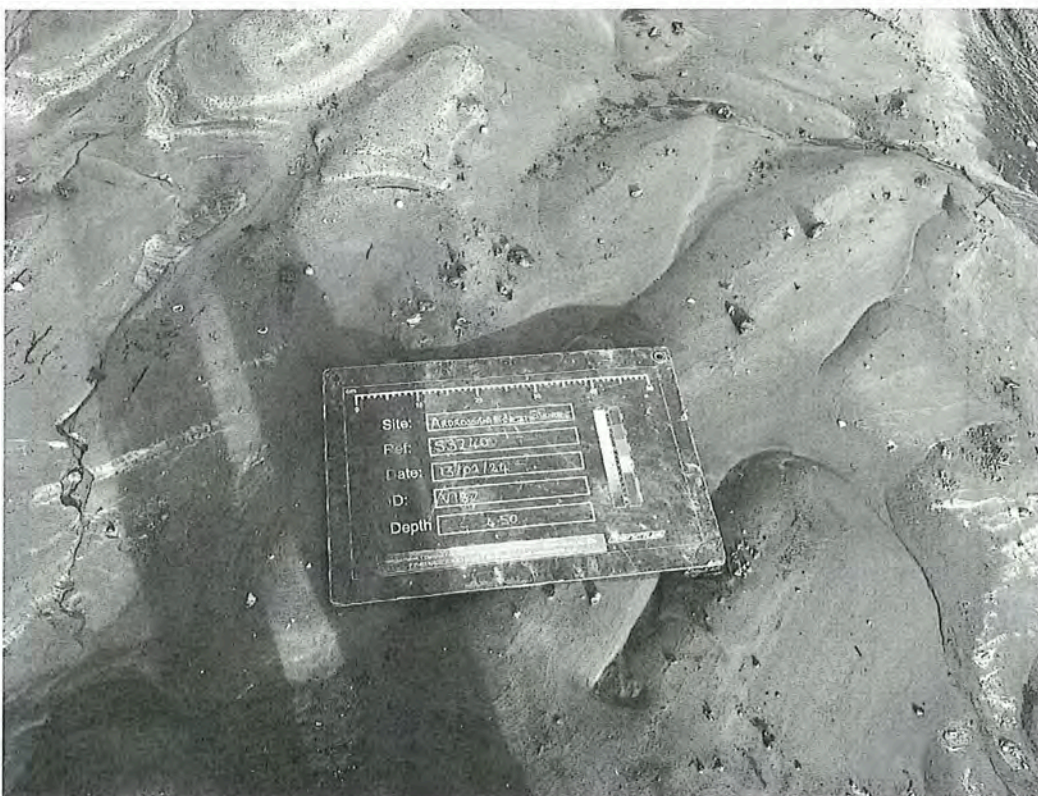
Plate No.: 36

Title.: Area 05 V182 Excavation Base at 4.50m bgl

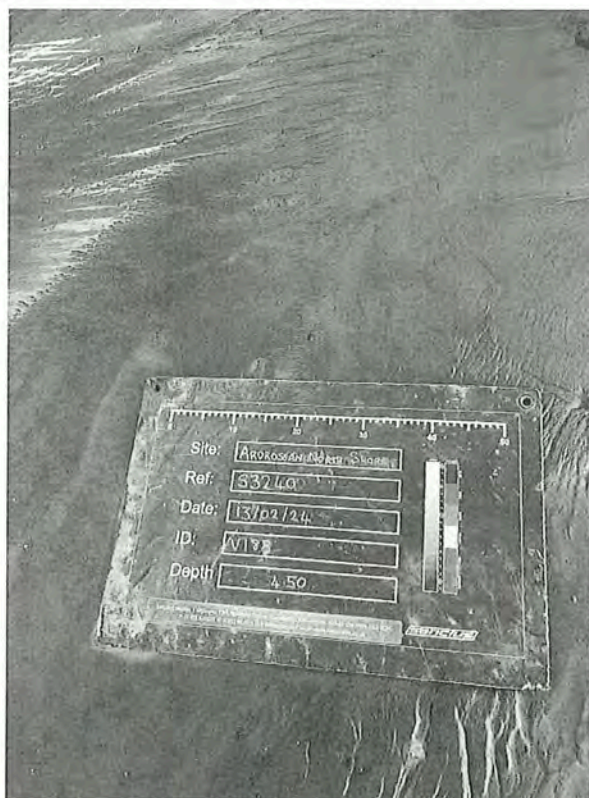
Plate No.: 39

Title.: Area 05 V185 Excavation Base at 4.50m bgl

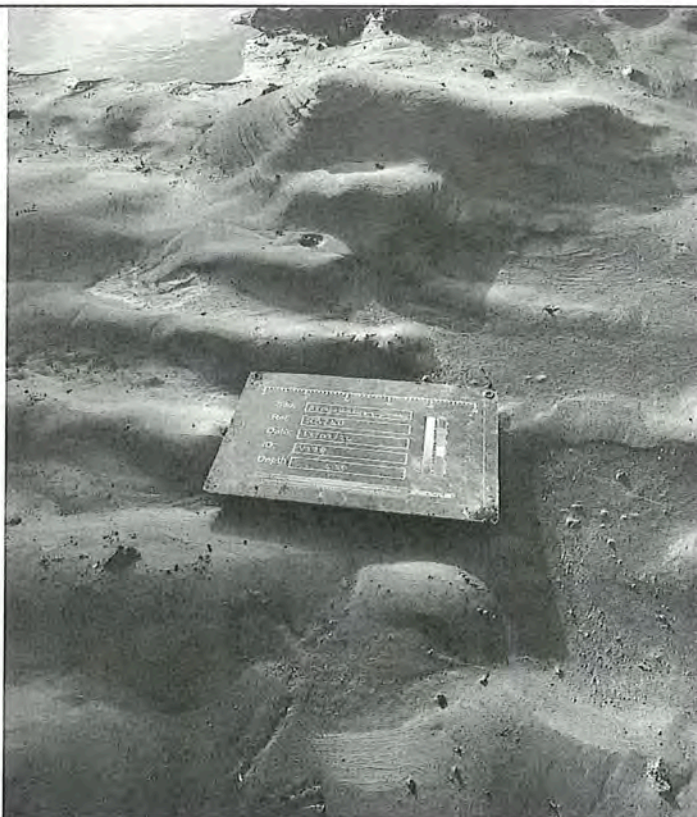
Plate No.: 40

Title.: Area 05 V186 Excavation Base at 4.50m bgl

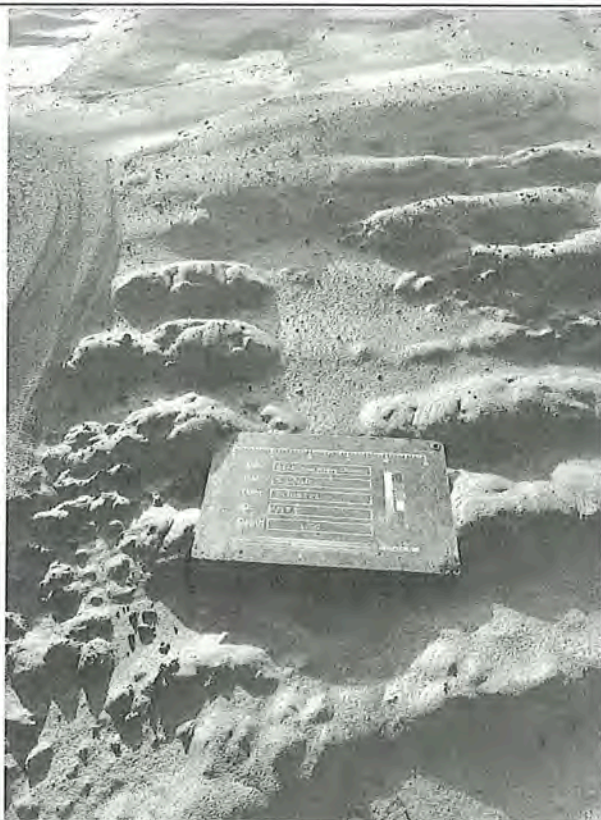
Plate No.: 41

Title.: Area 05 V187 Excavation Base at 5.10m bgl

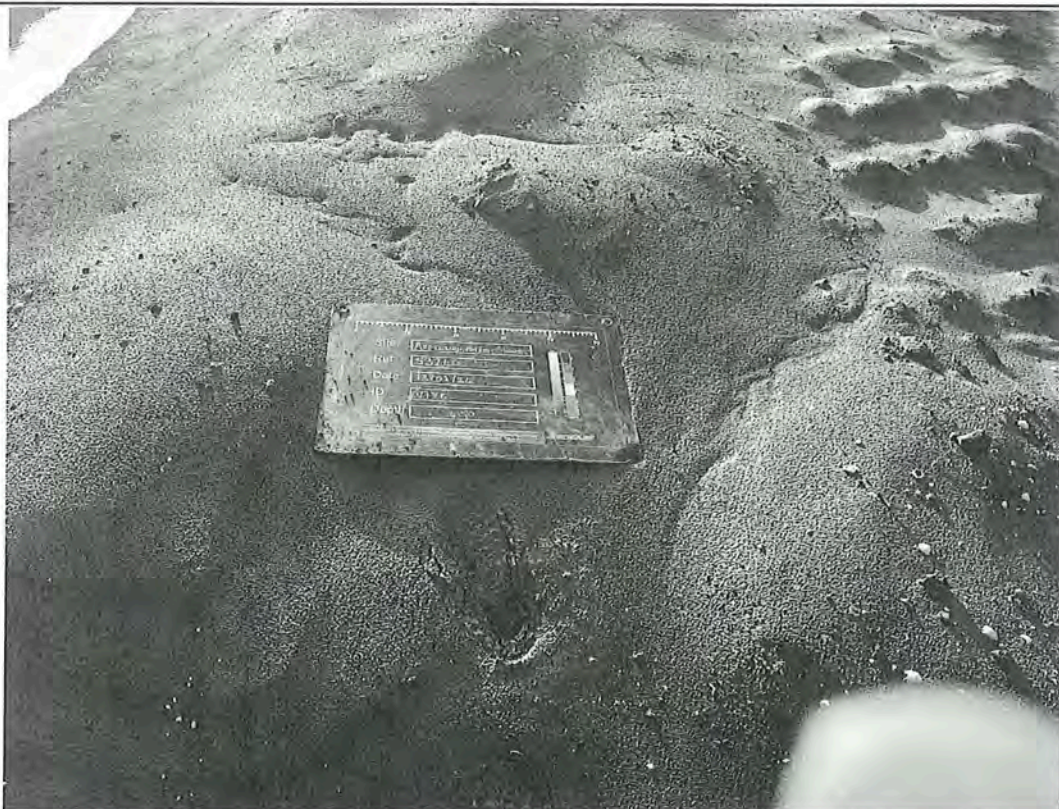
Plate No.: 42

Title.: Area 05 V188 Excavation Base at 5.10m bgl

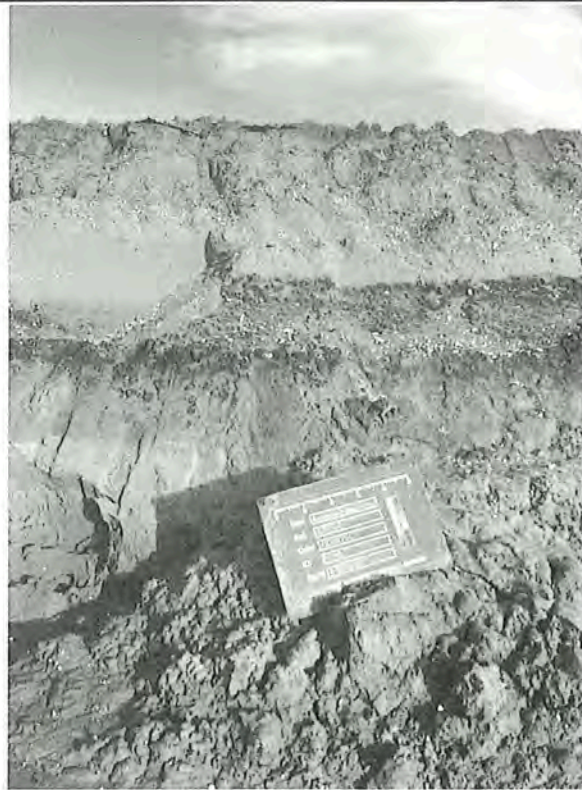
Plate No.: 43

Title.: Area 05 V189 Northern Face from 3.20 – 5.10m bgl

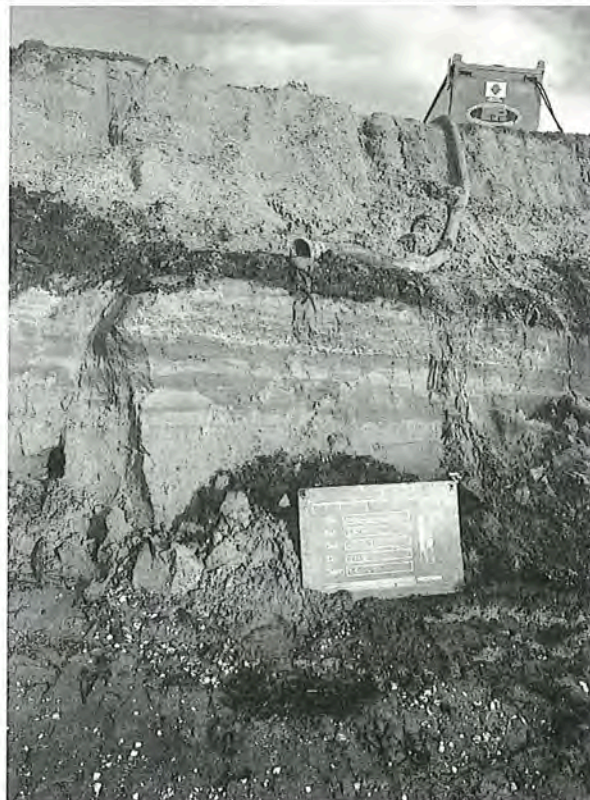
Plate No.: 44

Title.: Area 05 V190 Northern Face from 3.20 – 5.10m bgl

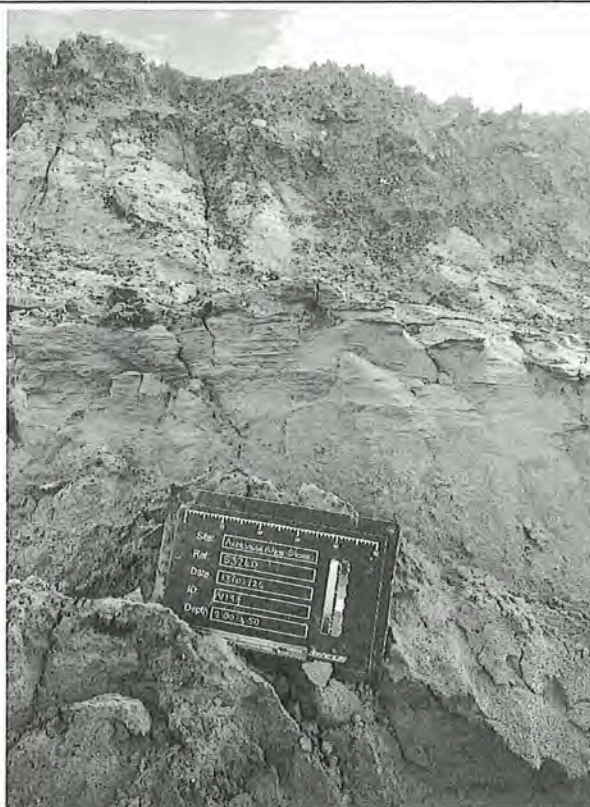
Plate No.: 44

Title.: Area 05 V191 Eastern Face from 3.20 – 5.10m bgl

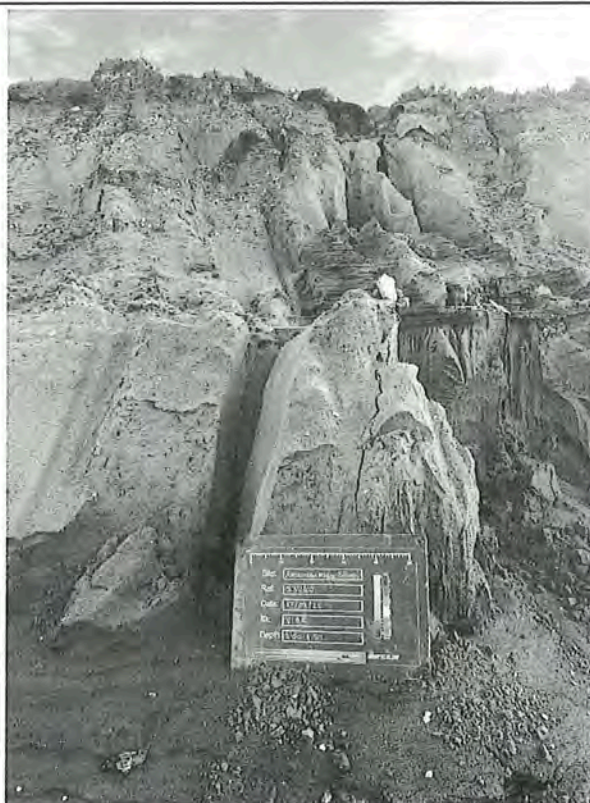
Plate No.: 45

Title.: Area 05 V192 Eastern Face from 3.20 – 5.10m bgl

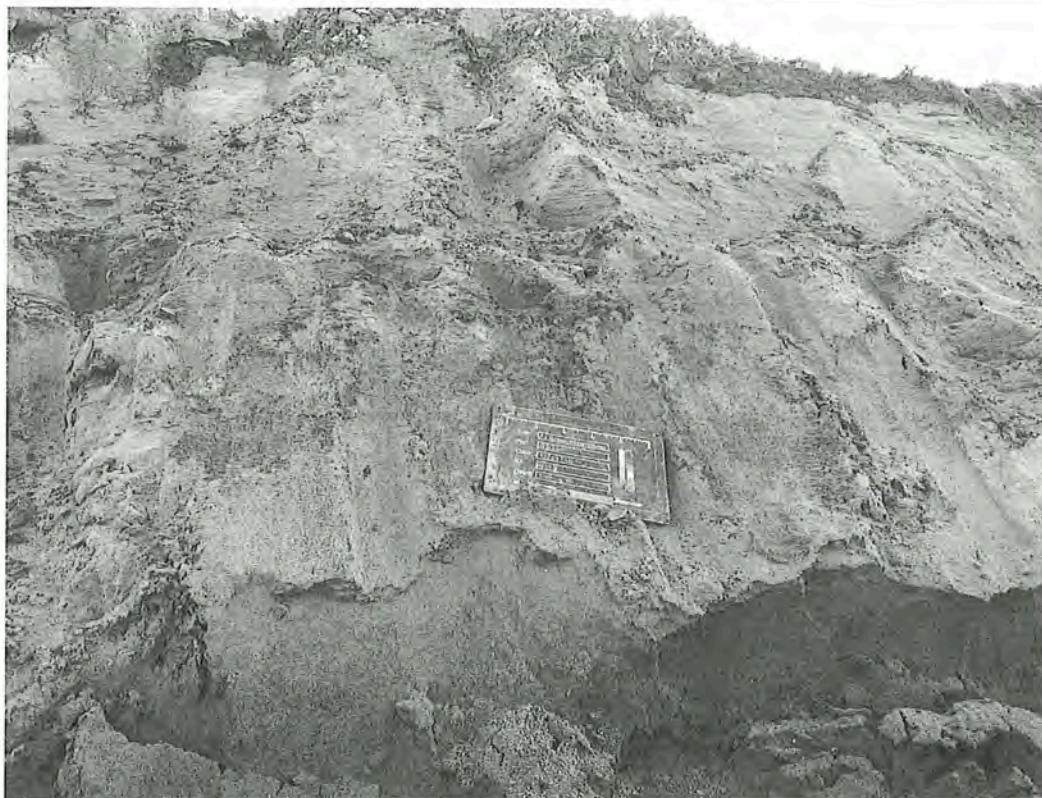
Plate No.: 46

Title.: Area 05 V193 Eastern Face from 3.20 – 5.10m bgl

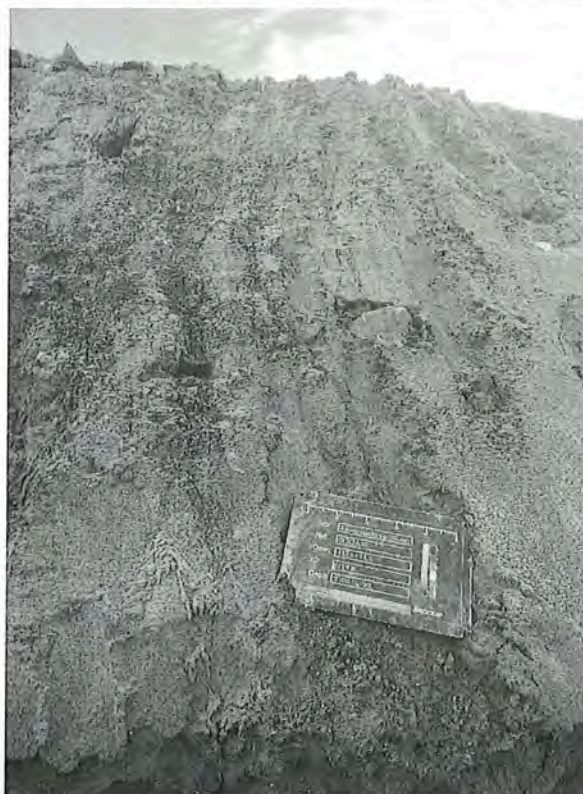
Plate No.: 47

Title.: Area 05 V194 Eastern Face from 3.20 – 5.10m bgl

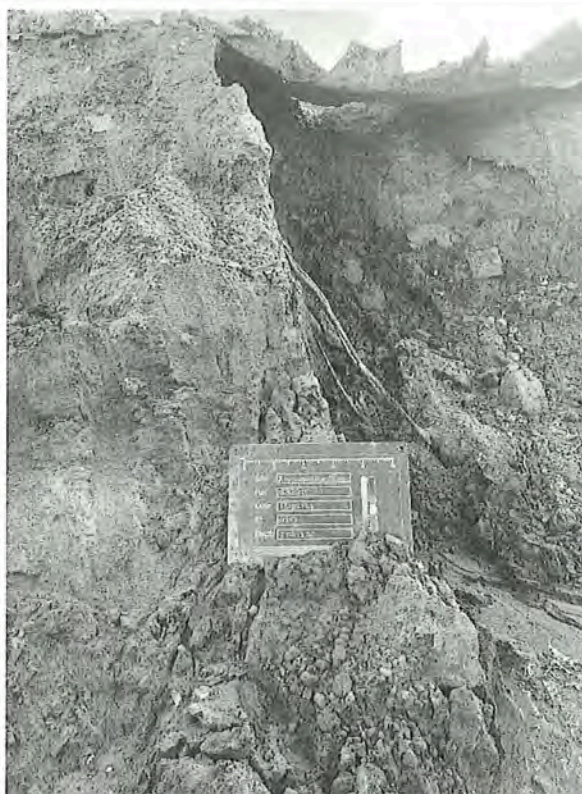
Plate No.: 49

Title.: Area 05 V195 Eastern Face from 3.20 – 5.10m bgl.

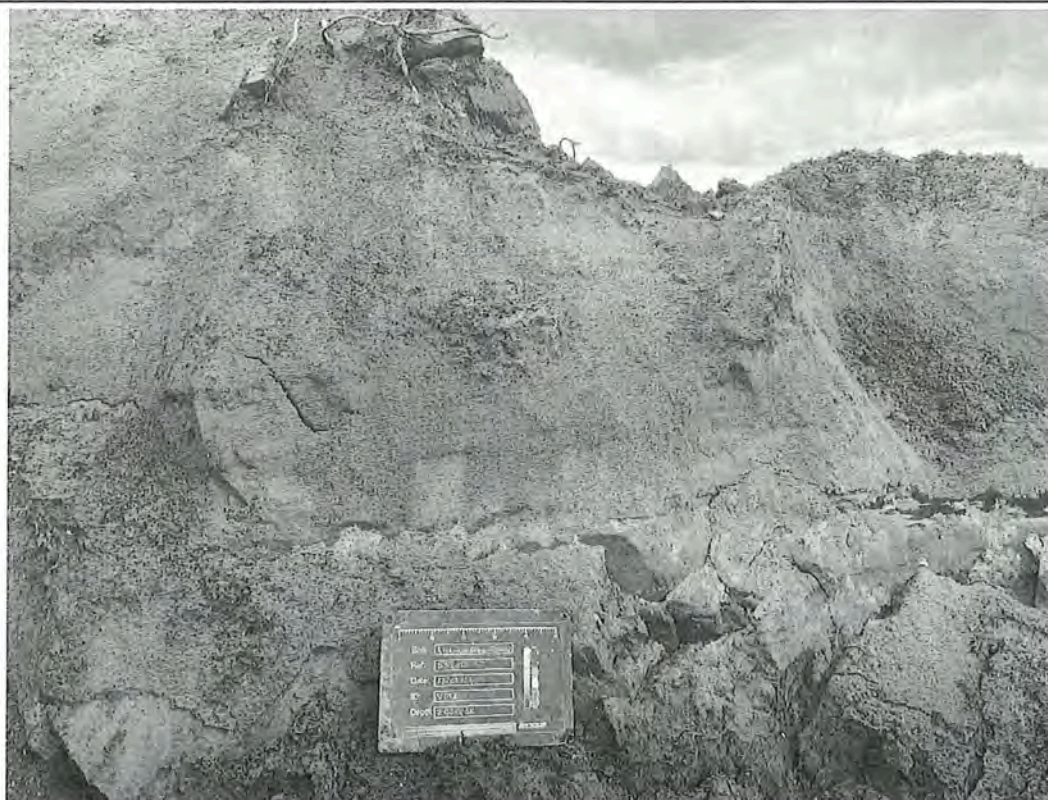
Plate No.: 50

Title.: Area 05 V196 Southern Face from 3.20 – 5.10m bgl

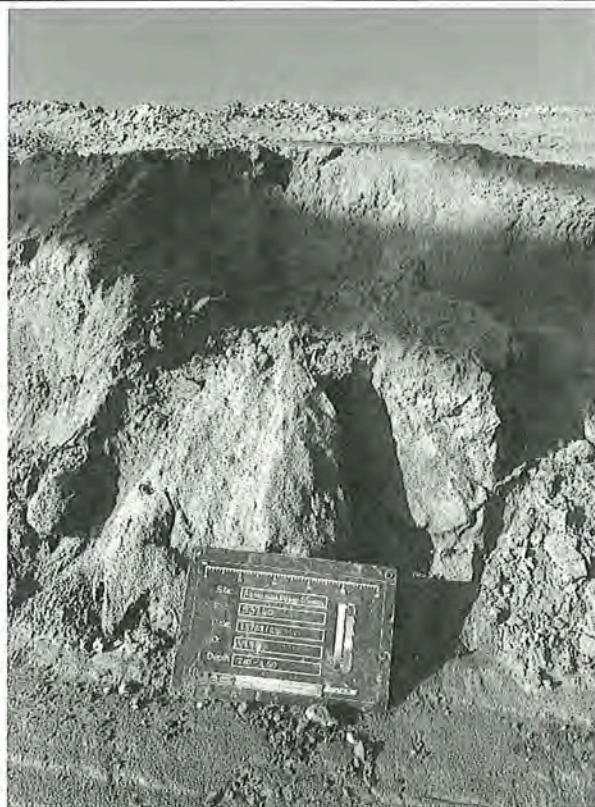
Plate No.: 51

Title.: Area 05 V197 Southern Face from 3.20 – 5.10m bgl

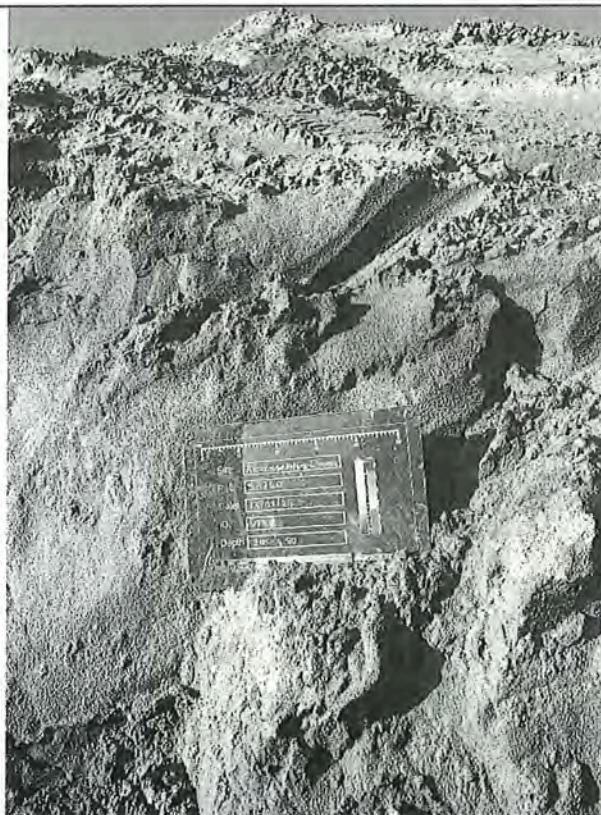
Plate No.: 52

Title.: Area 05 V198 Western Face from 3.20 – 5.10m bgl

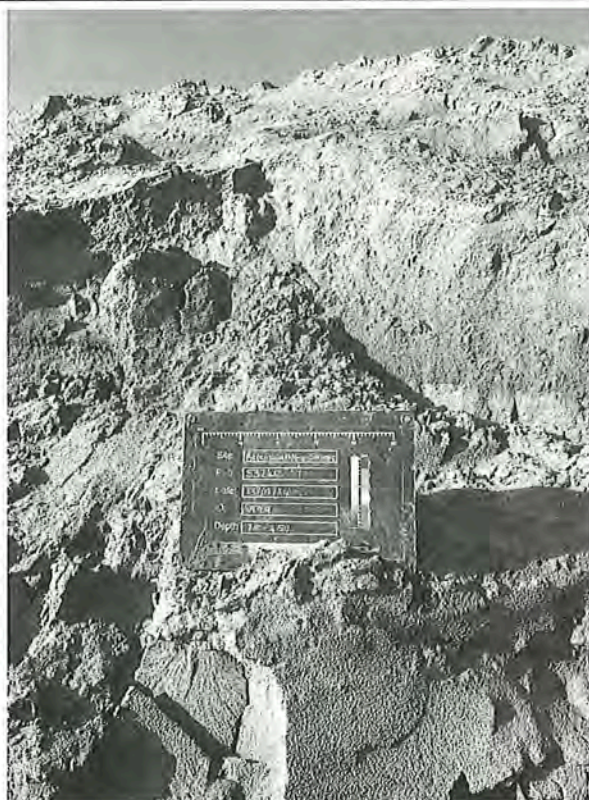
Plate No.: 1

Title.: Area 05 V199 Western Face from 3.20 – 5.10m bgl

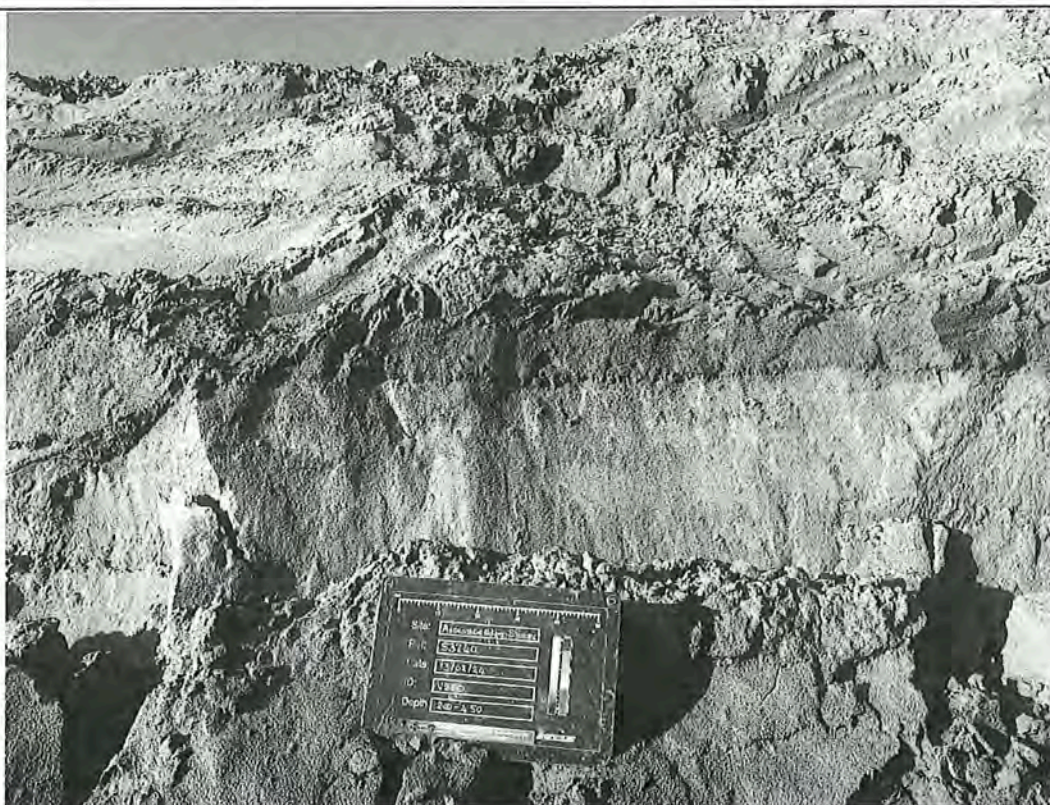
Plate No.: 2

Title.: Area 05 V120 Western Face from 3.20 – 5.10m bgl

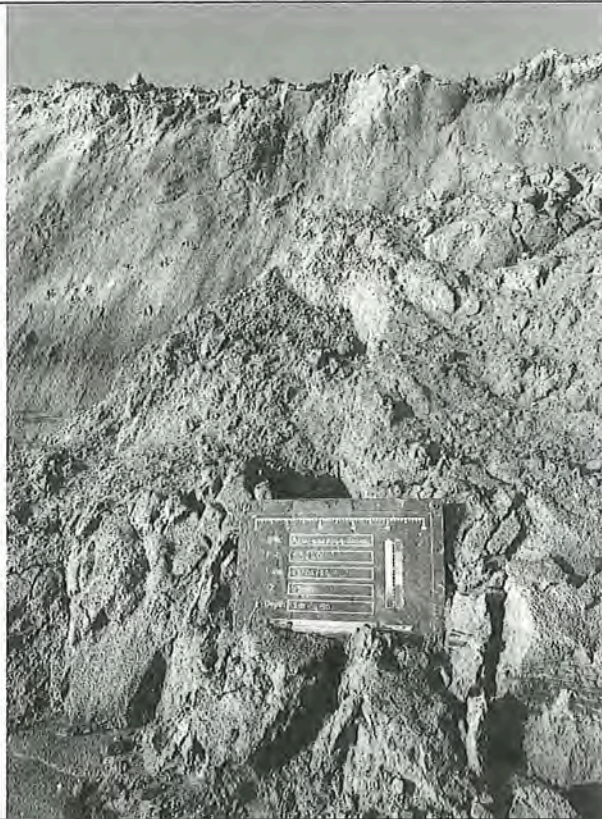
Plate No.: 53

Title.: Area 05 V201 Western Face from 3.20 – 5.10m bgl

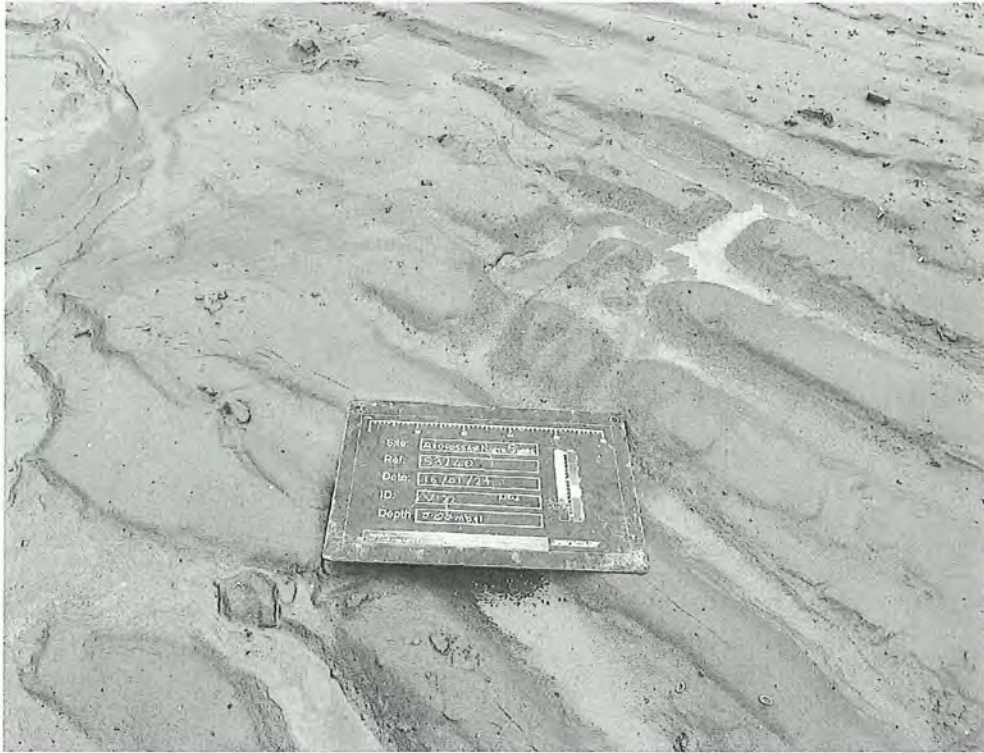
Plate No.: 55

Title.: Area 06 Excavation Base at 5.00m bgl

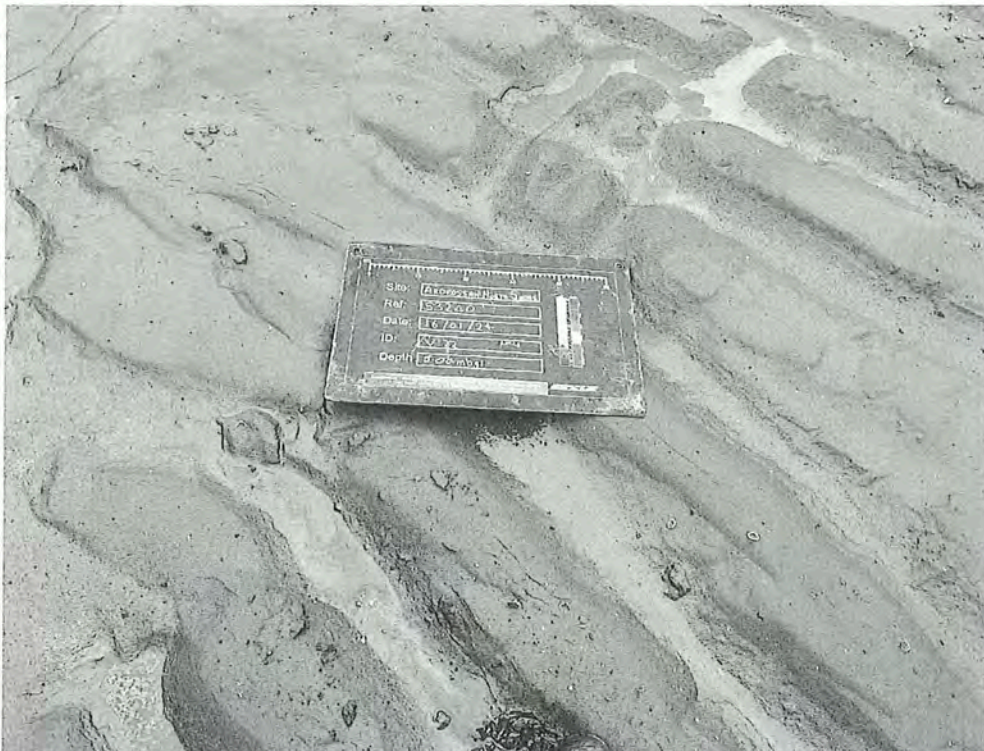
Plate No.: 56

Title.: Area 06 Excavation Base at 5.00m bgl

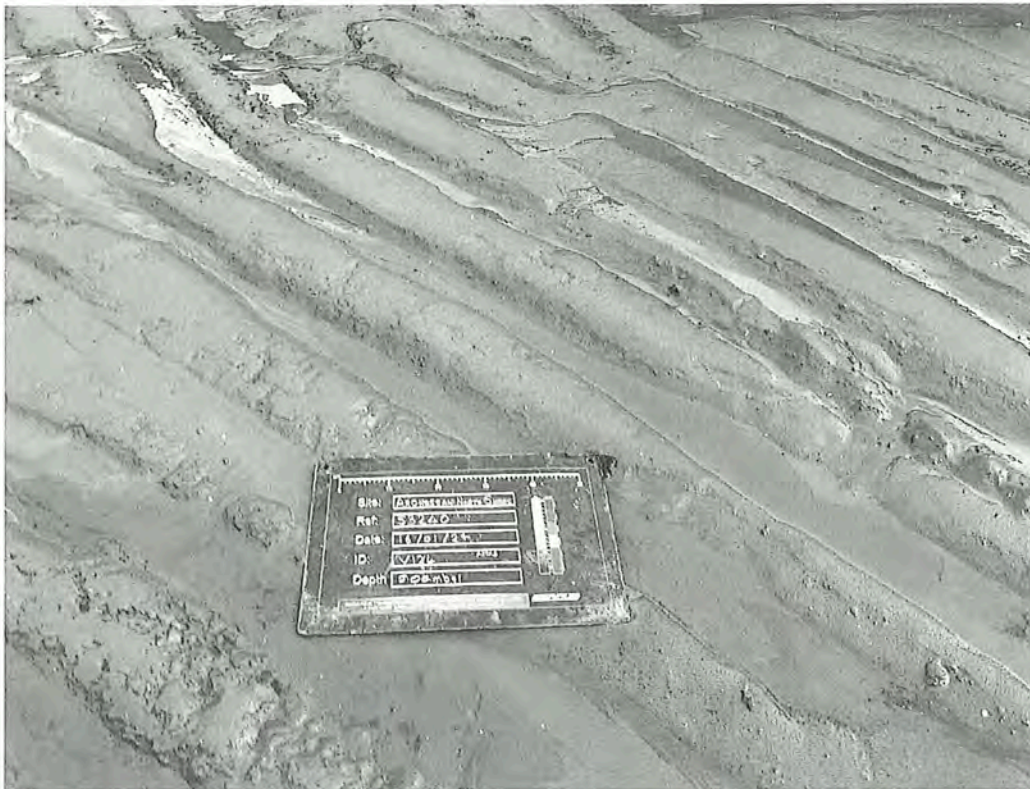
Plate No.: 57

Title.: Area 06 Excavation Base at 5.00m bgl

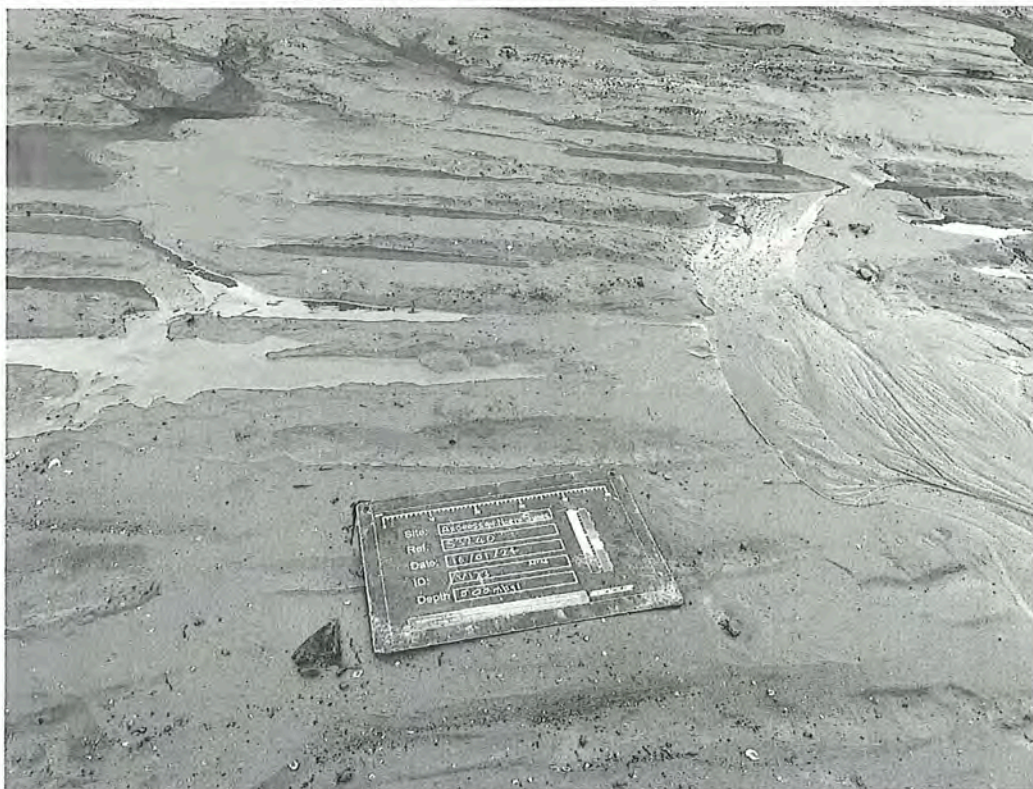
Plate No.: 58

Title.: Area 06 Excavation Base at 5.00m bgl .

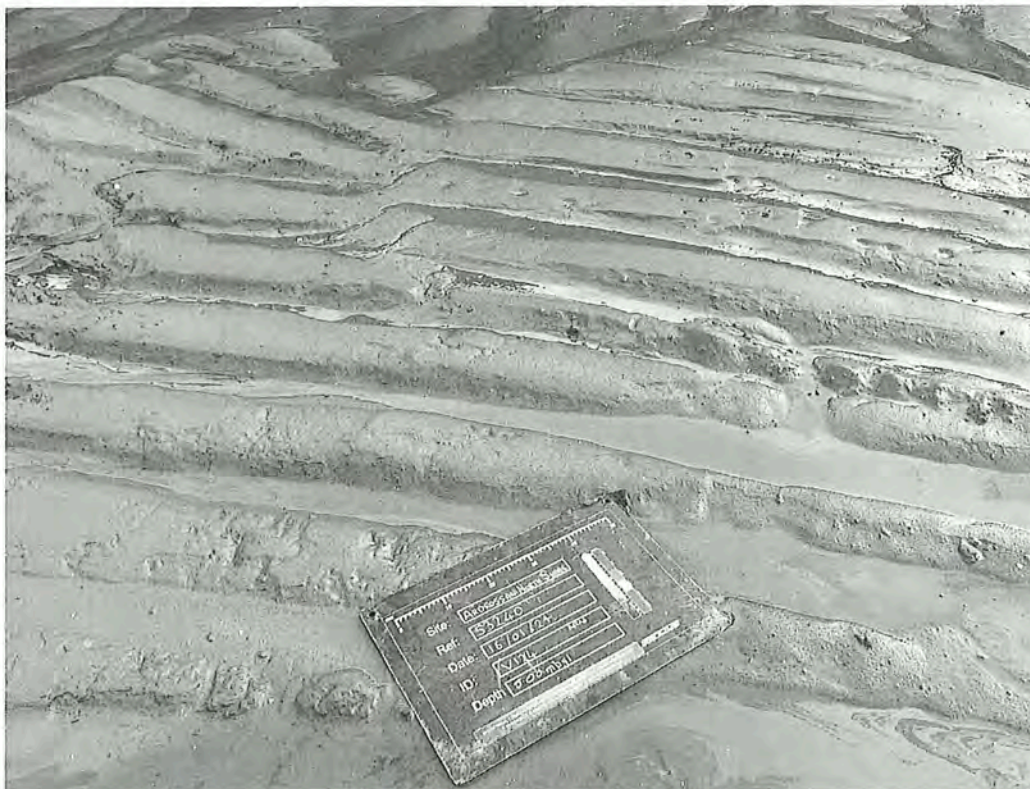
Plate No.: 59

Title.: Area 06 Area 06 Excavation Base at 5.00m bgl

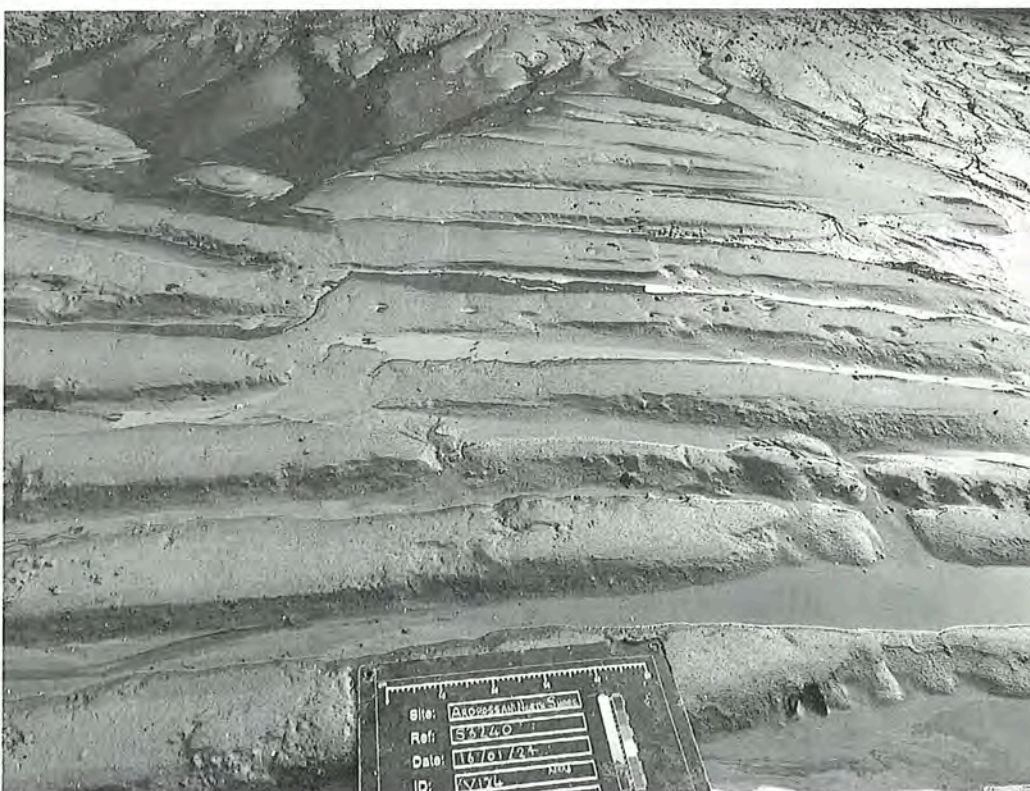
Plate No.: 60

Title.: Area 06 Area 06 Excavation Base at 5.00m bgl

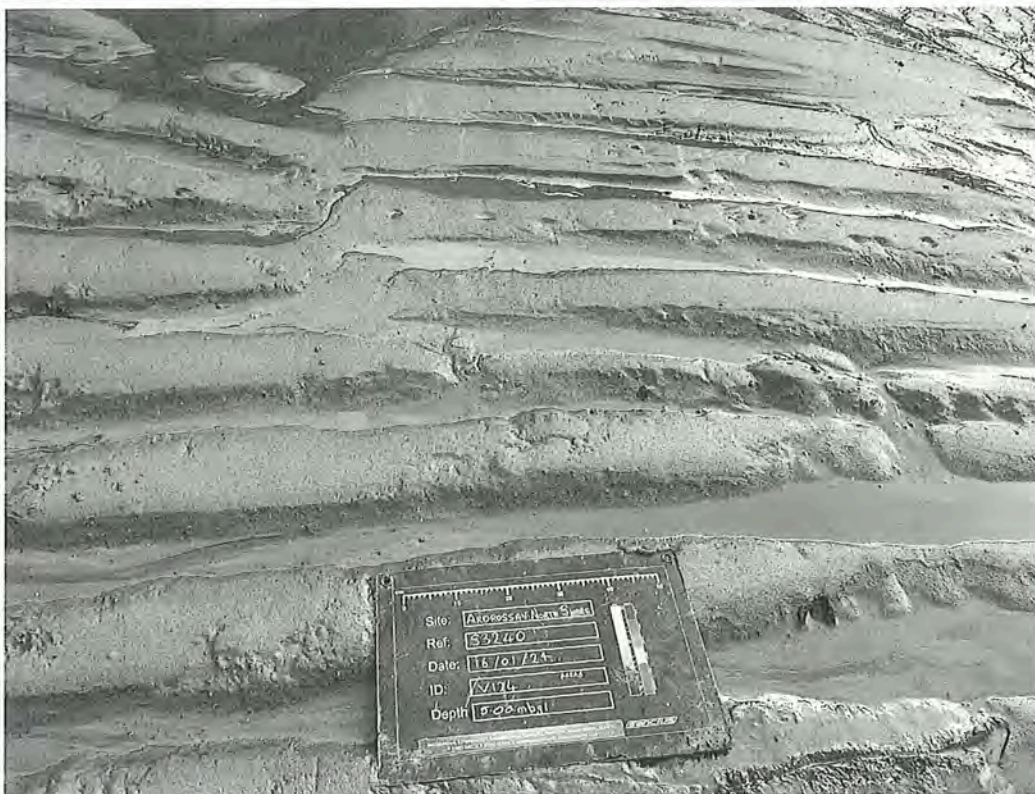
Plate No.: 61

Title.: Area 06 Area 06 Excavation Base at 5.00m bgl .

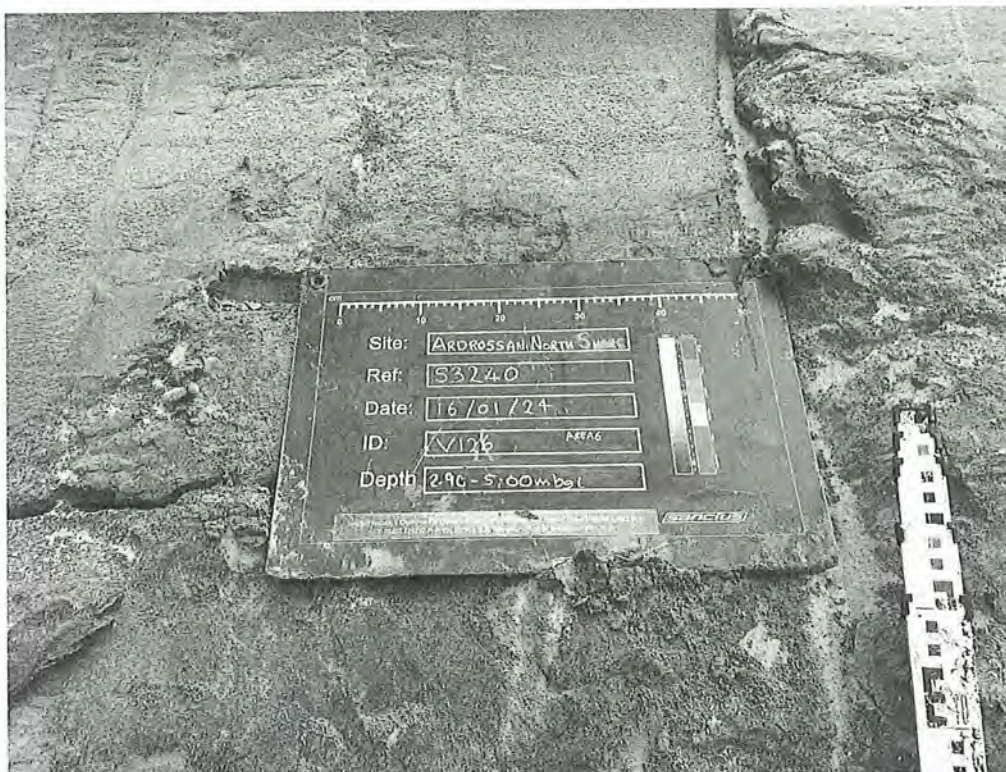
Plate No.: 63

Title.: Area 06 Eastern Extent.

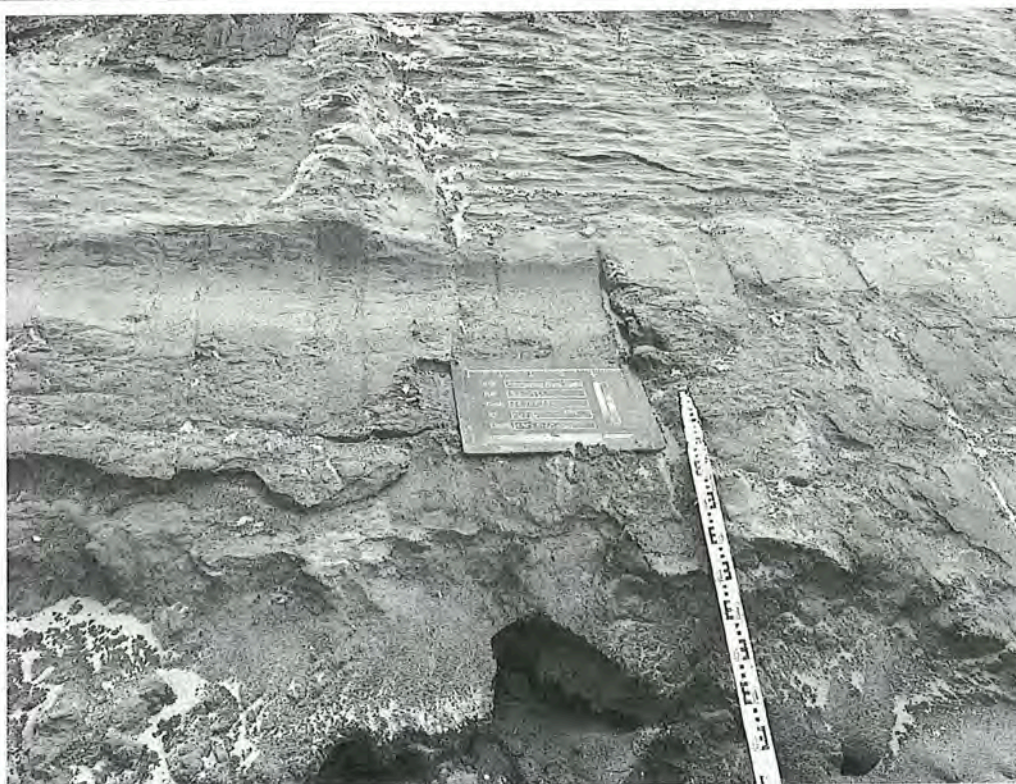
Plate No.: 64

Title.: Area 06 Eastern extent.

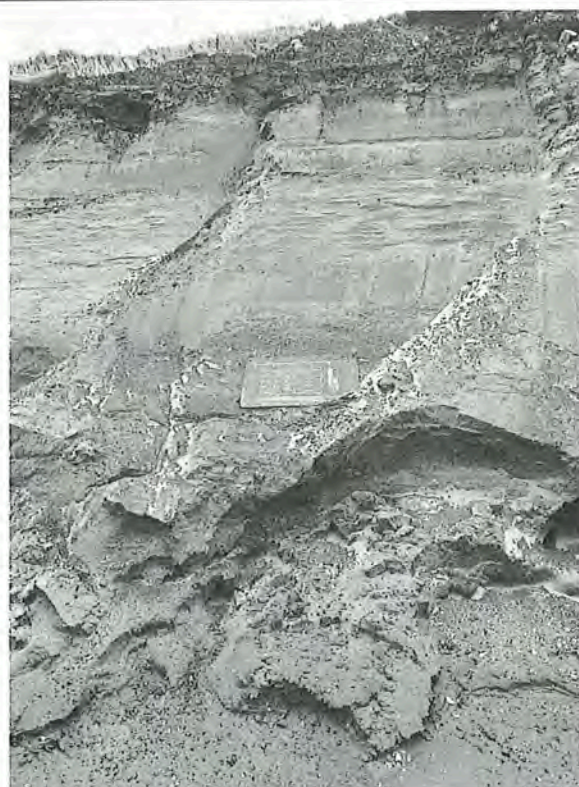
Plate No.: 66

Title.: Area 06 Eastern Extent.

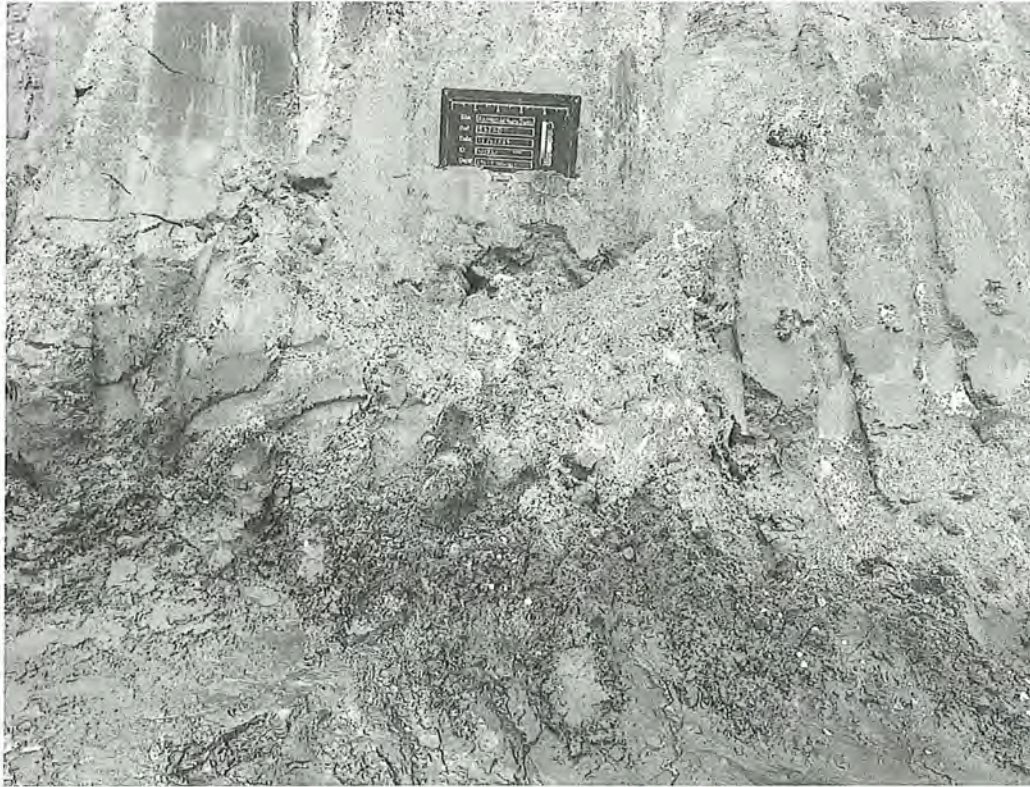
Plate No.: 1

Title.: Area 06 Western extent

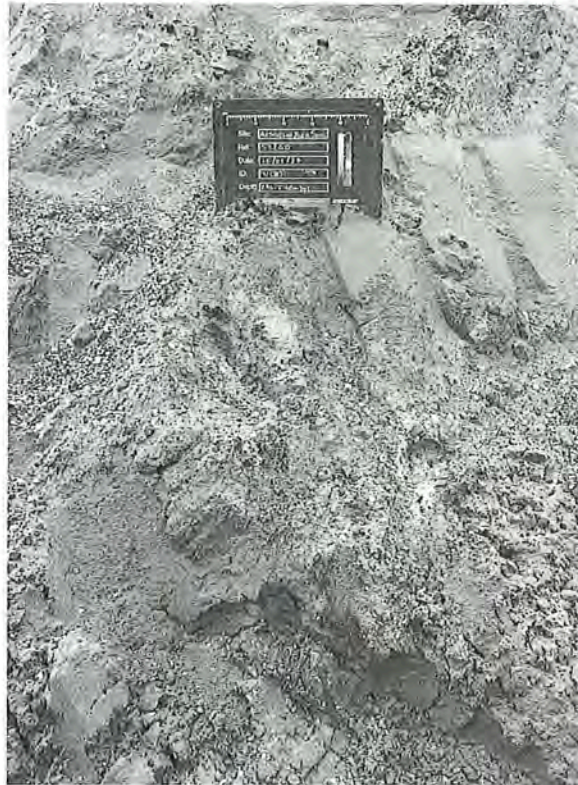
Plate No.: 1

Title.: Area 06 Southern Extent.
