Contract Name: Ardrossan, North Shore

**Appendix F S3240-015 Phase 02 Verification Report:
S3240-015**

Phase 02 Verification Report

Ardrossan, North Shore

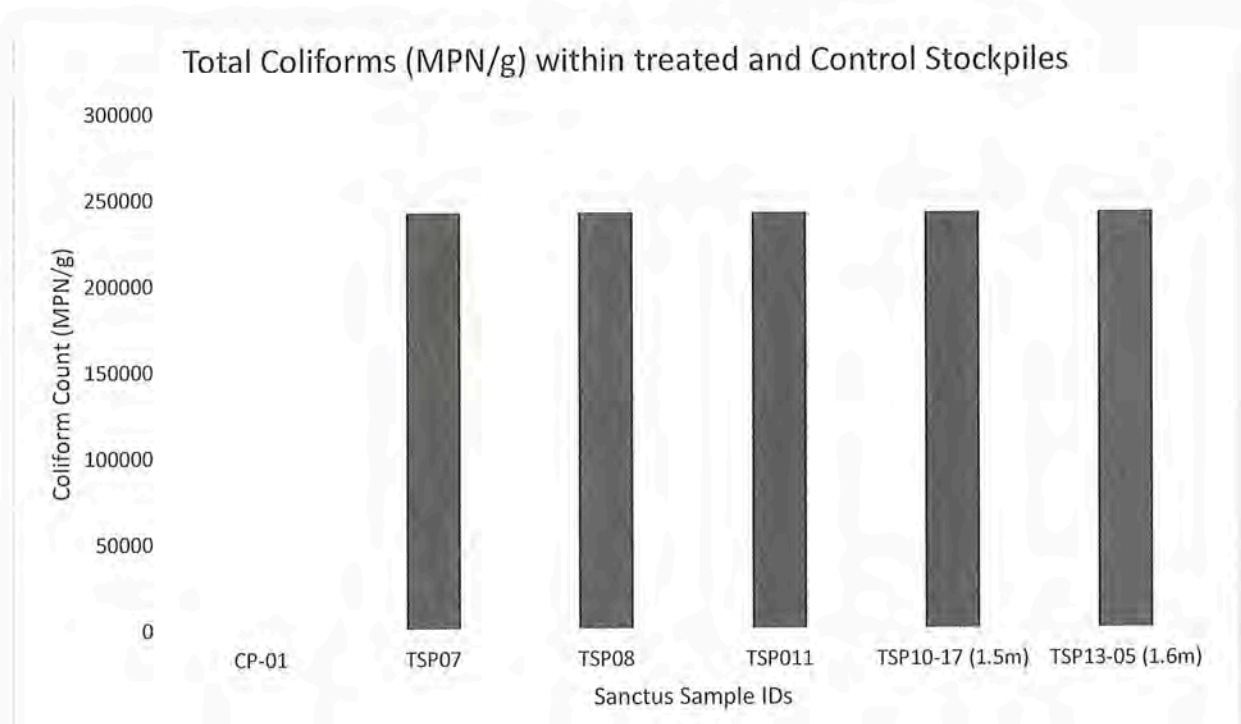
The data from the above Table 5-1, is graphically represented within Figure 1, below, which further demonstrates bacterial activity within the treated materials and the reductions achieved were through bacterial activity, as per the remedial design. A copy of the analysis is included within Appendix G.

Figure 1: Coliform Testing summary, based upon data within Table 5-7.
