**Ardrossan North Shore
Site Investigation 2022, Interpretative Report**

November 2023

Client: North Ayrshire Council
 Project Title: Ardrossan North Shore
 Report Title: Site Investigation 2022, Interpretative Report
 Document number: 13209
 Project number: 173958

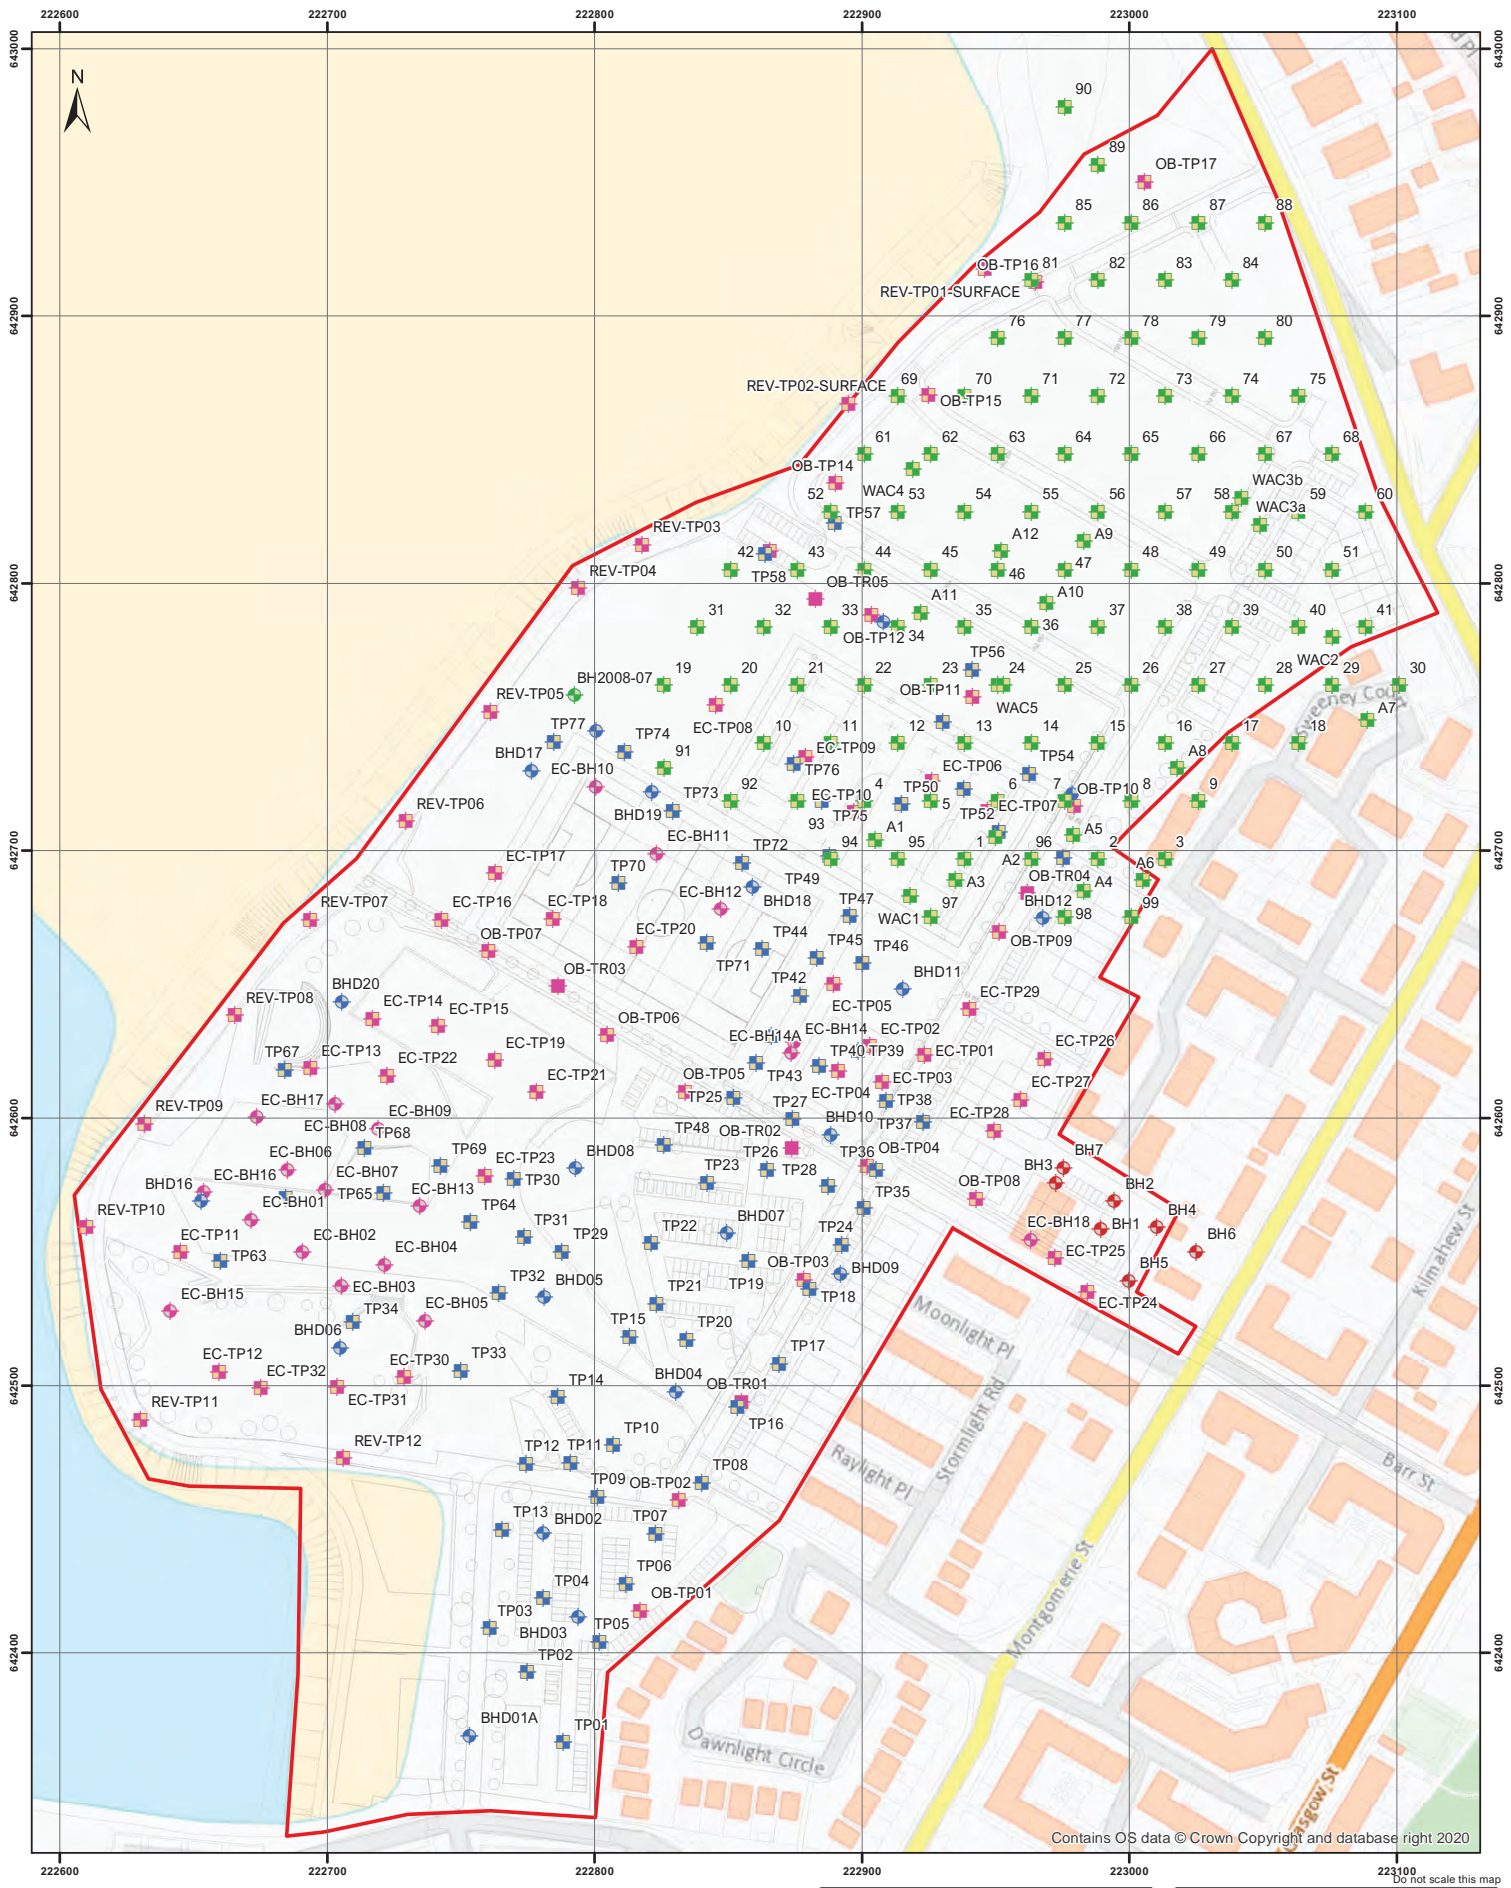
Drawing No. 173958-GIS015	Revision -	Date 25 Jan 2023	
Drawn FR	Checked GD	Approved GD	
Rev	Date	Amendment	Initials
-	-	-	-

A site investigation plan detailing these locations and those undertaken as part of the 2019 and 2020 and Coast to Coast site investigation works is provided in Appendix A as 173958-GIS015. The plan also incorporates intrusive investigation points from the 2008 site investigation in EnviroCentre Report No 3585 Delineation Investigation, Ardrossan Phase I (2008). The plan details all the locations from the Delineation Investigation, note the majority of these were subsequently remediated as detailed in EnviroCentre Report no 4295.

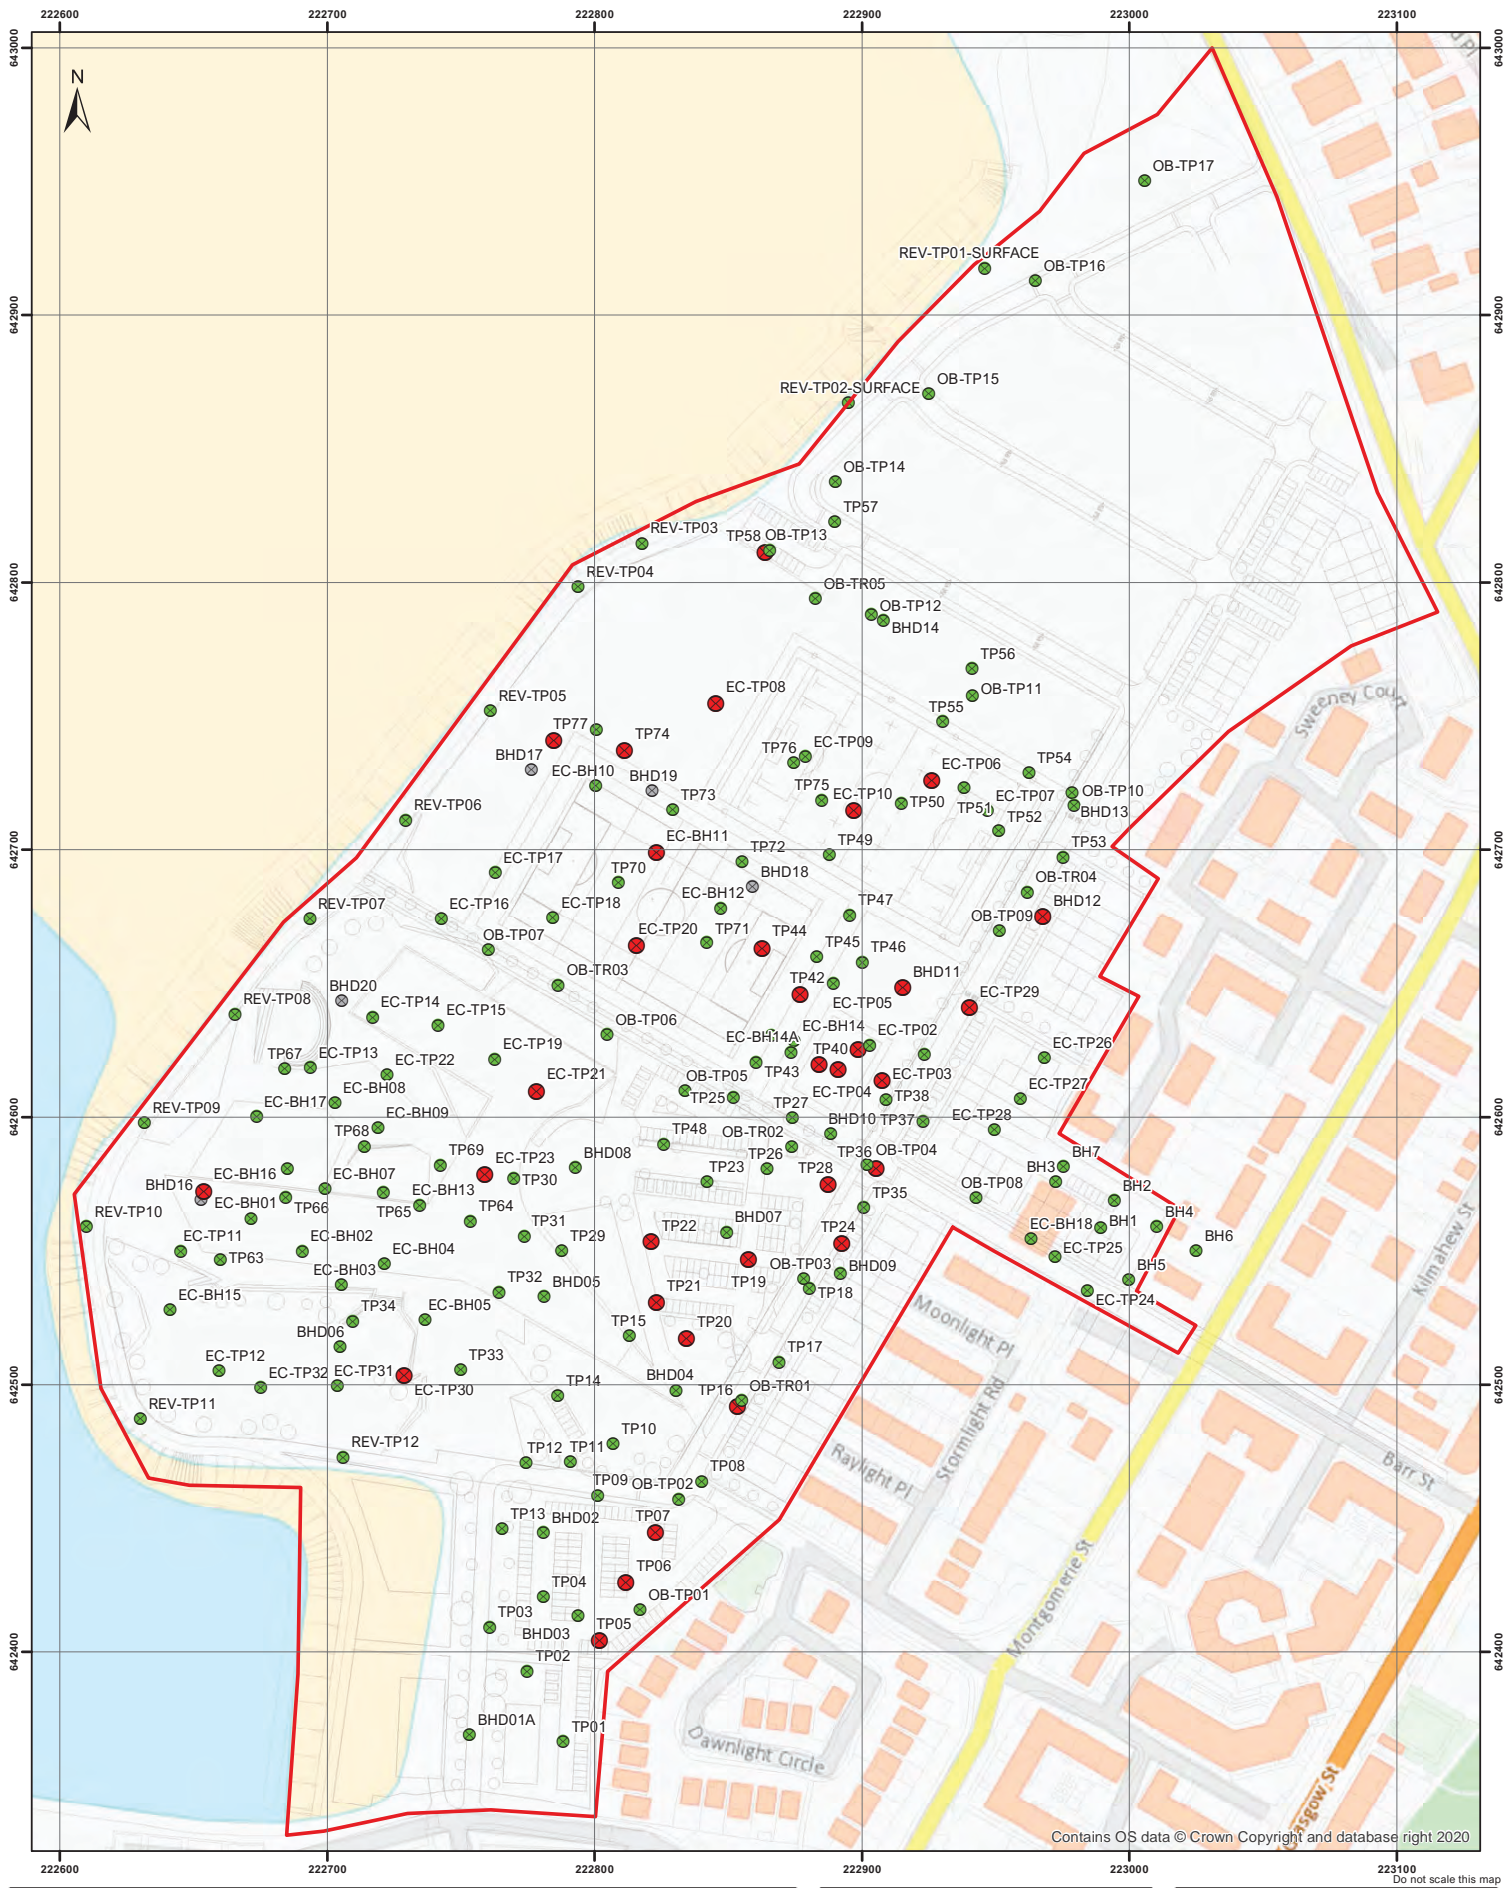
Status Final			
Drawing No. 173958-GIS017	Revision -	Date 24 Jan 2023	
Drawn FR	Checked GD	Approved GD	
Rev	Date	Amendment	Initials
-	-	-	-

Asbestos was identified within 16 of the 192 samples tested. The asbestos form identified incorporated a range of types including amosite, chrysotile and crocidolite. Quantification of the asbestos was undertaken with results provided in the SKF Factual Report in Appendix B.

The majority of asbestos was identified within the top metre of the site, which is deemed to be the soil profile of risk of generation of dust and therefore potential for asbestos exposure as part of the proposed development. There was asbestos identified up to depths of 4m in specific areas, which will require to be considered as part of any construction works involving excavation to depth.

Figure 173958-GIS017 in Appendix A details the locations of the asbestos identification for the 2022 investigation, the 2019 and 2020 investigation, the Coast to Coast investigation and the locations from the 2008 investigation which were not remediated at that time.

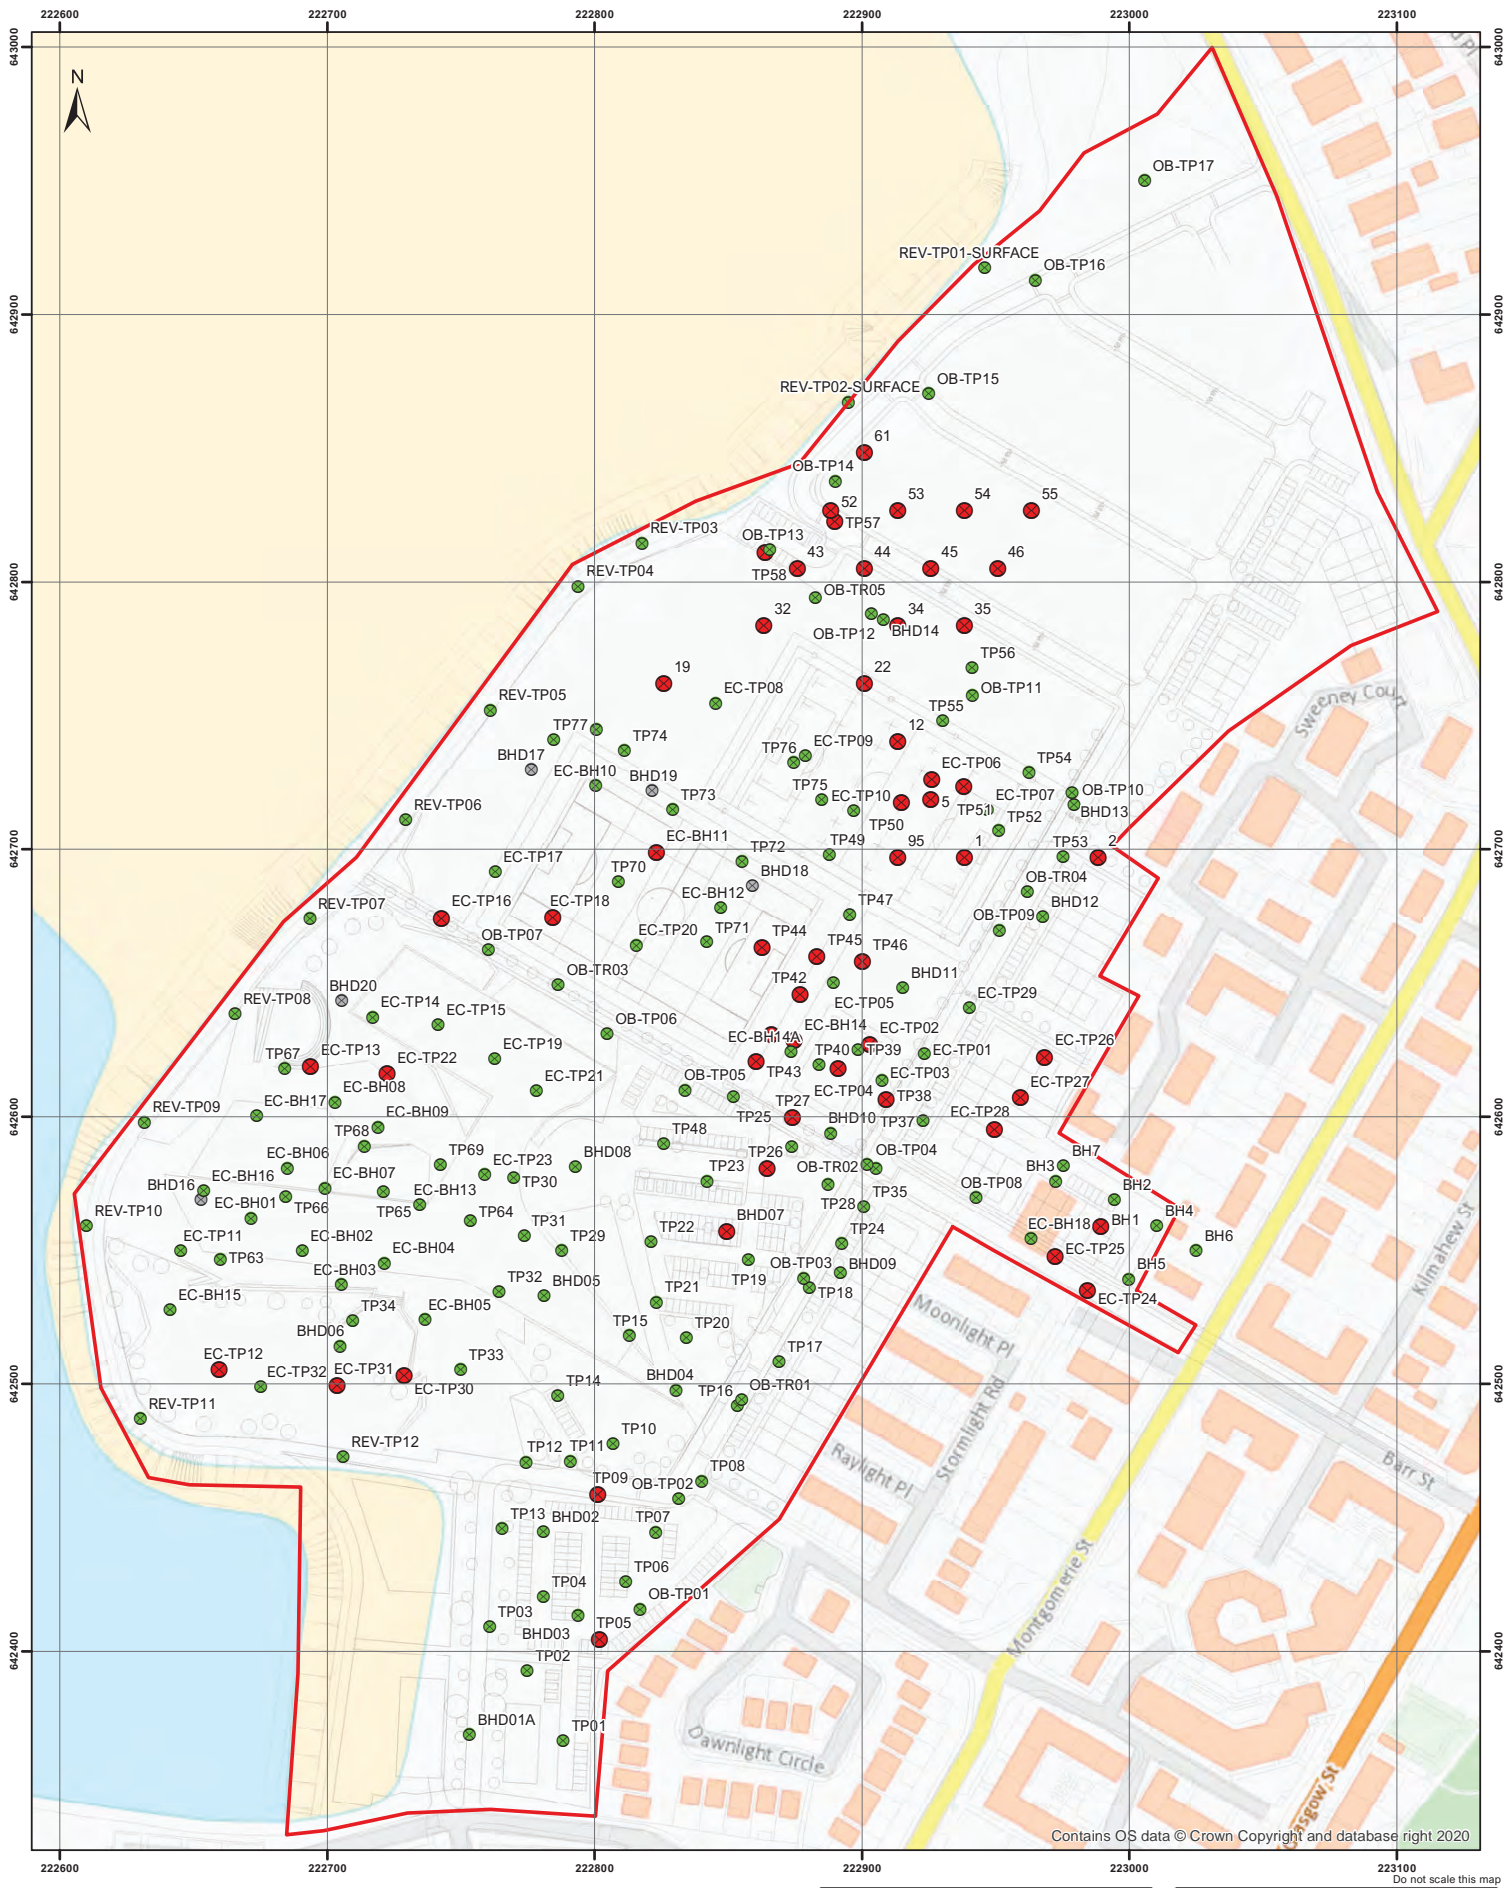
For the 2022 results the majority of metal/metalloid analytes did not exceed the screening assessment criteria, with the exception of arsenic, lead and nickel.

- A total of 5 of the 192 samples analysed recorded slight exceedances of the residential arsenic criteria.
- 4 of the 192 samples recorded nickel concentrations in excess of the screening criteria, 2 out of 4 of these samples were located within the upper metre of the soil profile.
- 18 of the 192 samples recorded concentrations of lead in excess of the screening criteria. The samples depths ranged from within the top metre to up to 4m depth.
- None of the samples collected from the stockpile material recorded exceedances of the metal screening criteria.

Figure 173958-GIS018 in Appendix A details the locations of the metal exceedances with respect to the screening criteria. This figure details all locations recorded from the 2019 and 2020 investigation, the 2022 investigation, the Coast to Coast investigation and those remaining areas from the 2008 investigation (still present post remedial works). Sample exceedances were recorded in the upper metre of the soil profile, which is deemed to be the critical depth with respect to the pathways to receptors from these contaminants (ingestion and direct contact with soil and inhalation of dust).

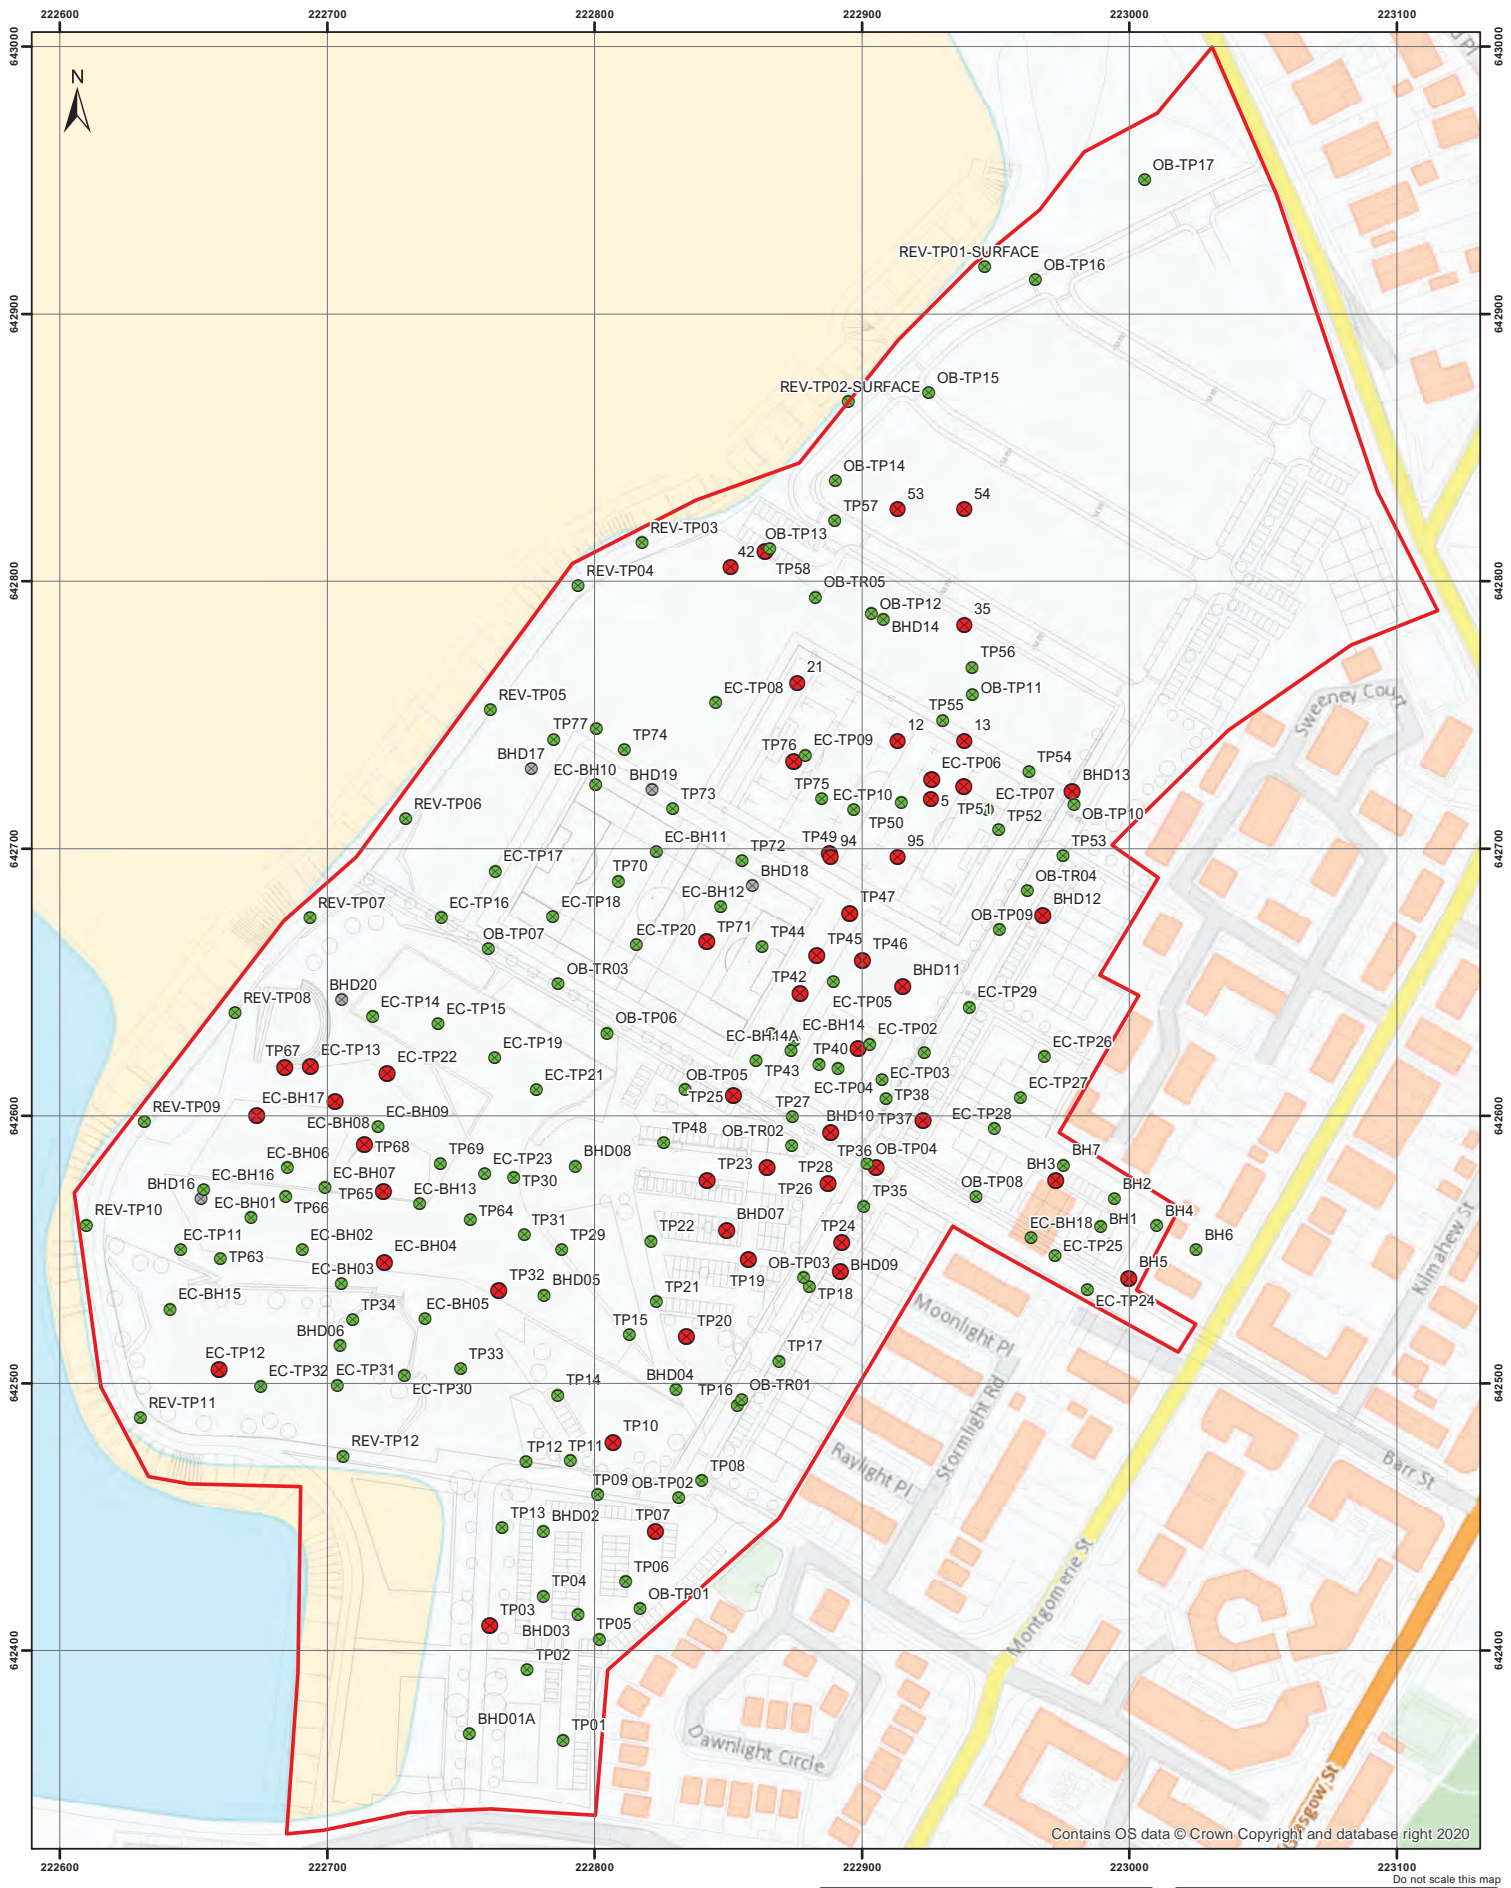
A total of 7 of the 192 2022 soil samples analysed recorded exceedances for specific TPH carbon band fractions. None of the samples from the stockpile material recorded exceedances of the TPH criteria. The fractions that recorded exceedances included:

The majority of the TPH exceedances have been recorded at depths of 2m below ground or greater, however given that vapour release is a key parameter the risks from these elevations is relevant. There are also exceedances of aromatic compounds within the top metre of the site which present an ingestion and inhalation risk.

Figure 173958-GIS019 in Appendix A details the areas where TPH elevations have been recorded. As above this incorporates the 2022 investigation, the 2019 and 2020 investigations and the areas from 2008 which were not remediated at that time.

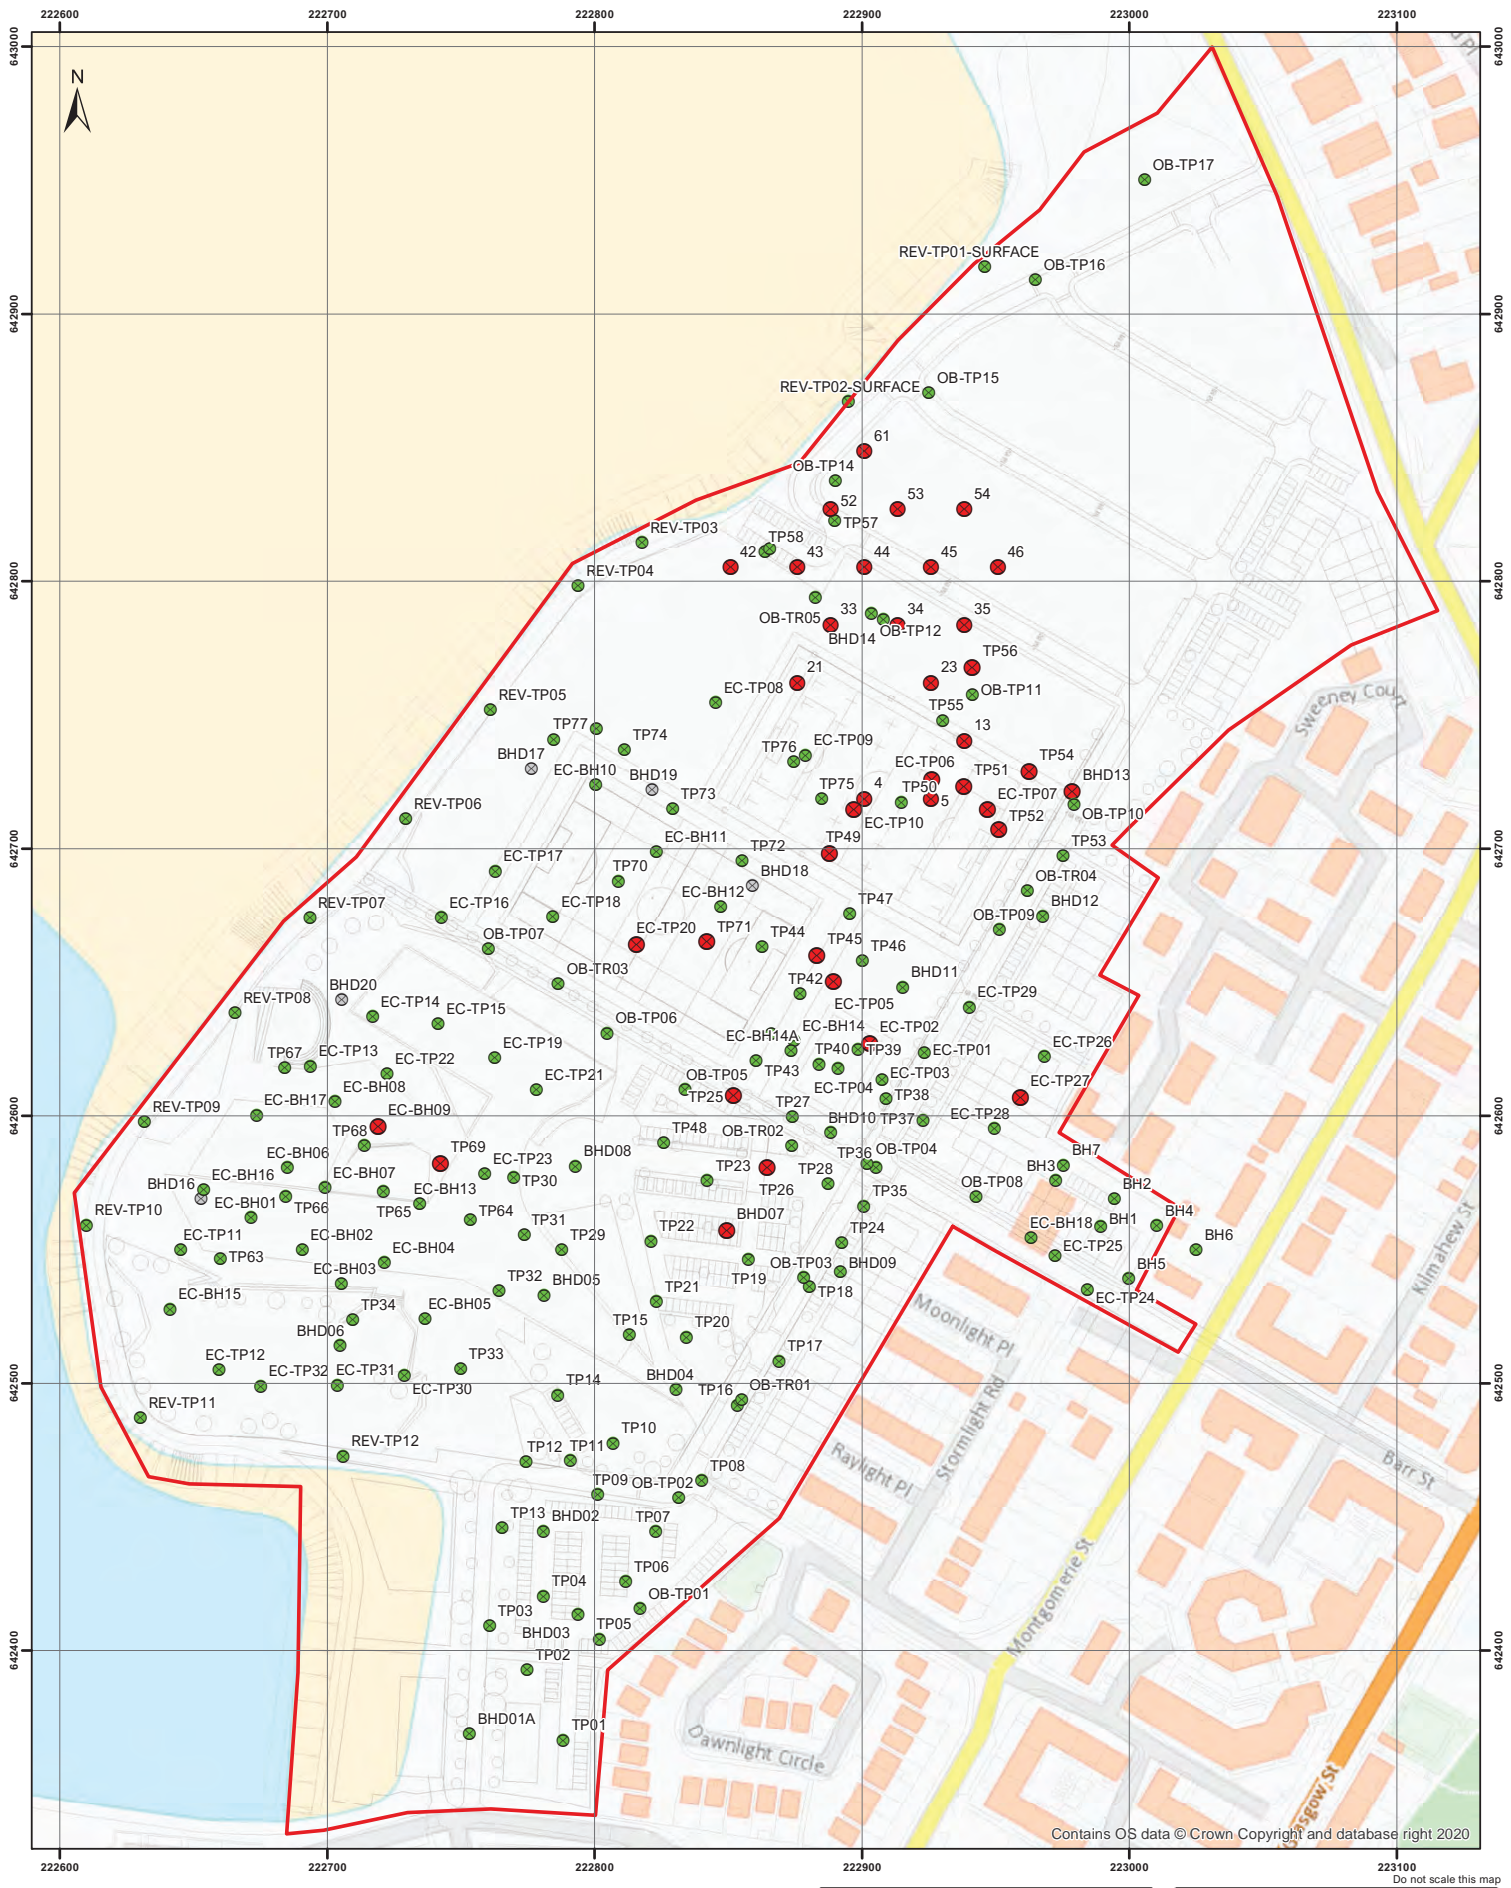
The majority of SVOCs from the 2022 samples did not record exceedances in relation to the screening criteria, however specific Polyaromatic Hydrocarbon (PAH) compounds were elevated above the assessment criteria including:

- Naphthalene (3 samples out of 192);
- Benzo(a)anthracene (3 samples out of 192);
- Chrysene (2 samples out of 192);
- Benzo(b)fluoranthene (9 samples out of 192);
- Benzo(a)pyrene (9 samples out of 192);
- Indeno(1,2,3-cd)pyrene (1 sample out of 192);
- Dibenzo(a,h)anthracene (9 sample out of 192).

For the majority of these PAHs the pathway of concern is ingestion of soil and indoor dust, with the exception of naphthalene which also poses an indoor vapour risk. None of the stockpile material samples recorded exceedances of the PAH screening criteria.

A plan showing the location of the PAH exceedances (again representing all the previously noted investigation findings) is provided as Figure 173958-GIS020 in Appendix A.

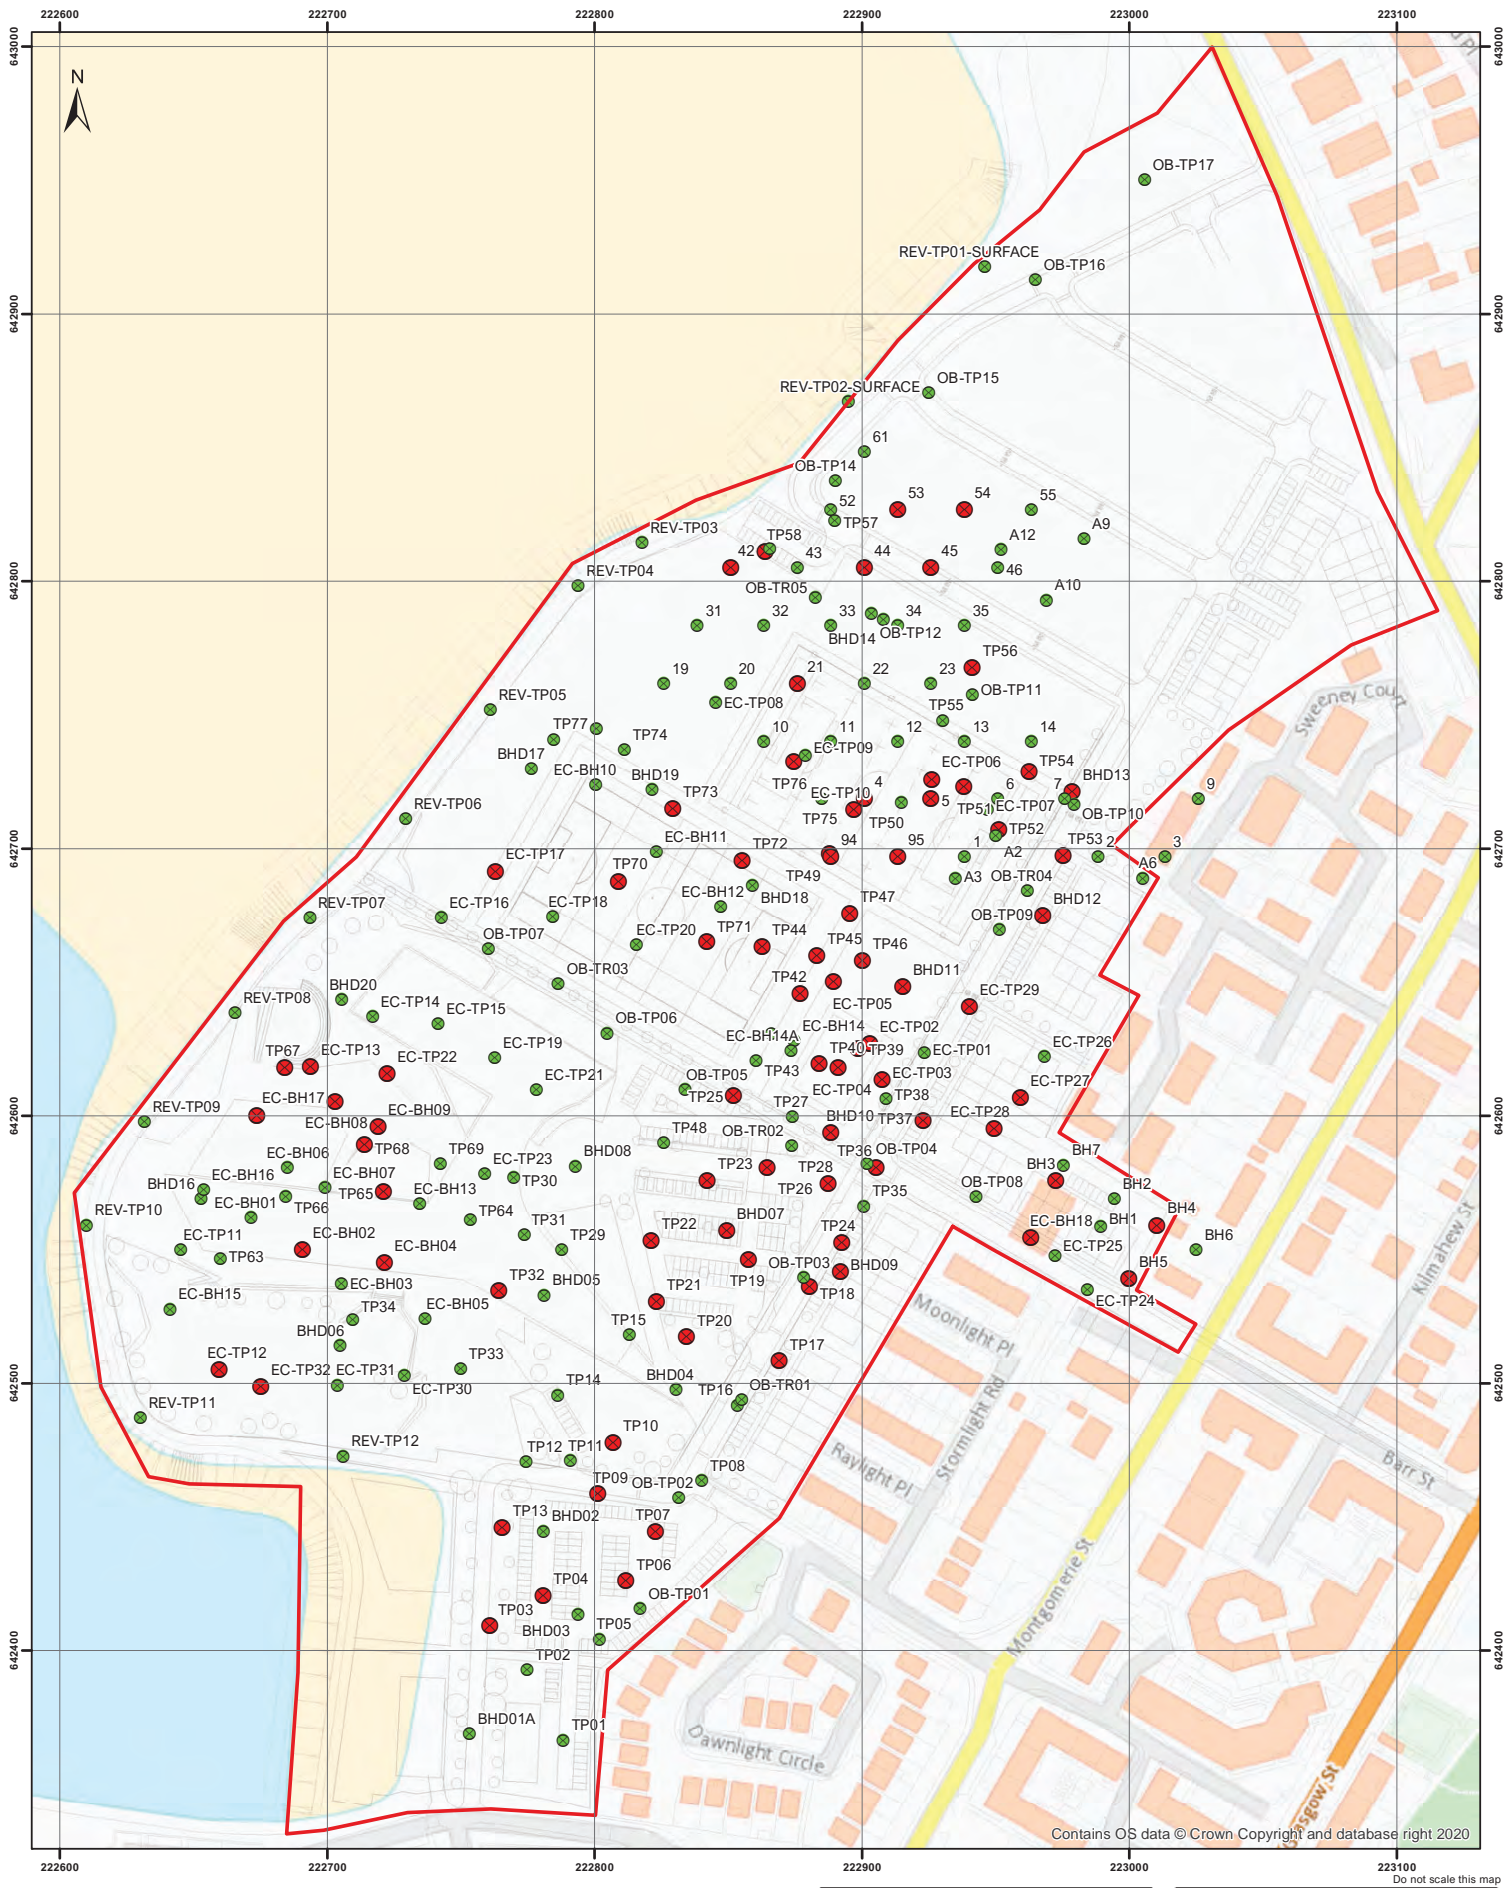
- Legend**
- Site Boundary
 - TPH & PAH**
 - TPH/PAH Exceedance(s)
 - No TPH/PAH Exceedances
