Millport Coastal Flood Protection Scheme: Environmental Statement

Chapter 8 Benthic and Intertidal Ecology

Reference: PB4749-RHD-ZZ-XX-RP-Z-0008

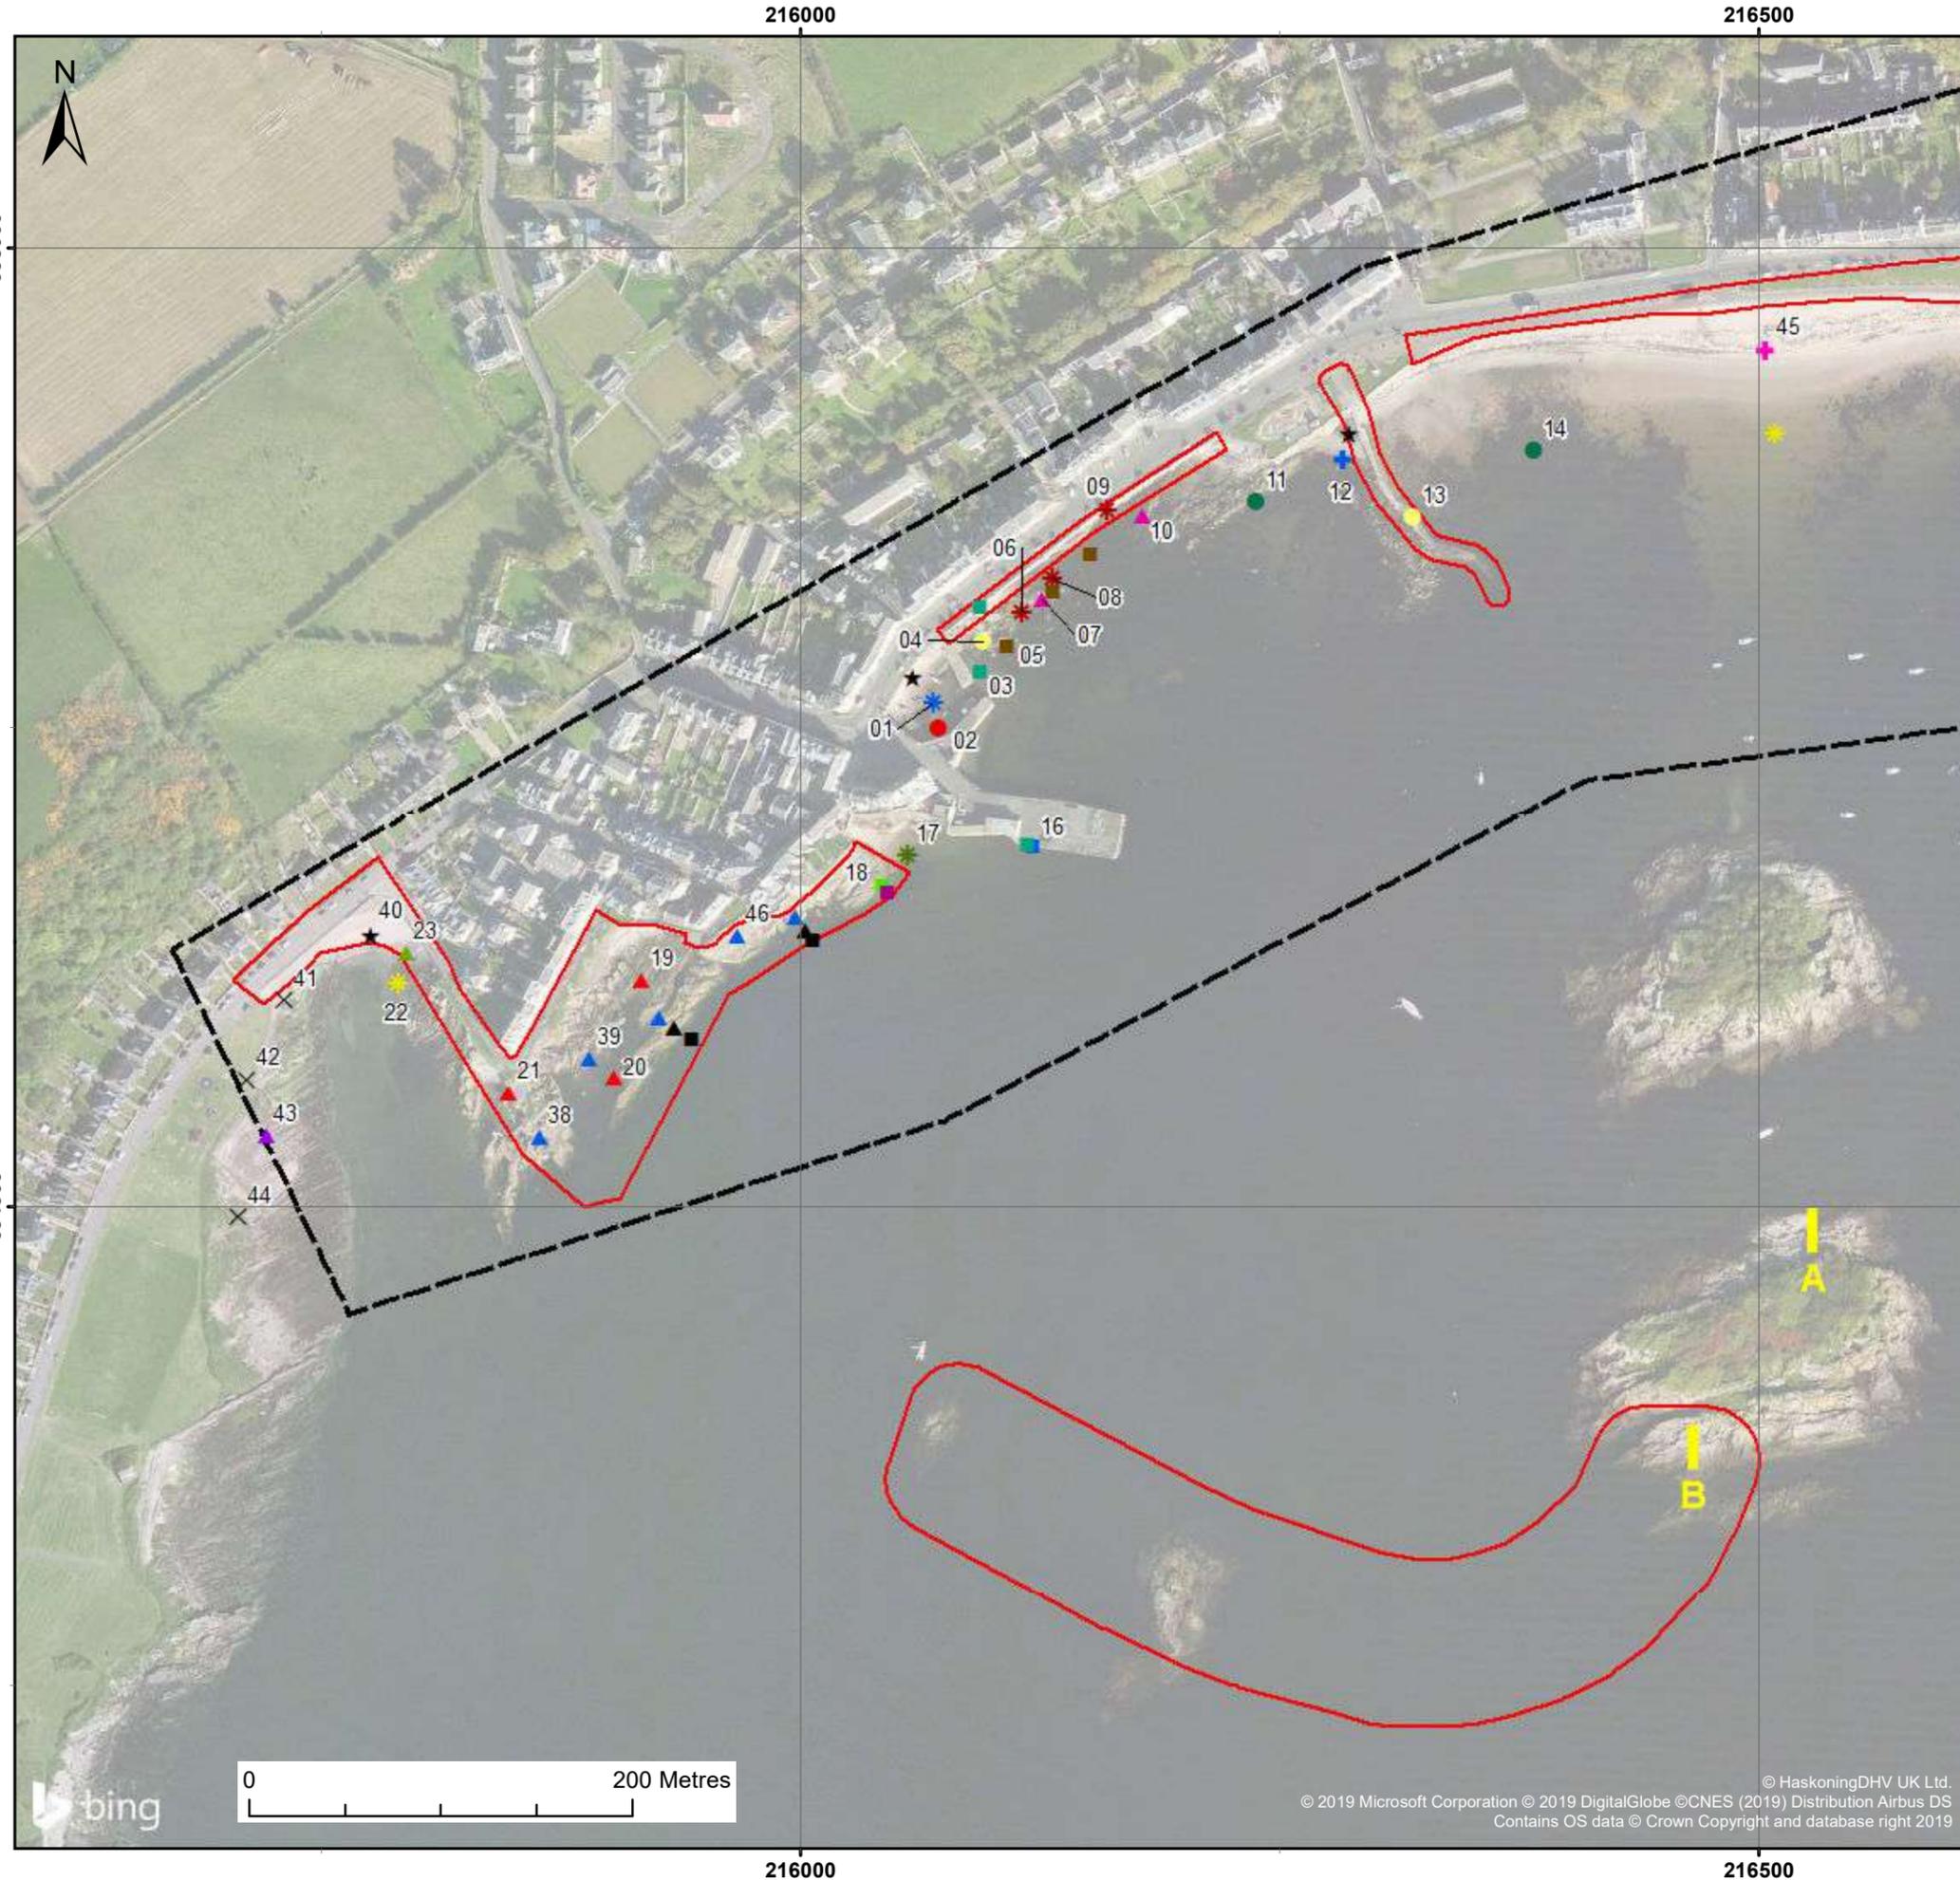
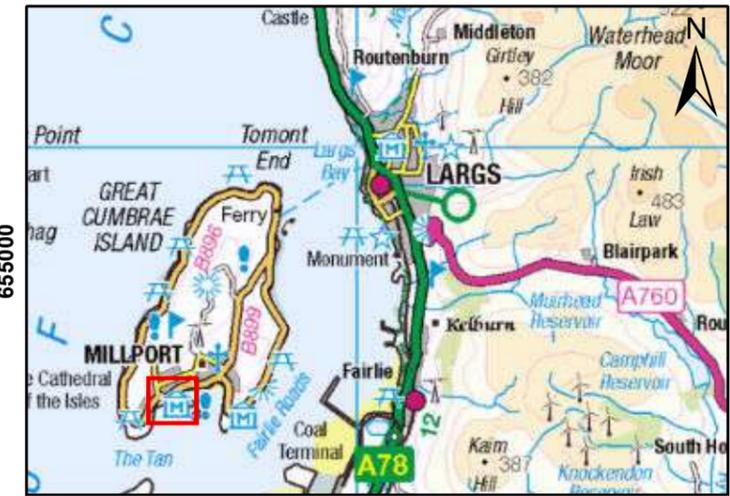
- Redline Boundary
 - Intertidal Study Area
 - Benthic Intertidal Transects 1
- Biotope²**
- ▲ LR.FLR.Eph.BLitX
 - ▲ LR.FLR.EphEnt
 - ▲ LR.FLR.Lic.Ver.B
 - ▲ LR.FLR.Lic.YG
 - ▲ LR.FLR.Rkp
 - ▲ LR.FLR.Rkp.G
 - LR.HLR.MusB
 - LR.HLR.MusB.Cht
 - LR.HLR.MusB.MytB
 - LR.HLR.MusB.Sem.FvesR
 - LR.HLR.MusB.Sem.LitX
 - LR.HLR.MusB.Sem.Sem
 - LR.MLR.BF.FspiB
 - LR.MLR.BF.FvesB
 - LR.MLR.BF.PelB
 - + LS
 - + LS.LCS
 - + LS.LCS.Sh.BarSh
 - + LS.LCS.sh.BarSh
 - × LS.LMp
 - * LS.LSa
 - * LS.LSa.FiSa.Po
 - * LS.LSa.MoSa
 - * LS.LSa.MuSa.MacAre
 - ★ LS.LSt.St
 - Lido

109. 26 different biotopes were recorded over the 44 different target notes (Table 8-11). Often multiple biotopes were recorded within a single target note and therefore 81 biotope positions were recorded. The locations of biotopes found during the survey are displayed in Figure 8-3.

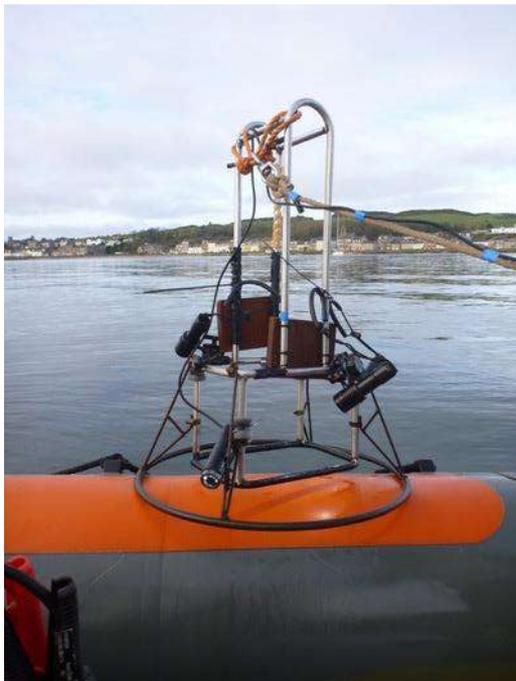
Figure 3 Dropdown video cameras and lights used in this study

A good quality hand-held GPS (Garmin Montana 610) was used, with the horizontal accuracy (as displayed on the GPS) being monitored at all times to ensure that it remains within ± 1 m. Care was taken to deploy the camera so that it landed as close to the target position as possible, by taking account of the current and controlling speed and angle of the camera's descent.

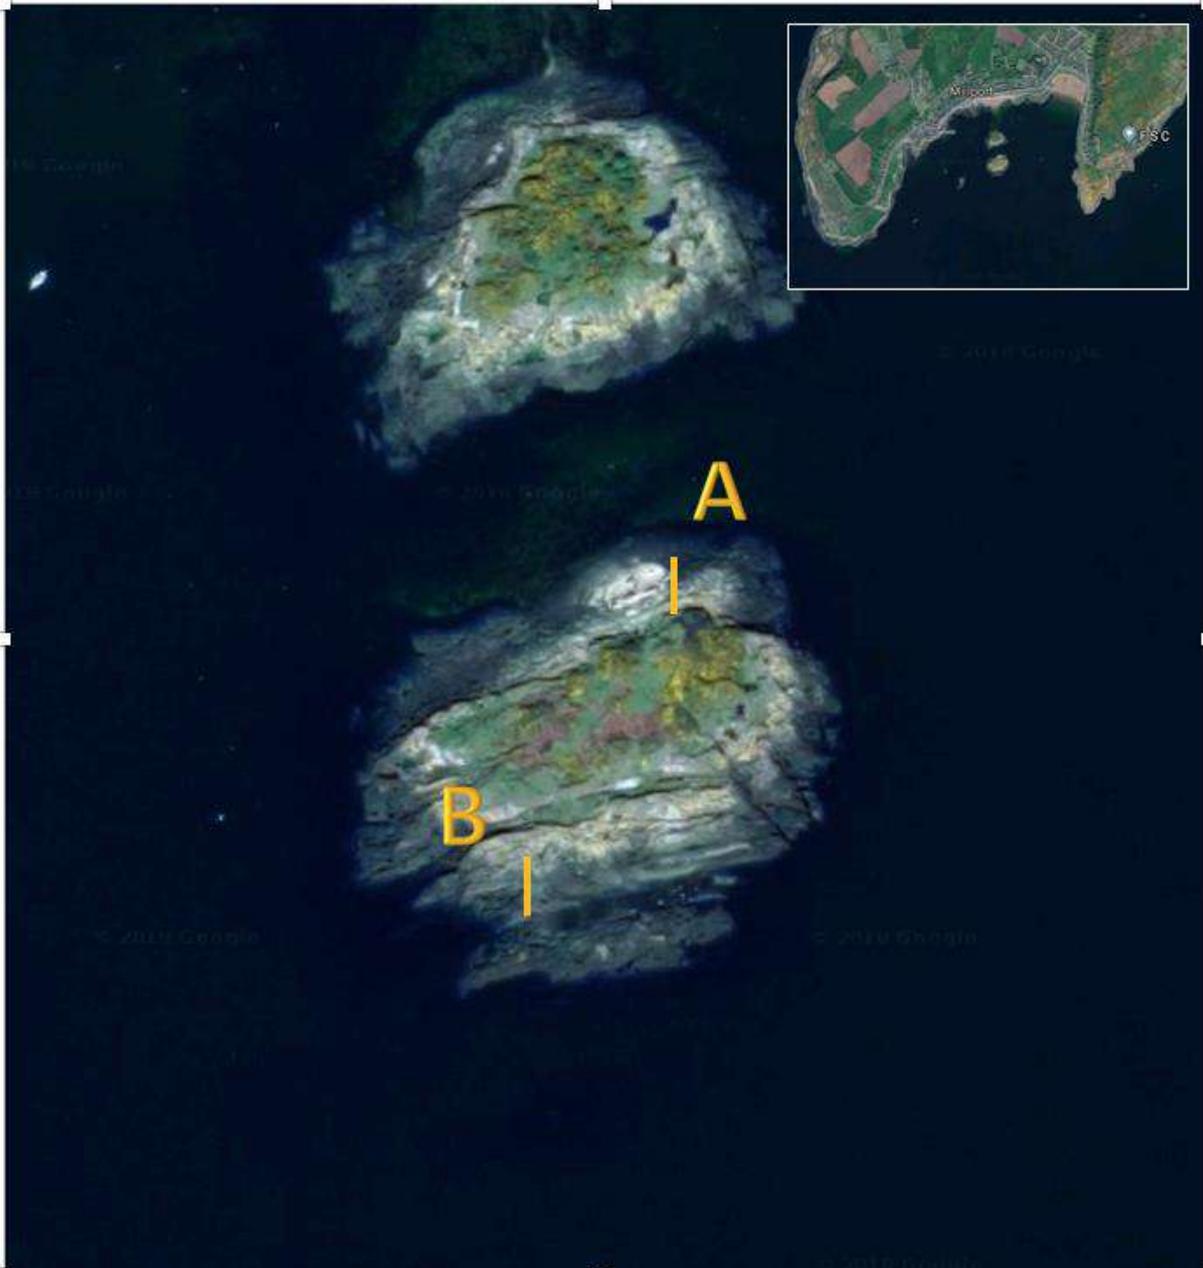
Figure 4 Aerial view of Eileans showing locations of the A and B transects.

Due to the height of the tide, much of the lower shore was covered by 0915hrs. However, the boat was landed near Transect A and a rapid assessment of the shore biotopes was undertaken through the water where biotopes were hidden. The survey results were supported by photographs and notes.

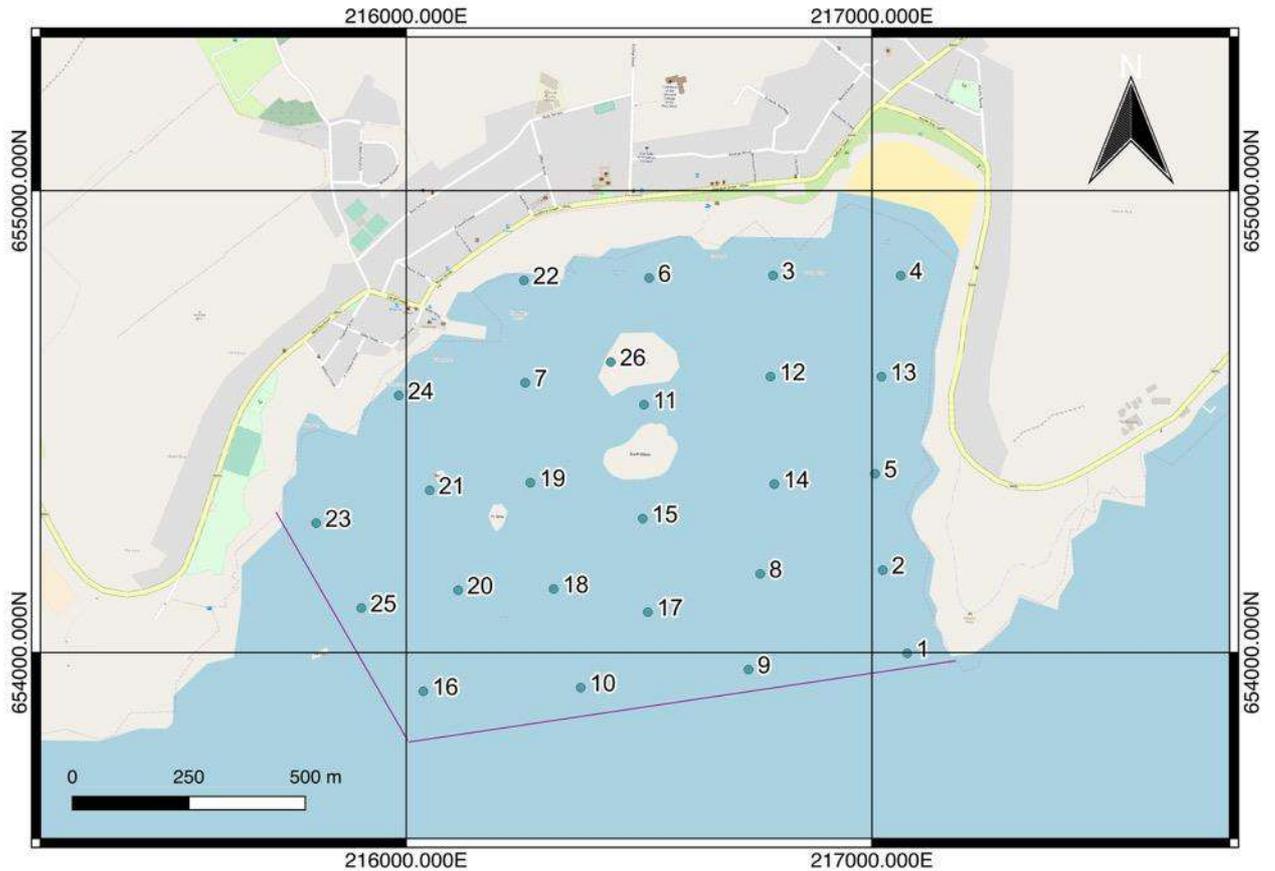
Figure 5 Drop down video locations within Kames Bay. The line offshore represents the limits of the survey area.

A total of 25 stations were studied using drop down video. The position of these stations are shown in Figure 5 and the northing and eastings are given in Table 1.

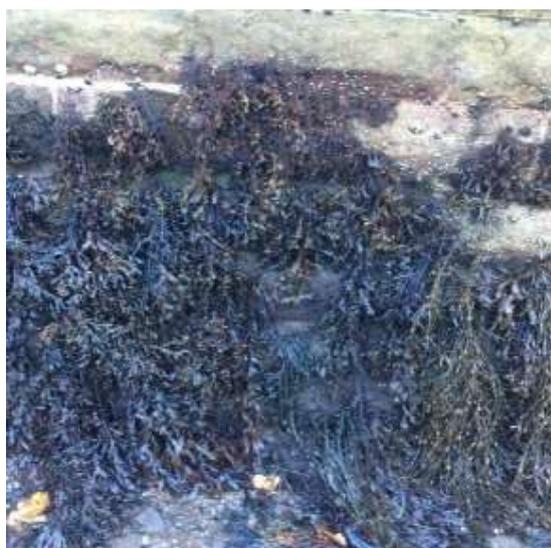
Plate 7 Harbour walls with clumps of *Fucus* and barnacle mosaics

Sheltered by the pier and large concrete walls is a small harbour (Figure 2a). The harbour walls supported sparse clumps of *Fucus vesiculosus* and barnacle mosaics (Plate 7). The harbour floor consisted of littoral fine sand with evidence of polychaetes including *Arenicola marina*. A fucoid strand line was present in the upper shore (TN1 in appendix A).

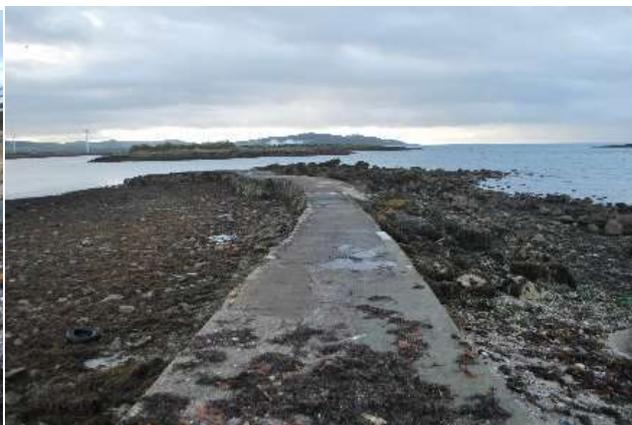
Plate 10 Walkway

At the eastern end of this section of Newtown Bay a concrete walkway bisects the shore (Plate 10). In the upper shore this forms a sheltered cobble filled bay in which a dense strand line (Figure 2a) was present (Plate 9). Further down the walkway boulders on either side supported Channelled wrack and barnacle communities (Plate 11).
